Mill Creek Outfall

LCR-78.9R

Strategy Objective: Collection : Prevent oil from entering the Columbia River

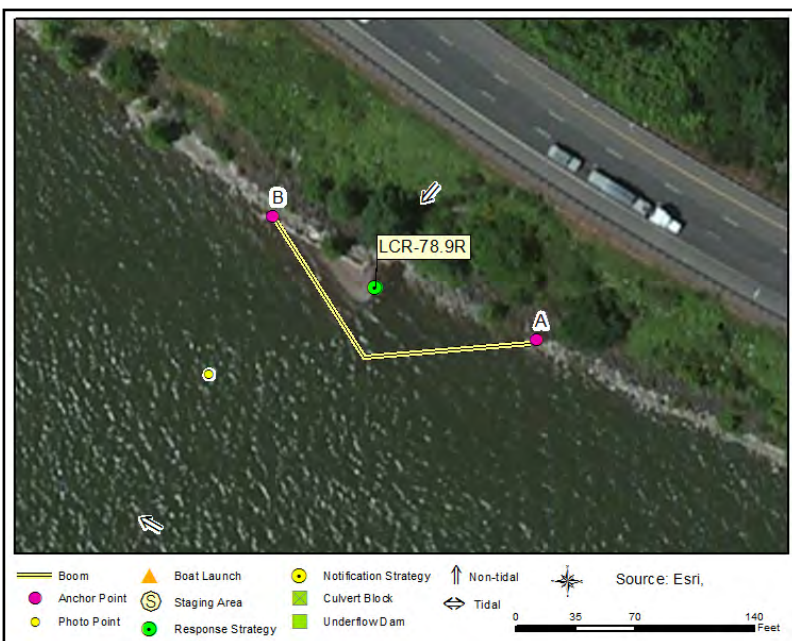
Implementation: Site accessible only by boat. Using workboat, anchor 200 ft of B3 boom to shore near A. Extend boom downstream and anchor to shore on the other side of the outfall, near B. Use in-line anchors to create on-water collection pocket. Back hard boom with sorbent boom. Collect oil using skimmer & floating storage. Adjust anchor locations and boom angles as needed for conditions.

Field Notes: Confluence of Mill Creek and Columbia River just downstream of Martin Island. Mill Creek is submerged under I-5 and BNSF tracks and enters river via outfall pipe.
