TRANSAXLE—CD4E—CLEARING TRANSAXLE SHIFT TABLES—SERVICE TIP	Article No. 99-20-9

FORD: 2000 CONTOUR

MERCURY: 2000 MYSTIQUE

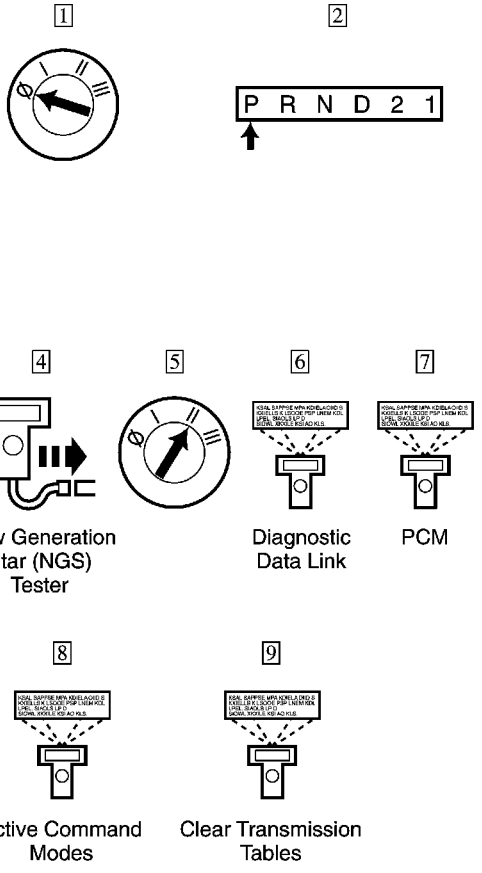
Figure 1 - Article 99-20-9

After any major transaxle repair or replacement such as any disassembly/repair which involves new clutches, seals, friction plates, servo, valve body, or solenoids, the Keep Alive Memory (KAM) transaxle shift tables in the Powertrain Control Module (PCM) should be cleared. The KAM shift tables should also be cleared after certain engine system repairs such as Mass Air Flow (MAF) sensor, injectors, exhaust/catalyst, fuel filter, fuel pressure, fuel pump, throttle position sensor, throttle body, air bypass or plugged air filters. Adaptive Pressure Control (APC) has compensated data stored in KAM shift tables for worn hardware and operator driving habits.

Clearing the KAM shift tables will allow the strategy to adjust to the repaired/replaced components. After clearing KAM transaxle tables, the APC strategy will readjust the stored data in the KAM shift tables to the new hardware. Refer to Figure 1 for procedures on clearing the KAM shift tables.

3 Check to make sure transmission harness connector is fully seated, terminals are fully engaged in connector and in good condition before proceeding. 9 Trigger on “Clear Transmission Tables” only.
