AXC F 2152 – CHANGE NOTES

Change notes for the AXC F 2152 controller

Application note

108427_en_41

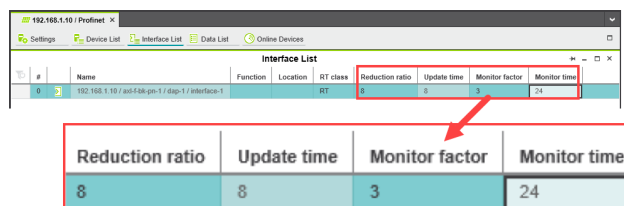
- Static_String array in C++ programs
The array sizes are incorrectly calculated in Static_String-type arrays (C++), meaning that access to the second element contained in the array and to those following is incorrect.
String arrays in IEC 61131 programs are not affected by this.
- AXC F 2152 as a PROFINET device
The AXC F 2152 cannot be operated as a PROFINET device under PROFINET controllers from third-party manufacturers.
- Monitor time of PROFINET data
The PROFINET data monitor time must be at least 24 ms. The monitor time is the product of “Reduction ratio” and “Monitor factor” (in PLCnext Engineer: “Profinet” editor group, “Interface list” editor).

| # | Name | Function | Location | RT class | Reduction ratio | Update time | Monitor factor | Monitor time |
| 0 | 192.168.1.10 / axi-f2152-pro-1 / diag-1 / interface-1 | | | RT | 8 | 8 | 3 | 24 |

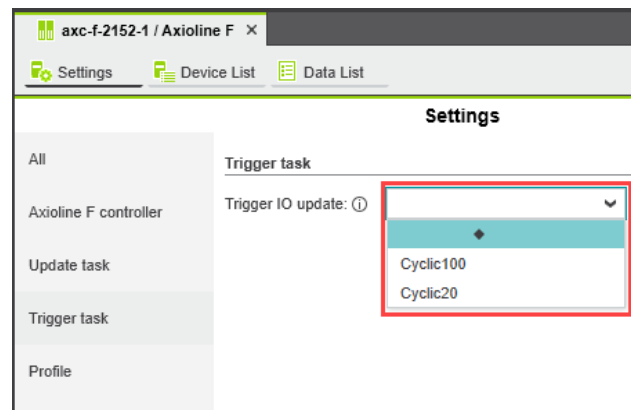
Figure 2 Select Trigger task

The “/ Axioline F” controller editor group opens.

- Select the “Trigger task” view in the “Settings” editor.
- In the drop-down list, select the task that is to trigger the Axioline F I/O data update.

If you do not select a task, the update will occur by default every 50 ms.
