LEFT FRONT SAFETY BELT RETRACTOR

AFFECTED VEHICLES: **CERTAIN 1996 THROUGH 2000 MODEL YEAR CROWN VICTORIA, GRAND MARQUIS AND TOWN CAR**

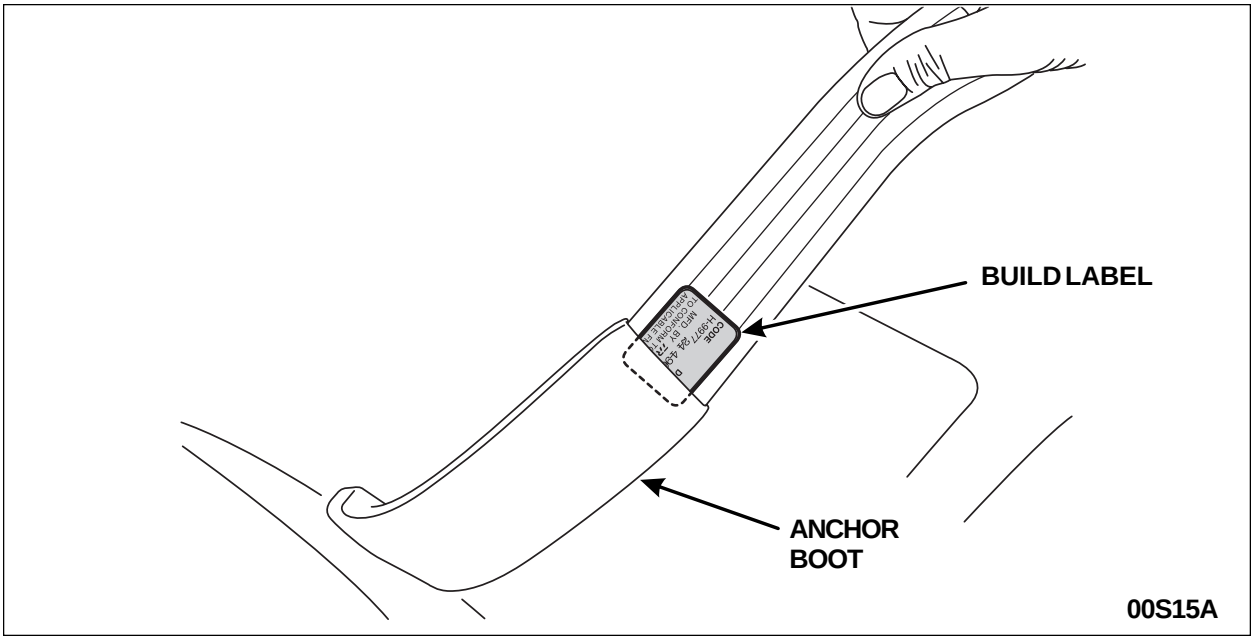
FIGURE 1

- Look for the build label on the webbing directly above the anchor boot. If the build label is located here proceed to Label Inspection on page 3. If the label is not located here proceed to the next bullet point. See Figure 1.

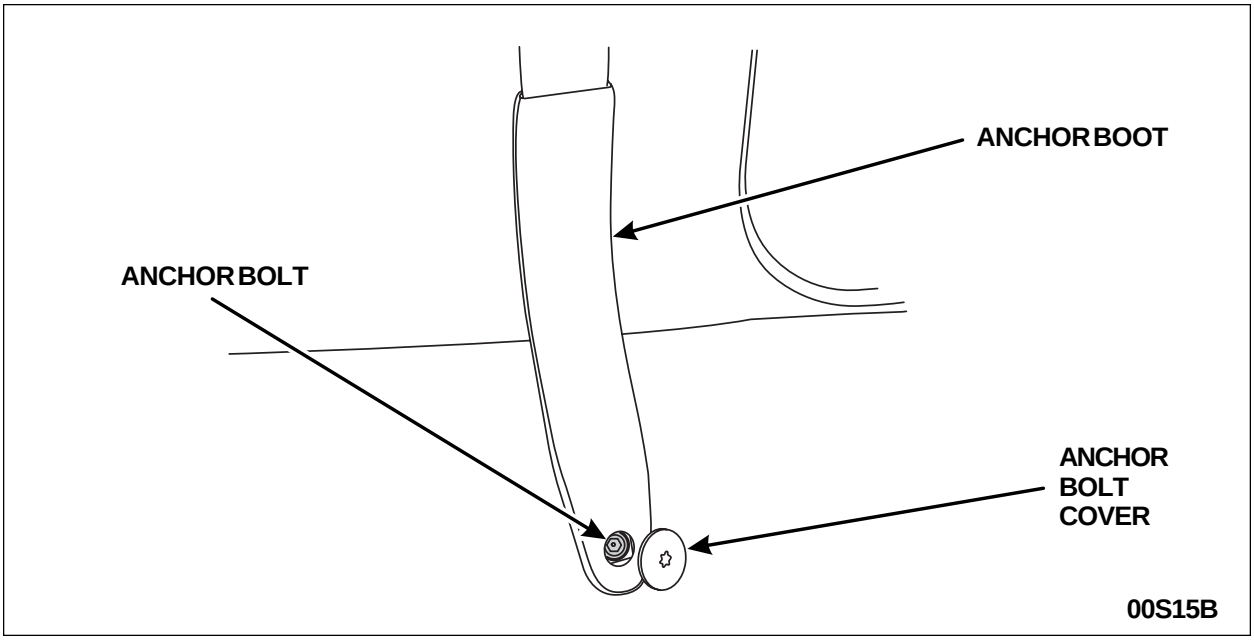
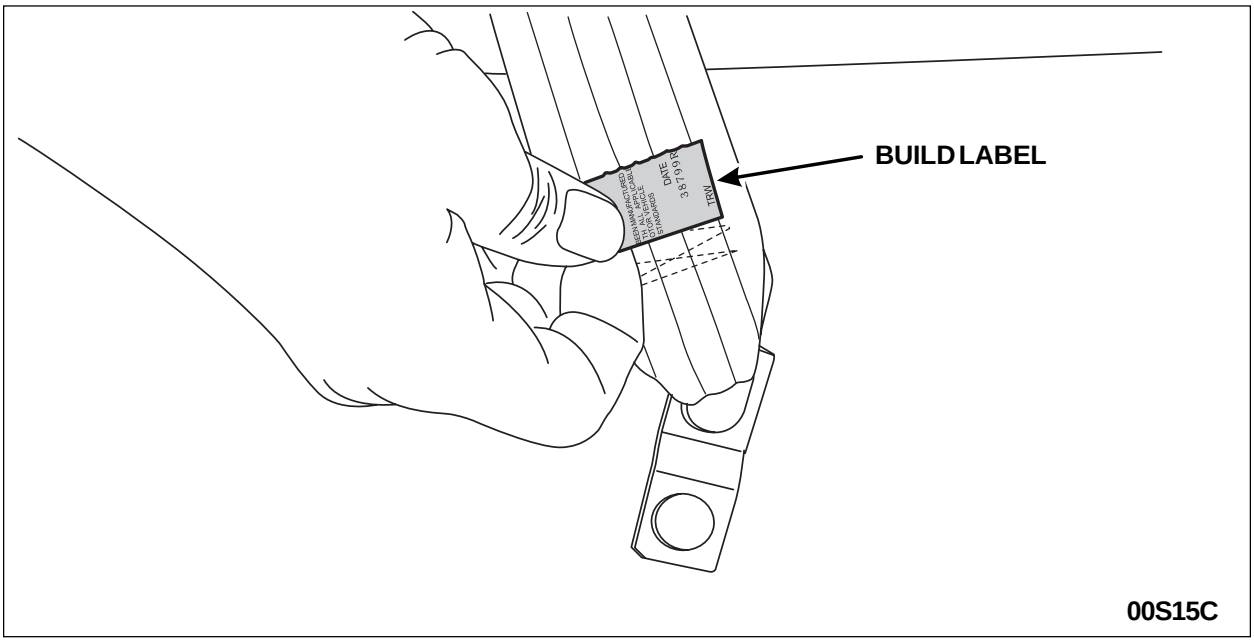
FIGURE 2

- Remove the anchor bolt cover, then the anchor bolt. Cut off the steel washer and remove the rubber washer to allow the bolt to come off, then slide the anchor boot off of the webbing. The build label is folded and sewn into the webbing. See Figures 2 and 3. Proceed to Label Inspection on page 3.

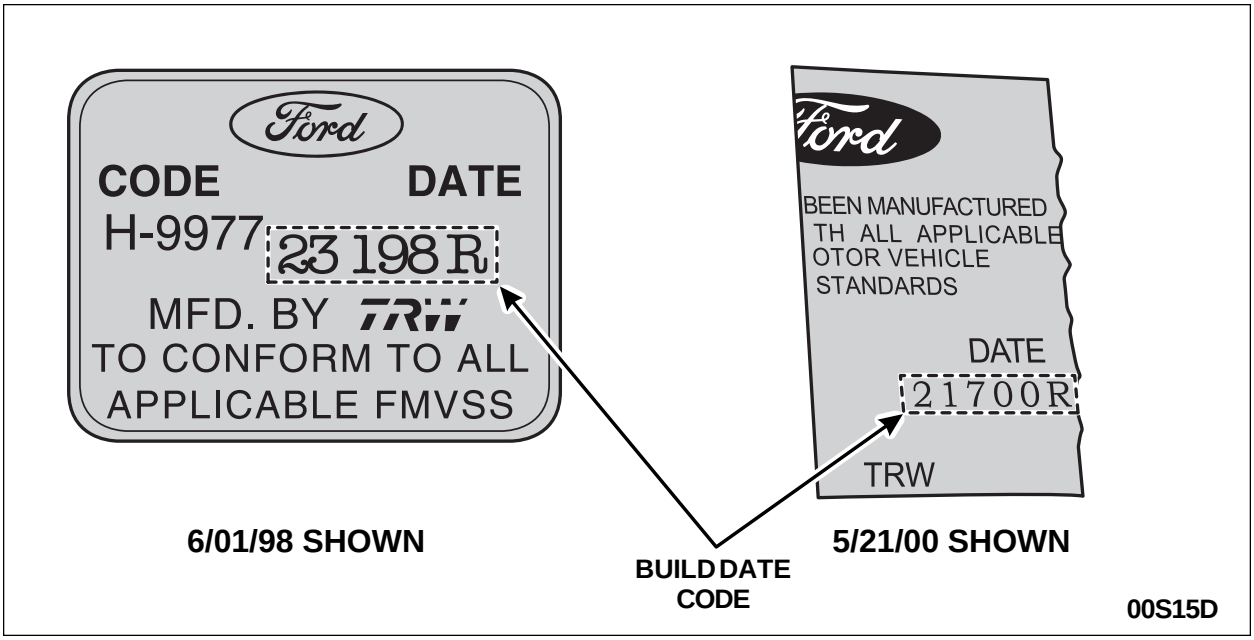
FIGURE 4

1. Locate the build date code on the build label. Use the examples in Figure 4 and the Build Date Code Translator chart to determine the build date.

2. The affected seat belt retractors were built from 6/01/98 (23 198 R) through 5/21/00 (21700R) and **must** be replaced.

A. If you have determined the seat belt must be replaced based on the build date, replace the seat belt retractor following the service procedures in Section 01-20A or 501-20A of the appropriate workshop manual.
