• **SUNROOF— "GRINDING/GROANING/SQUEAKING/SQUEALING" NOISE FROM SUNROOF WHILE OPENING OR CLOSING** • **NOISE— "GRINDING/GROANING/SQUEAKING/SQUEALING" FROM SUNROOF WHILE OPENING OR CLOSING**	**Article No. 99-19-3**

MERCURY: 1999-2000 COUGAR

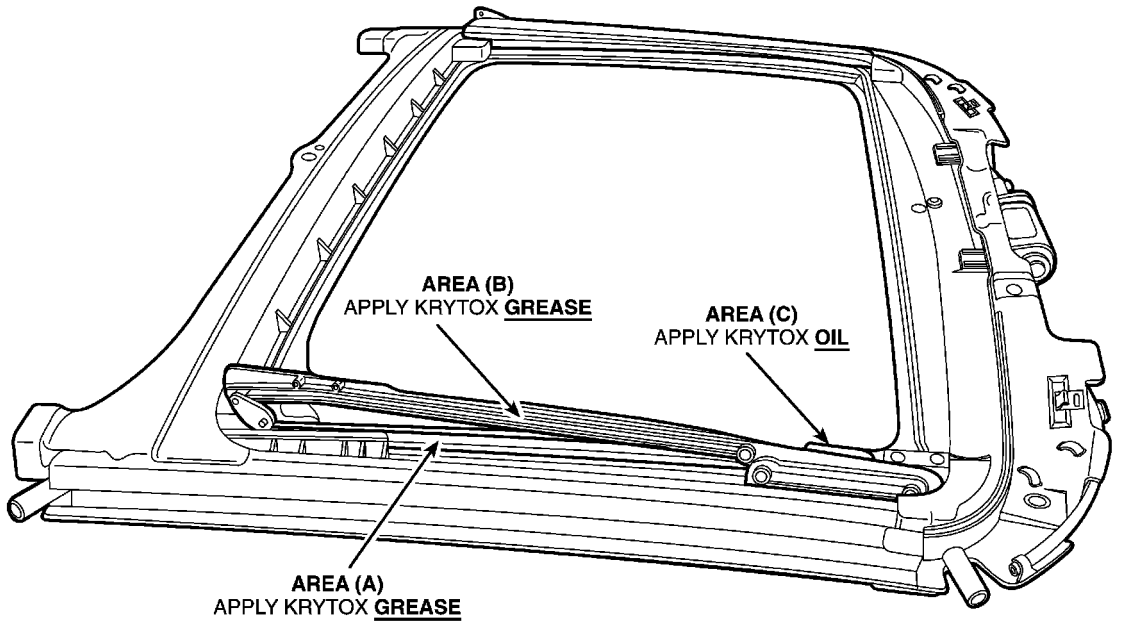
Figure 1 - Article 99-19-3

A "grinding/groaning/squeaking/squealing" noise when opening or closing the sunroof may be heard on some vehicles. This may be due to insufficient lubrication or dirt accumulation in the track.

1. Raise the sunroof to the fully open position.
2. From inside the vehicle, wipe as much of the existing grease out of the lower stationary LH and RH tracks (which run parallel to the roof line) as possible (Figure 1, Area A).

3. Apply Krytox grease (164-R4906) to the stationary tracks.
4. From the outside of the vehicle, wipe as much of the existing grease out of the moveable LH and RH tracks (attached to the sunroof panel) as possible (Figure 1, Area B).

5. Apply Krytox grease (164-R4906) to the moveable tracks.
6. Apply Krytox oil (164-R4905) to a small brush, and from the outside of the vehicle apply it to the flocking at the front of the track (Figure 1, Area C).
