AXC F 2152 – CHANGE NOTES

Change notes for the AXC F 2152 controller

Application note

108427_en_20

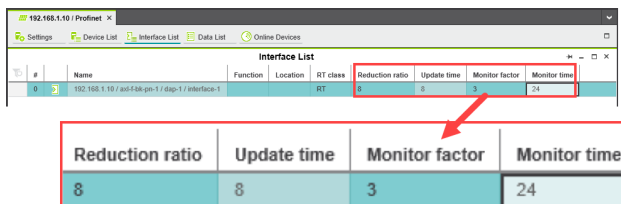
- Static_String array in C++ programs
The array sizes are incorrectly calculated in Static_String-type arrays (C++), meaning that access to the second element contained in the array and to those following is incorrect.
String arrays in IEC 61131 programs are not affected by this.
- AXC F 2152 as a PROFINET device
The AXC F 2152 cannot be operated as a PROFINET device under PROFINET controllers from third-party manufacturers.
- Monitor time of PROFINET data
The PROFINET data monitor time must be at least 24 ms. The monitor time is the product of „Reduction ratio“ and „Monitor factor“ (in PLCnext Engineer: „Profinet“ editor group, „Interface list“ editor).

#	Name	Function	Location	RT class	Reduction ratio	Update time	Monitor factor	Monitor time
0	192.168.1.10 / axi-fib-gp-1 / dip-1 / interface-1	RT			8	8	3	24
