2001 ESCAPE STEERING WHEEL RETENTION NUT

AFFECTED VEHICLES: CERTAIN 2001 MODEL YEAR ESCAPE

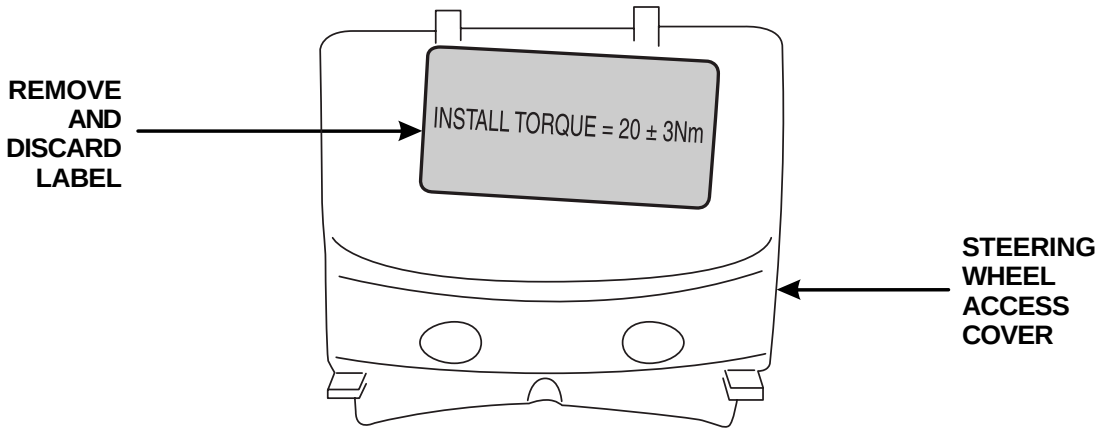
FIGURE 1

1. Remove the steering wheel. Refer to the service procedures in Section 211-04 of the appropriate Workshop Manual.
2. **CAUTION: The torque information label located on the steering wheel access cover contains inaccurate information. This label MUST be removed and discarded.**

LABEL CONTAINS INACCURATE INFORMATION

Remove and discard the torque information label. See Figure 1.

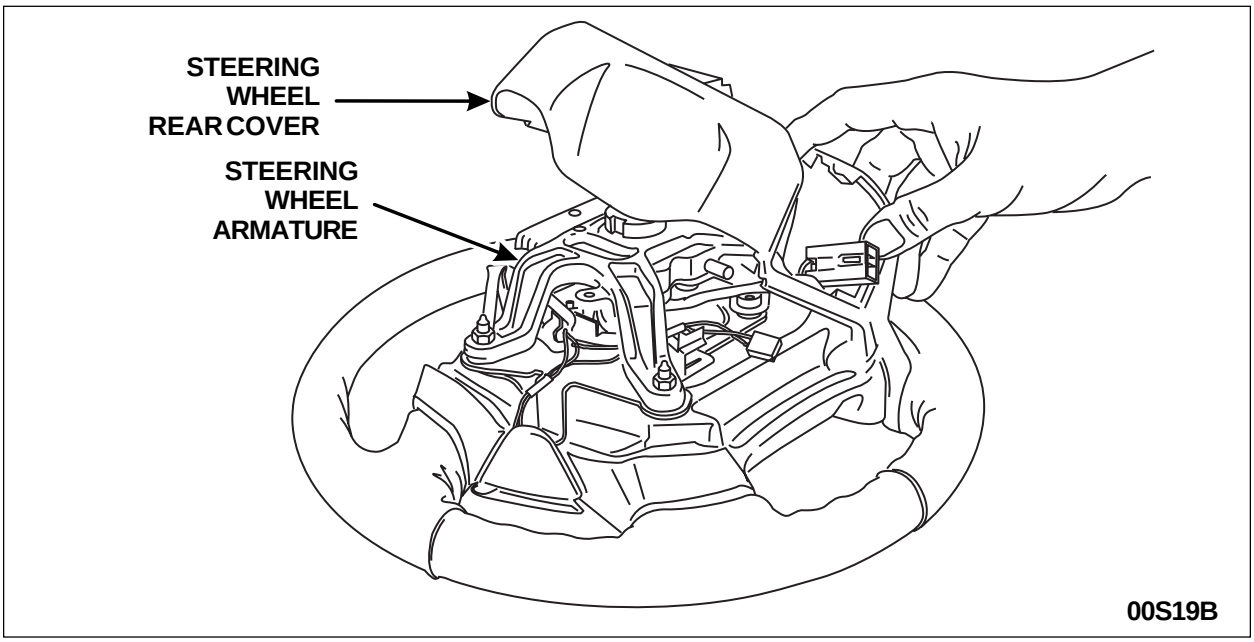
FIGURE 2

Disassemble the steering wheel as follows. See Figure 2.
   - Remove the steering wheel rear cover.
   - Remove the steering wheel armature.

5. **CAUTION: Do not reinstall the original armature after inspection. Install a *new* armature on all vehicles.**

A. If a square edge is found, the steering wheel retention nut is correctly installed.
   - Install a ***new*** steering wheel armature. Tighten the nuts to 12 Nm (9 lb-ft).
   - Install the steering wheel rear cover. Tighten the screws to 2 Nm (18 lb-in).
   - Install the steering wheel. Tighten the steering wheel retention nut to 12 Nm (9 lb-ft). Refer to the service procedures in Section 211-04 of the appropriate Workshop Manual.

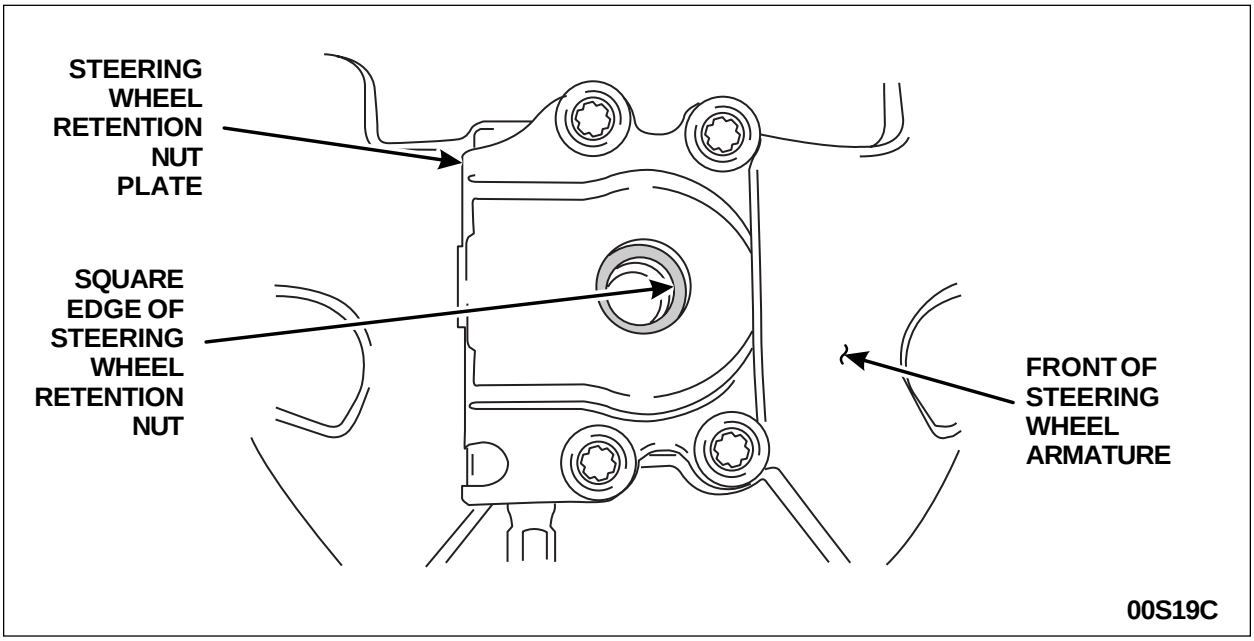
FIGURE 3

Inspect the steering wheel retention nut. The surface of the steering wheel retention nut should form a square edge with the threads of the nut. See Figure 3.

B. If a tapered edge is found, the steering wheel retention nut is NOT correctly installed. The steering wheel armature AND steering column must be replaced.

- Install a ***new*** steering column (Refer to your parts catalog to determine the specific steering column [-3524-] for the vehicle application). Use two (2) ***new*** ignition module shear bolts (YL8Z-12049-AA) and one (1) ***new*** pinch bolt (YL8Z-3R827-AA) when installing the ***new*** steering column. Refer to the service procedures in Section 211-04 of the appropriate Workshop Manual.

- Install a ***new*** steering wheel armature. Tighten the nuts to 12 Nm (9 lb-ft).
   - Install the steering wheel rear cover. Tighten the screws to 2 Nm (18 lb-in).

- Install the steering wheel. Tighten the steering wheel retention nut to 12 Nm (9 lb-ft). Refer to the service procedures in Section 211-04 of the appropriate Workshop Manual.
