AXC F 2152 – CHANGE NOTES

Change notes for the AXC F 2152 controller

Application note

108427_en_22

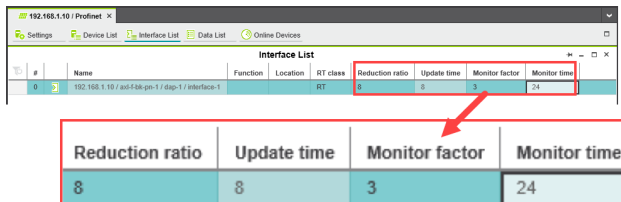
- Static_String array in C++ programs
The array sizes are incorrectly calculated in Static_String-type arrays (C++), meaning that access to the second element contained in the array and to those following is incorrect.
String arrays in IEC 61131 programs are not affected by this.
- AXC F 2152 as a PROFINET device
The AXC F 2152 cannot be operated as a PROFINET device under PROFINET controllers from third-party manufacturers.
- Monitor time of PROFINET data
The PROFINET data monitor time must be at least 24 ms. The monitor time is the product of „Reduction ratio“ and „Monitor factor“ (in PLCnext Engineer: „Profinet“ editor group, „Interface list“ editor).

#	Name	Function	Location	RT class	Reduction ratio	Update time	Monitor factor	Monitor time
0	192.168.1.10 / axi-fib-gp-1 / dip-1 / interface-1	RT			8	8	3	24
