BRAKE PRESSURE CONTROL REDUCING VALVE (PCRV) REPLACEMENT

AFFECTED VEHICLES: CERTAIN 1996-1998 CONTOUR/MYSTIQUE WITHOUT ABS

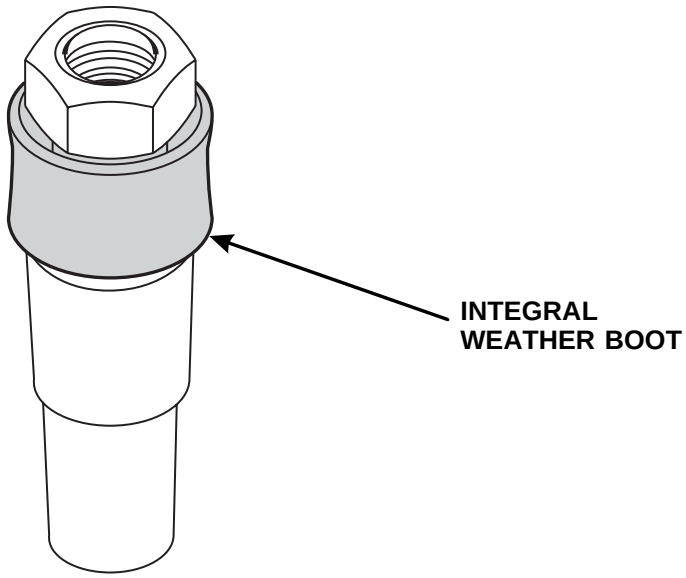
FIGURE 1

- Replace both rear-mounted PCRVs (if equipped) with ***new***, redesigned PCRVs. The new valves have an integral weather boot. (See Figure 1.)
- Bleed the rear brakes.

REDESIGNED PCRV

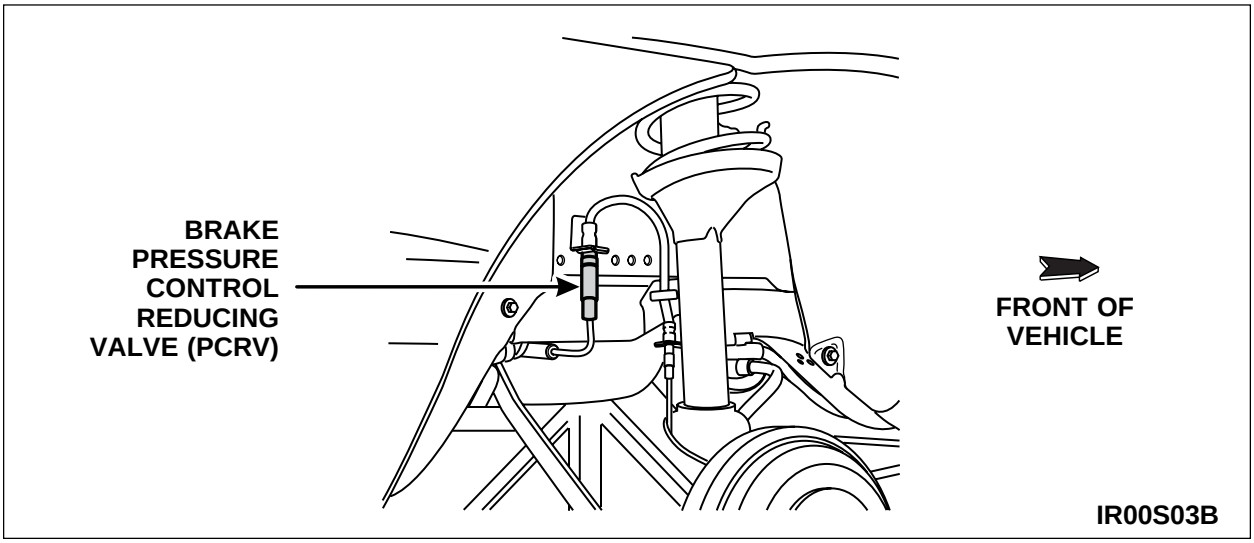
FIGURE 2

On 1996 Model Year vehicles only, inspect for the presence of a PCRV near either rear wheel. See Figure 2 of the Service Procedure for location. Neither rear tire has to be removed to perform this inspection. If a valve is present, proceed with the service procedure. If a valve is not present, no service is required. Release the vehicle to the owner.

1. Raise the vehicle on the hoist and remove the rear tires.
2. Apply Penetrating and Lock Lubricant E8AZ-19A501-B or equivalent to the brake line and brake hose. See Figure 2.
3. Disconnect the brake line and brake hose from the PCRV. See Figure 2.
4. Remove the PCRV. See Figure 2.

5. Install the ***new*** PCRV. Tighten the line fittings to 13 Nm (10 lb-ft).
