MOP for Ceragon Radio signal degrade Alarm Fault management

This document outlines the step-by-step process involved in Ceragon Radio signal degrade Alarm Fault management.

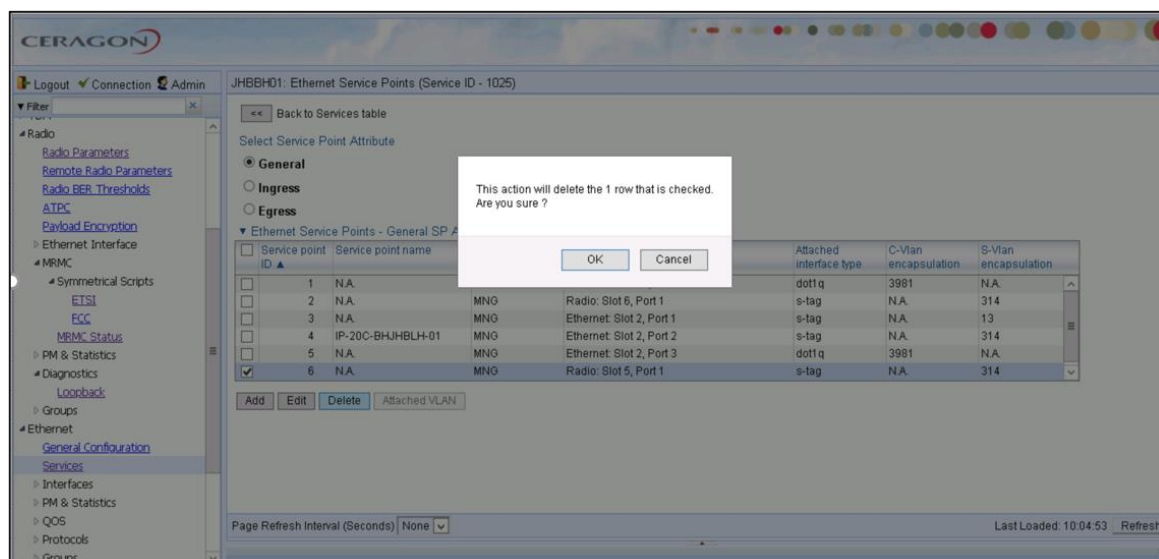
After deleting radio port from Eth services.

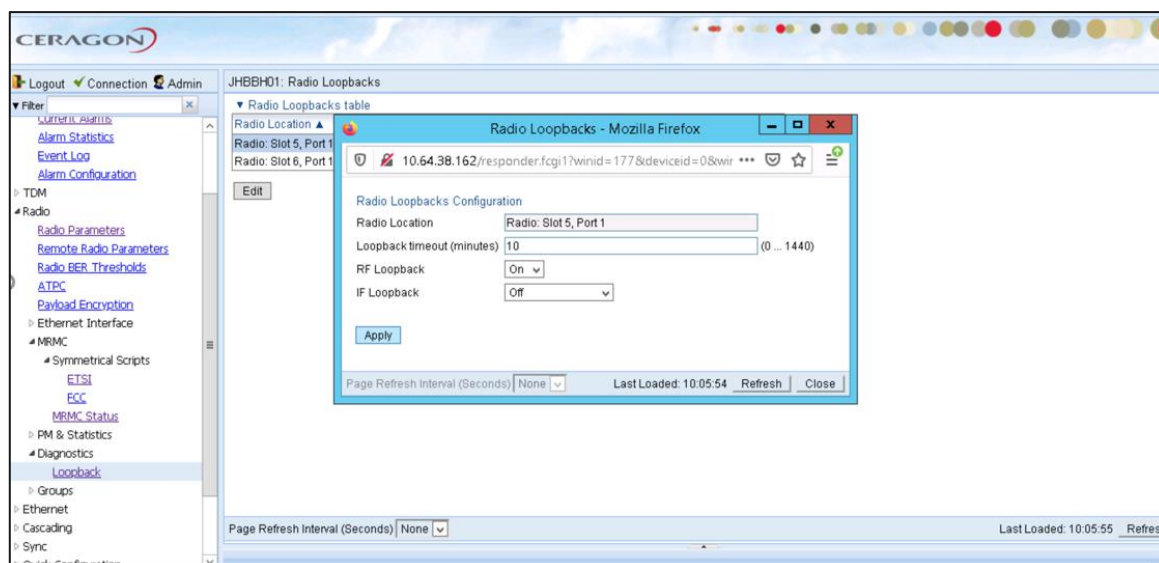
Set Loopback timeout and enable RF loop back and click on Apply. Far-end Radio TX should be mute before performing loopback.

After enabling RF loopback, RSL as per configured modulation. (recommended MSE value table according to modulation attached). and defective blocks should not increase. if not then replace ODU or check IF connectivity.

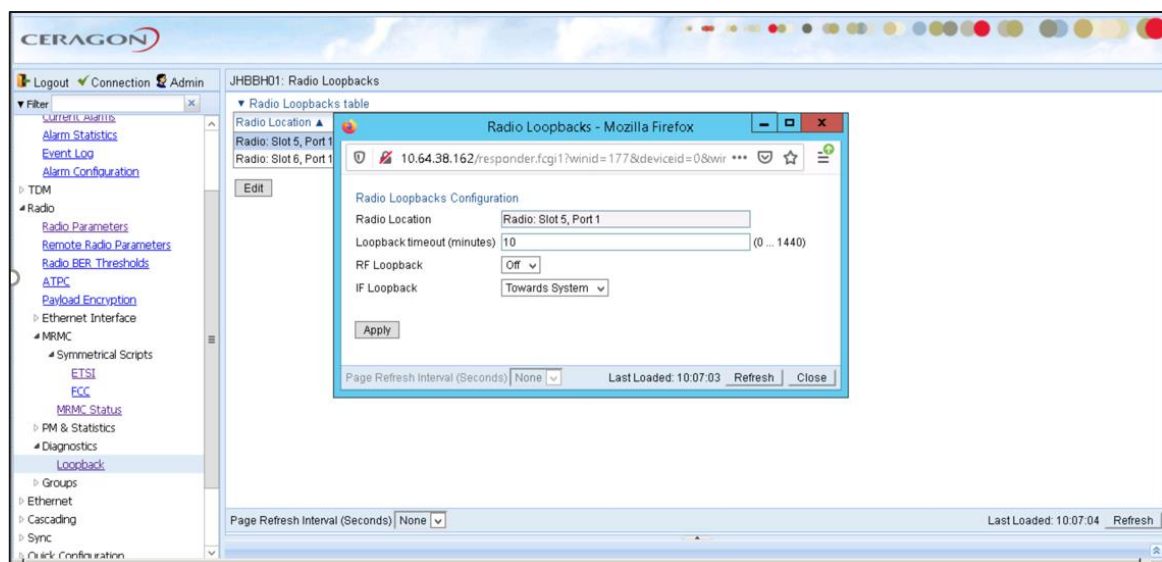
Set Loopback timeout and enable IF loop back and click on Apply. Far-end Radio TX should be mute before performing loopback.

After enabling IF loopback, MSE should be OK, as per configured modulation. (recommended MSE value table according to modulation attached). and defective blocks should not increase if not then replace RMC.

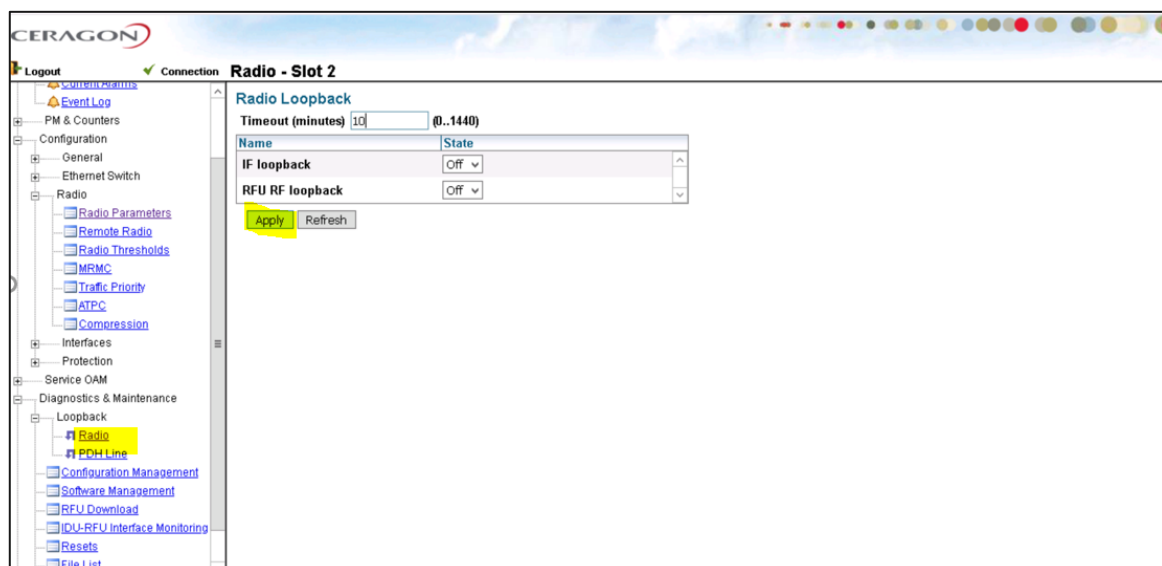
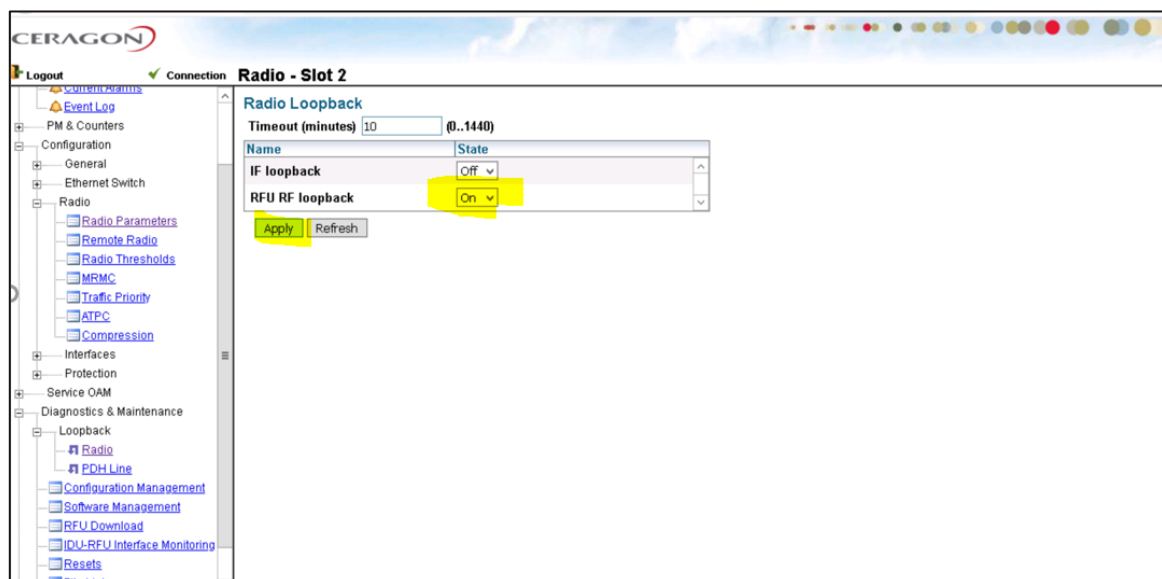
Set Loopback timeout and enable RF loop back and click on Apply. Far-end Radio TX should be mute before performing loopback.

After enabling RF loopback, RSL and MSE should be OK, as per configured modulation. (recommended MSE value table according to modulation attached). and defective blocks should not increase. if not then replace ODU or check IF connectivity.
