MOP for Ceragon Radio Excessive BER Alarm Fault management

This document outlines the step-by-step process involved in Ceragon Radio Excessive BER Alarm Fault management.

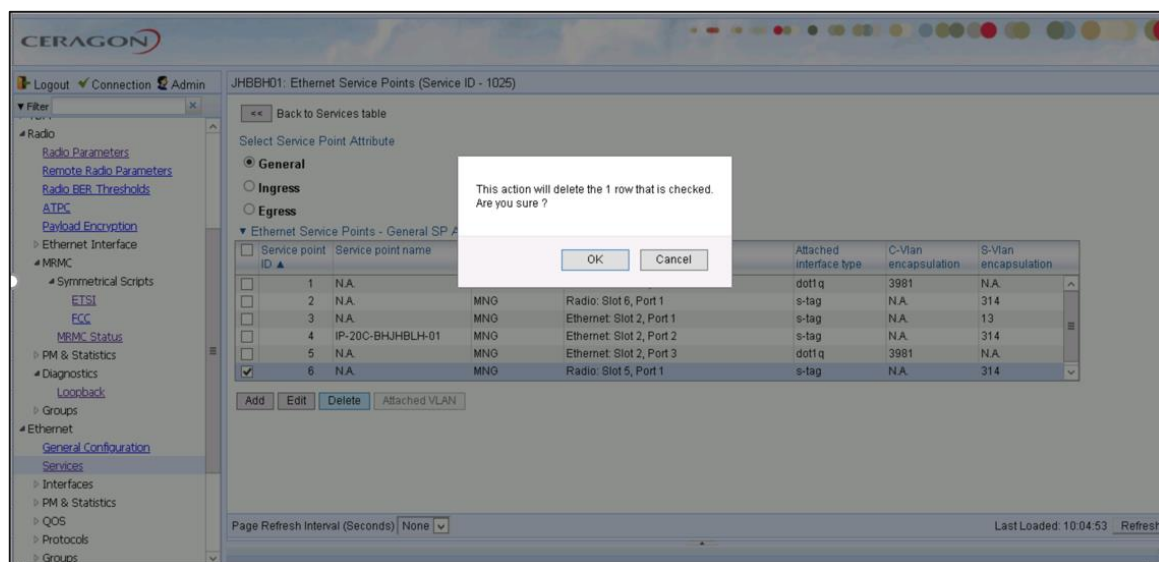
After deleting radio port from Eth services.
