- **LEAK—AUTOMATIC TRANSMISSION FLUID—CD4E TRANSAXLE—FLUID SEEPING FROM VENT, RESULTING IN FLUID COLLECTING ON MAIN CONTROL ASSEMBLY**
- **LEAK—AUTOMATIC TRANSMISSION FLUID—CD4E TRANSAXLE—FROM TRANSAXLE FLUID FILL TUBE**
- **TRANSAXLE—CD4E—TRANSMISSION FLUID LEAKING FROM TRANSAXLE FLUID FILL TUBE**
- **TRANSAXLE—CD4E—TRANSMISSION FLUID SEEPING FROM VENT, RESULTING IN FLUID COLLECTING ON MAIN CONTROL COVER**

Article No. 99-24-9

FORD: 1994-1997 PROBE
1995-2000 CONTOUR

MERCURY: 1995-2000 MYSTIQUE
1999-2000 COUGAR

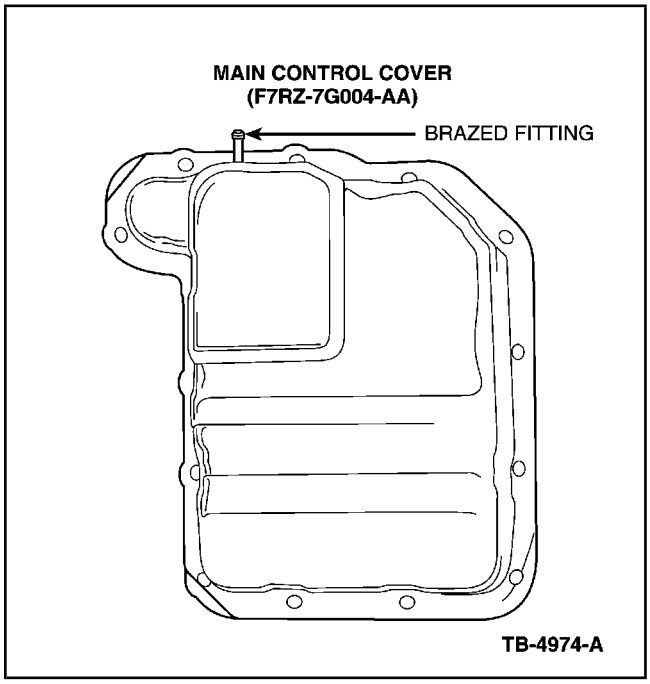
Figure 1 - Article 99-24-9

BEGINNING JANUARY 1997, ALL CD4E TRANSAXLES CONTAIN A REVISED MAIN CONTROL COVER (F7RZ-7G004-AA), FIGURE 1, AND VENT TUBE ASSEMBLY (F7RZ-7034-CA FOR PROBE AND F7RZ-7034-BA FOR CONTOUR/MYSTIQUE), FIGURE 2. THIS NEW DESIGN WILL PREVENT FLUID FROM SEEPING FROM THE VENT. IF THE VENT HOSE IS KINKED OR BLOCKED INTERNALLY, FLUID WILL LEAK FROM THE TRANSAXLE FILL TUBE.

If replacement of a main control cover is required, replace with a new Main Control Cover (F7RZ-7G004-AA) and a Vent Tube Assembly (F7RZ-7034-BA).

Vehicles built with the new designed main control cover must use the new Main Control Cover (F7RZ-7G004-AA) and/or new design Vent Tube Assembly (F7RZ-7034-CA for Probe, F7RZ-7034-BA for Contour/Mystique) if replacement is required.
