MOP of Loss of Active/Standby Communication Link (199005122) for ZTE Site

Activity Description

This activity is for E2E troubleshooting and alarm clearance of Temperature sensor abnormal(198092071)

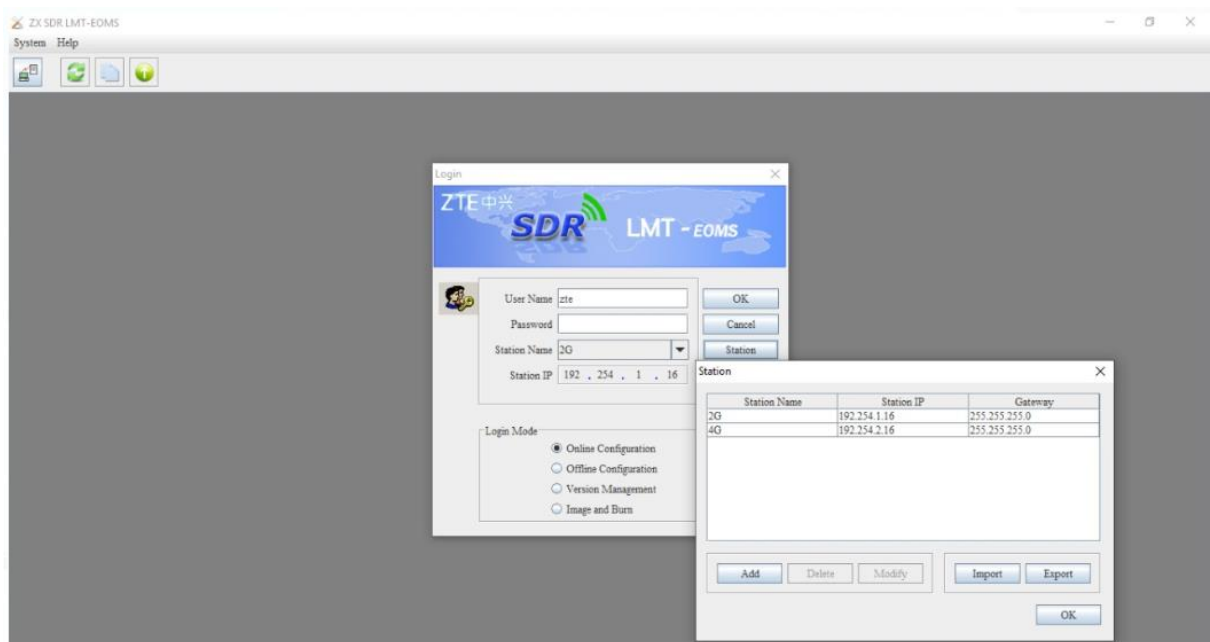
A) Login in 2G BBU/ enodeb as per RAN MOP via ZX SDR LMT OEMS connect using LAN cable

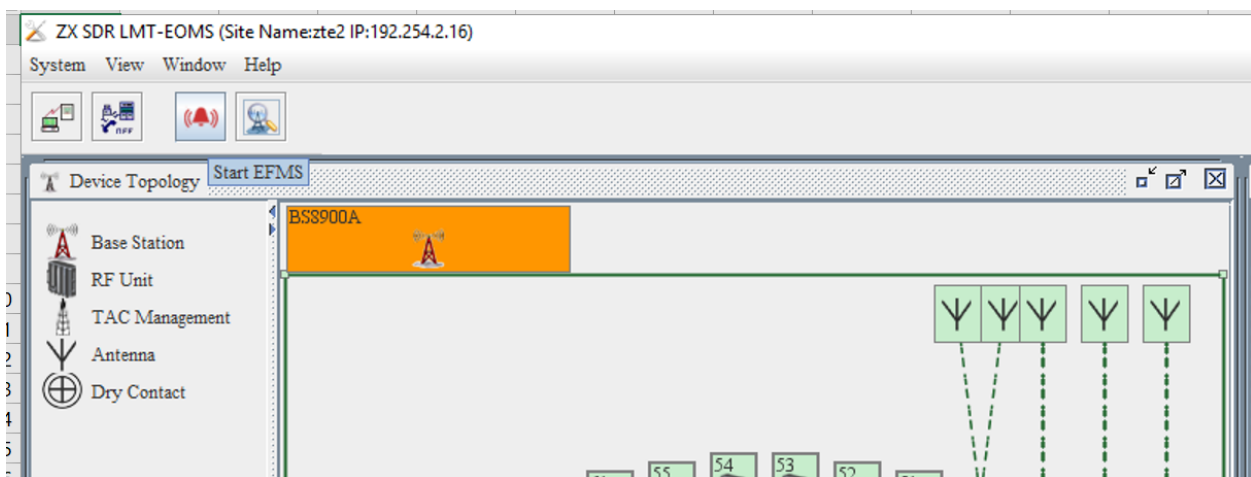
a) Start EFMS to view alarm window

EMS View:-

No.	Ro...ACK State	Severity	NE	Location	System Type	Alarm Code	Raised Time	NE Type	A
1	Unacknowledged	Major	YMN61(906611)	Equipment Resource(M...	Platform Alarm(20420)	Board communication link interrupted(198097060)	2020-02-06 16:37:10	ME(MO SDR)	E

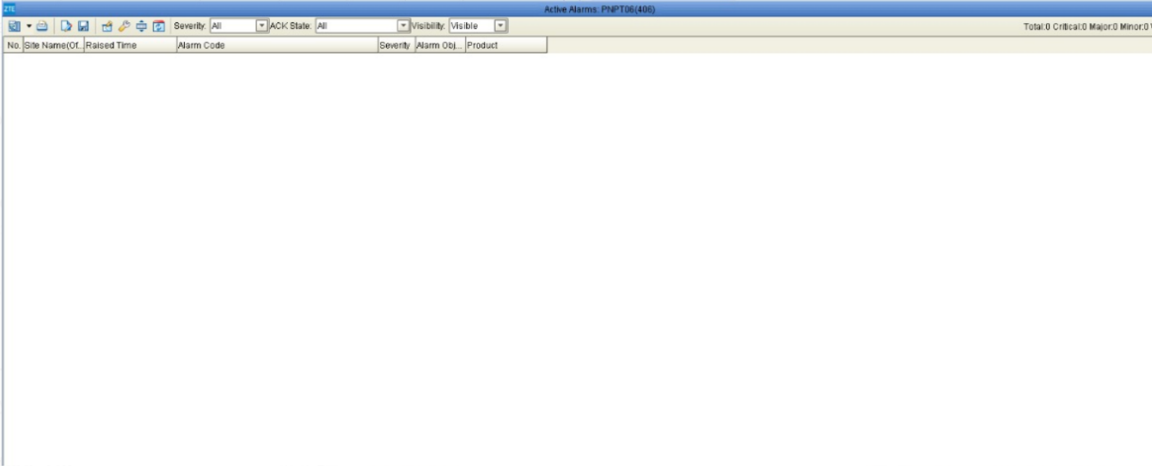
e) Check in EFMS/OneFM/Netnumen whether alarm cleared or not.

In Below Snapshot no any alarm visible , as its cleared.
