TRANSMISSION—4R100—DELAYED OR NO 2ND GEAR—DIAGNOSTIC TROUBLE CODES P0781, P0755 AND/OR P0756—VEHICLES EQUIPPED WITH 4R100 TRANSMISSION WITH TRANSMISSION BUILD DATES BETWEEN 7/27/2000 AND 3/23/2001 ONLY

Article No. 01-13-5

FORD: 2001 E SERIES, EXCURSION, EXPEDITION, F-150, SUPER DUTY F SERIES, SUPER DUTY F-53 STRIPPED CHAS.

LINCOLN: 2001 NAVIGATOR

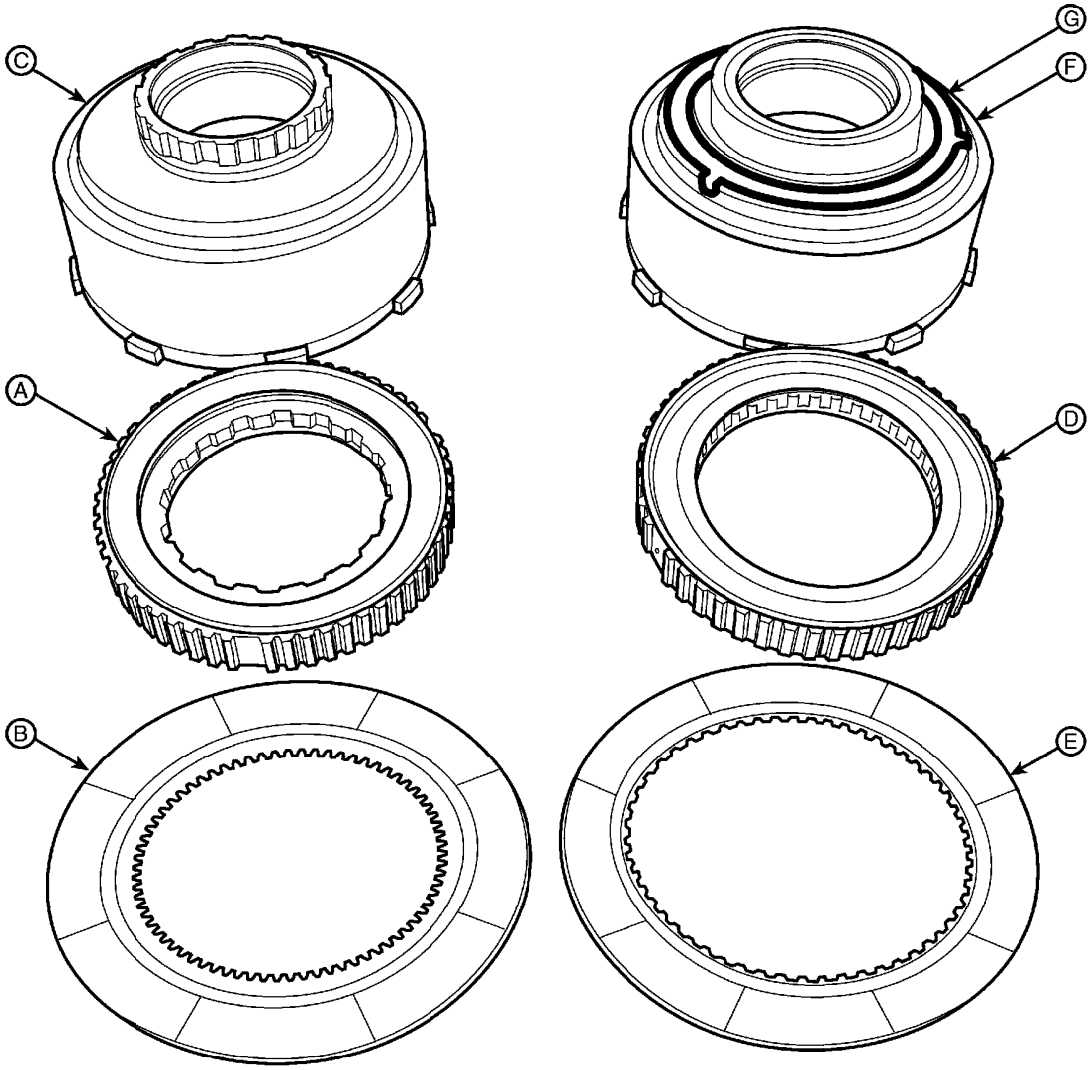
Figure 1 - Article 01-13-5

THE MECHANICAL DIODE DESIGN ONE WAY CLUTCH, DID NOT USE A #7 THRUST WASHER. THERE ARE NO MACHINED SLOTS IN THE INTERMEDIATE BRAKE DRUM FOR THE THRUST WASHER TABS. THE SPRAG DESIGN ONE WAY CLUTCH MUST BE USED WITH A #7 THRUST WASHER. THE INTERMEDIATE BRAKE DRUM USED WITH THE SPRAG OWC DESIGN HAS SLOTS MACHINED IN THE DRUM FOR THE #7 THRUST WASHER TABS.

REMOVE
MECHANICAL DIODE ONE-WAY CLUTCH (OWC)
DESIGN COMPONENTS

INSTALL
SPRAG ONE-WAY CLUTCH (OWC)
DESIGN COMPONENTS

Verify condition, follow normal diagnostics per the appropriate Workshop Manual. If diagnostics leads to the described condition, replace the Intermediate One Way Clutch (OWC) (mechanical diode style 7A089), Intermediate Brake Drum (7D044) and Intermediate Clutch internally splined friction plates (7B164). Refer to the following Service Procedure for details.

MAKE SURE ALL MATING COMPONENTS LISTED ARE CHANGED. THE MATING COMPONENTS OF THE TWO DESIGN ONE WAY CLUTCHES (7A089) ARE NOT INTERCHANGEABLE. IF ALL THE COMPONENTS ARE NOT CHANGED, INTERNAL TRANSMISSION DAMAGE MAY RESULT.
