MOP-B1 ES 24 h threshold crossing alarm clearance OEM Ericsson

This document outlines the systematic process involved in clearing B1 ES 24 h threshold crossing alarm clearance on node.

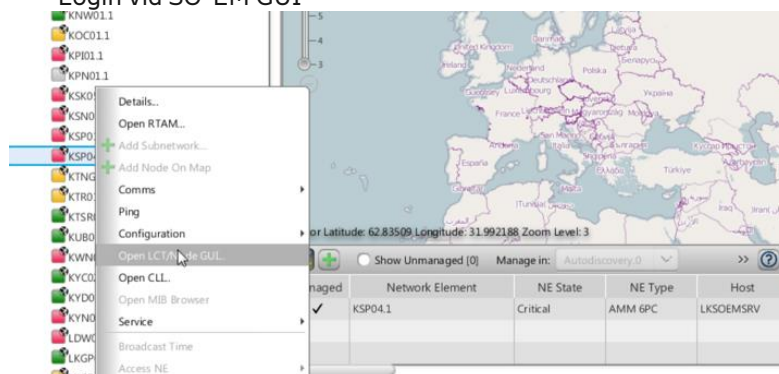
Login via SO-EM GUI

1. If node is managed, then open node using SO-EM GUI or directly from Mini-Link Craft using node IP.

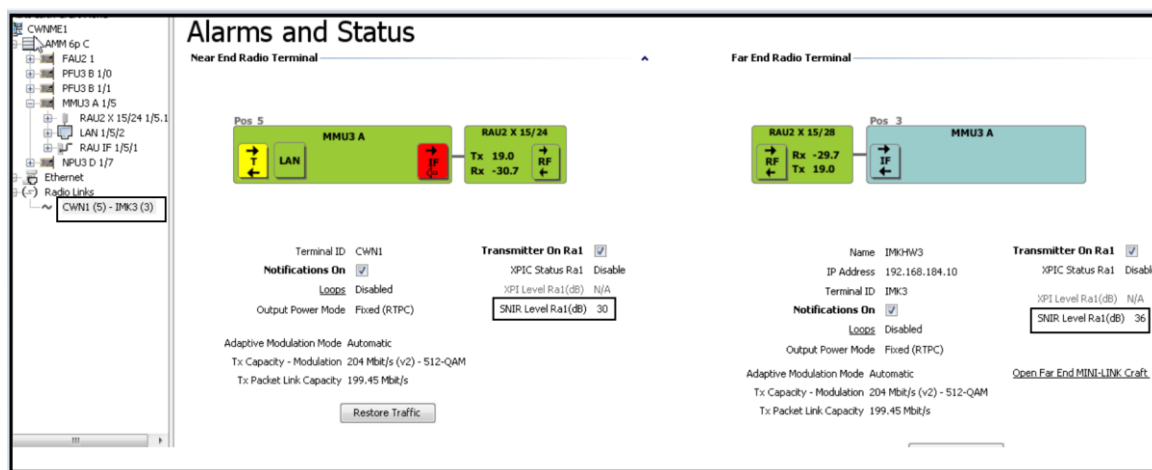
3. Check the status, if alarm is cleared, monitor the link error for next 24 hours.
4. If alarm is not cleared and SES 15 min threshold crossing alarm appear on the node within 15 minutes, then check the SNIR of the link.

5. SNIR should be approximately 40. If it is less than that go for further steps to troubleshoot
Note: Some minor Error cases SNIR might be 40 approximately. That is exceptional.
A Frequency scan test:

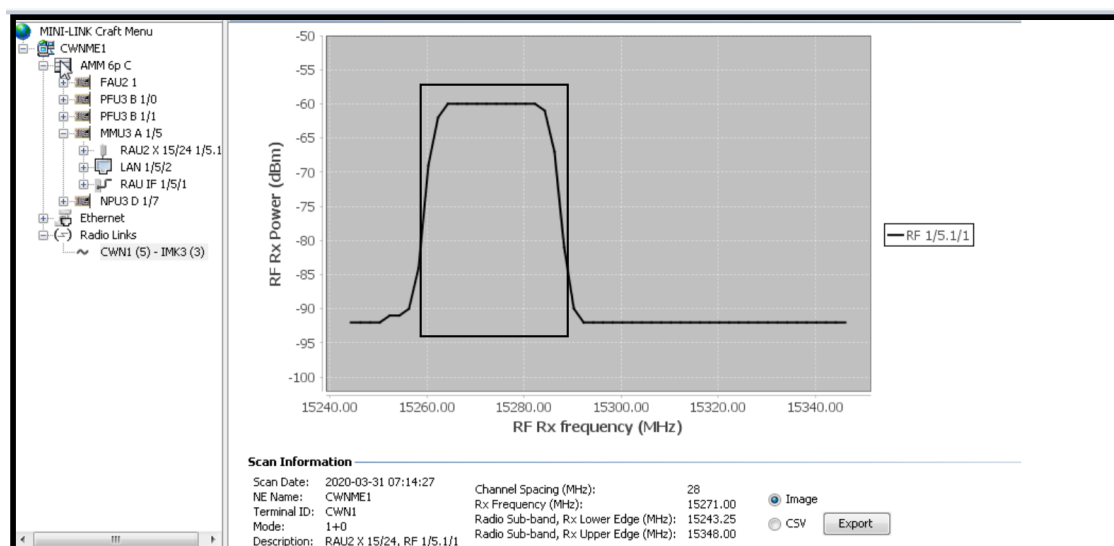
Check the result graph (Frequency Vs Rsl):

B If interference not found from both ends, then go for further test at both ends.

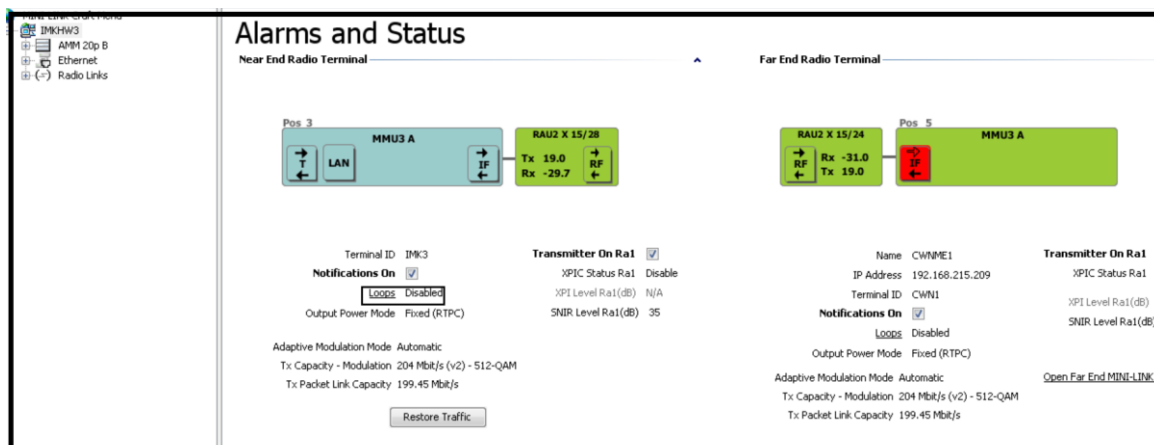
RF and IF loop test:

Select RF loop and save it. Then check the Receiving level of the link, alarms on the link and errors on the link.

Note: Rx level should be 40 to 60, alarms free and errors free on the link. If any mismatch please change the hardware accordingly (MMU, RAU & IF cable or IF connector) at same end. For confirming MMU issue we can use IF loop also in the same way.

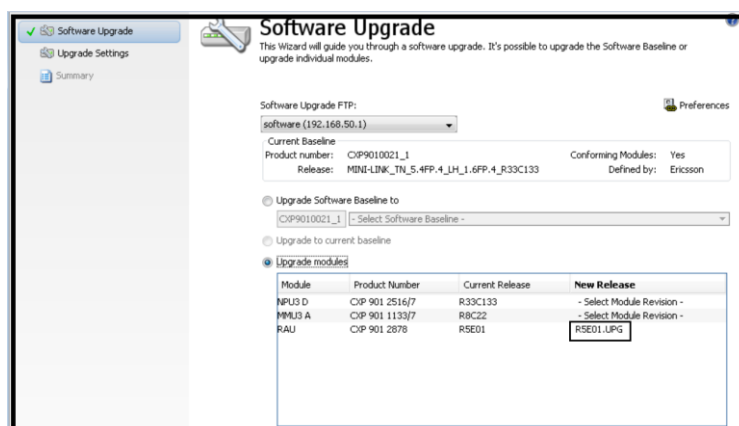
- If RAU upgrade is required, connect the node with FTP server having required software type of RAU.
- In the node go to software upgrade window. Select the new release software as per recommendation and compatibility. Once downloaded, activate the same and check the status of RAU in inventory window.

Note: In this example we are not changing any hardware as already found interference. This snapshot is for where we need to upgrade a RAU software.
