TRANSMISSION—5R44E OR 5R55E—FLUID LEAK AT SERVO COVER—VEHICLES PRODUCED 6/1/2001 THROUGH 3/31/2002 EQUIPPED WITH 2.3L, 3.0L OR 4.0L ENGINES	Article No. 02-8-3

FORD: 2001-2002 EXPLORER SPORT TRAC, EXPLORER SPORT, RANGER

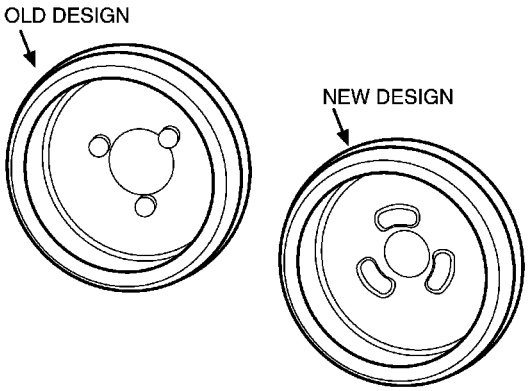
Figure 1 - Article 02-8-3

Some vehicles equipped with a 2.3L, 3.0L or 4.0L engine and 5R44E or 5R55E automatic transmission, produced 6/1/2001 through 3/31/02, operating in cold climates, may exhibit a fluid leak at the transmission Servo Cover(s). This may be caused by the Servo Cover.

Verify the condition. If the condition exists, the Servo Cover(s) may need to be replaced with new cover(s) (Figure 1). Check the transmission fluid level and fluid condition. If fluid is just low and the fluid condition is not burnt, refer to the following Service Procedure to replace the Servo Cover(s). If the transmission shows evidence of damage due to no fluid, no engagements or severely burnt fluid, the transmission may need additional repair or replacement. Follow normal repair or replacement procedures when servicing anything other than the Servo Cover(s).
