MOP for Huawei ETH_LOS Alarm Troubleshooting

This document outlines the step-by-step process involved in MOP for ETH_LOS Alarm Troubleshooting.

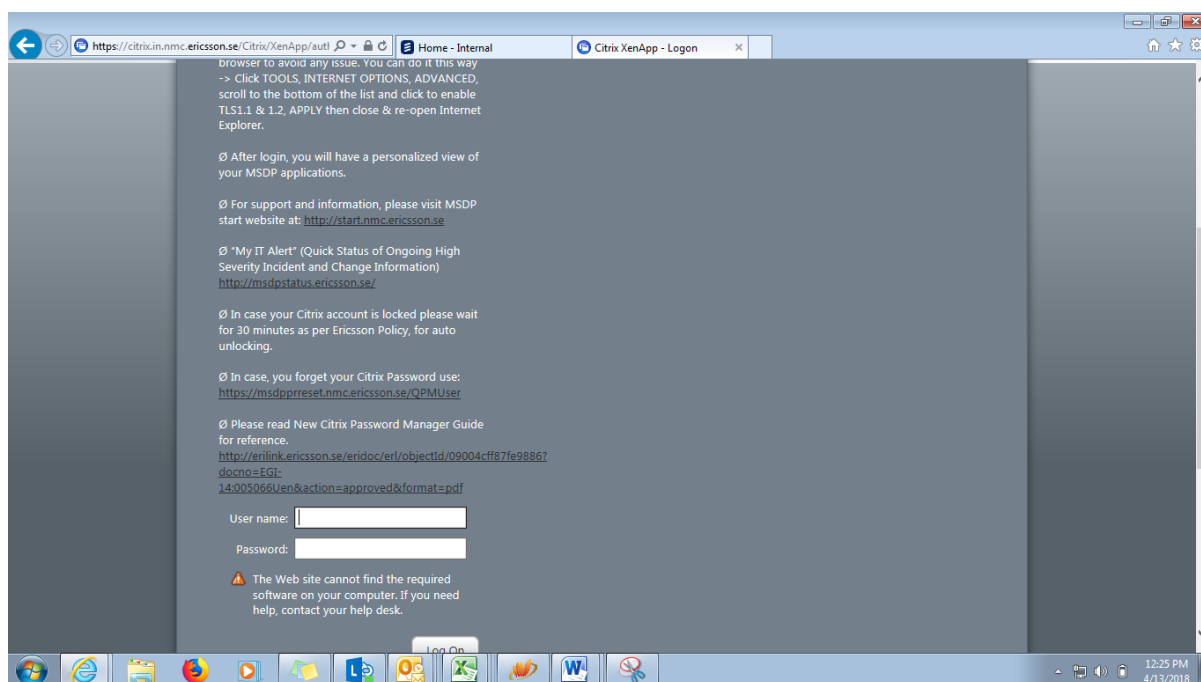
1. Login MSDP through below mentioned link.
<https://citrix.in.nmc.ericsson.se/>
2. Provide CITRIX username and password.

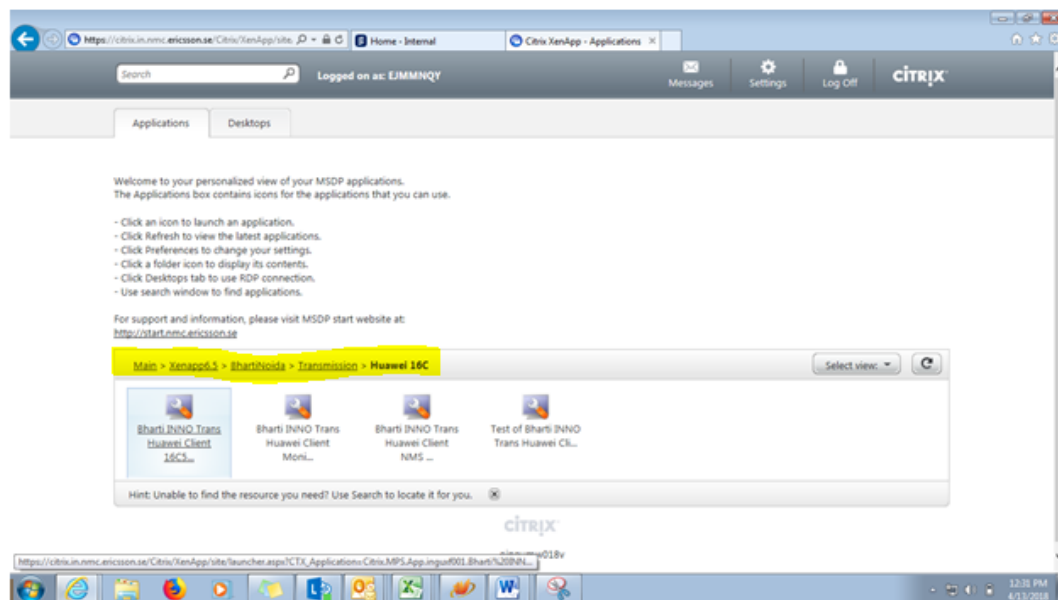
3. Click on "Xenapp6.5 >> BhartiNoida >> Transmission >> Huawei 16C/17C/18C >> Bharti INNO Trans Huawei client.

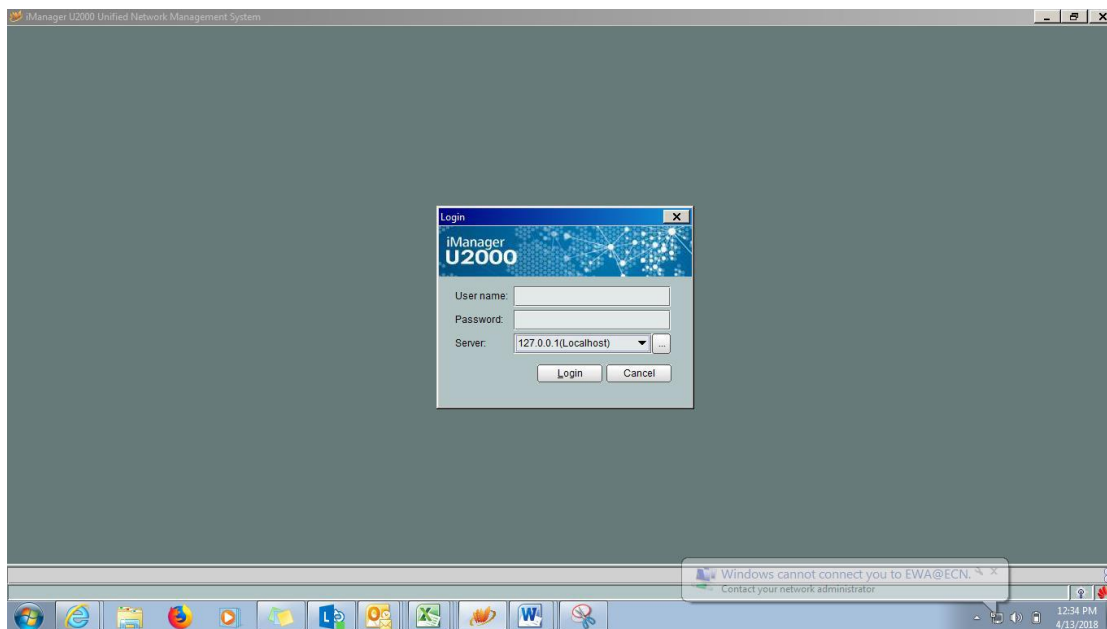
4. Now Huawei is launched enter the credentials and server IP of the circle must log in.

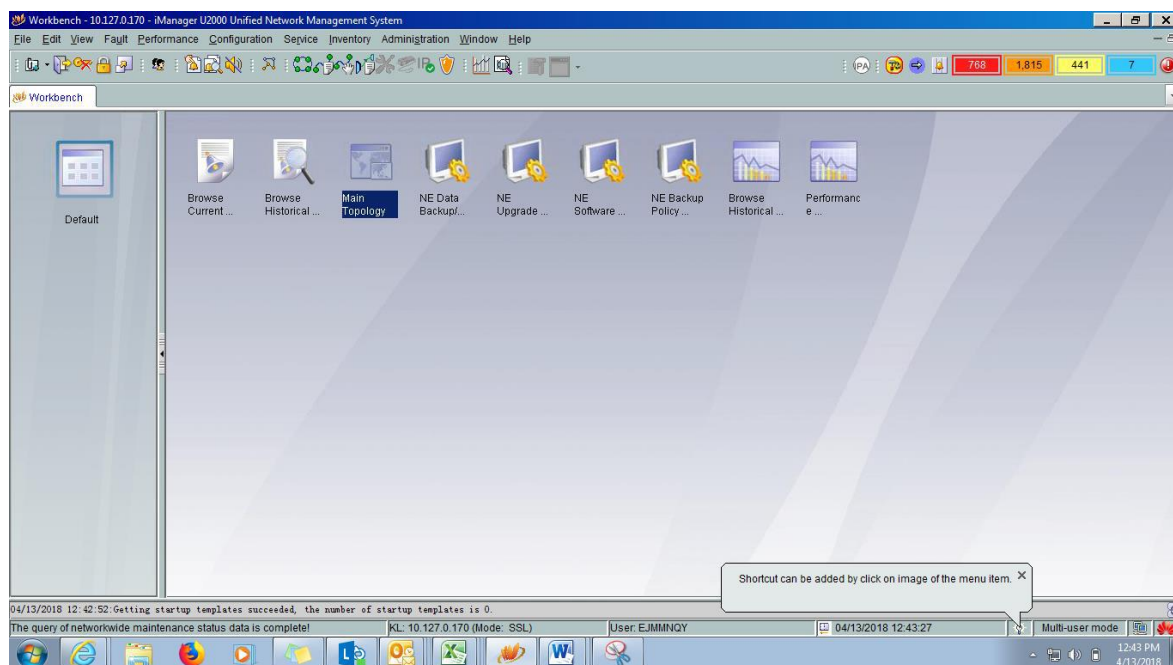
5. Click on "Main Topology" to open the Topology.

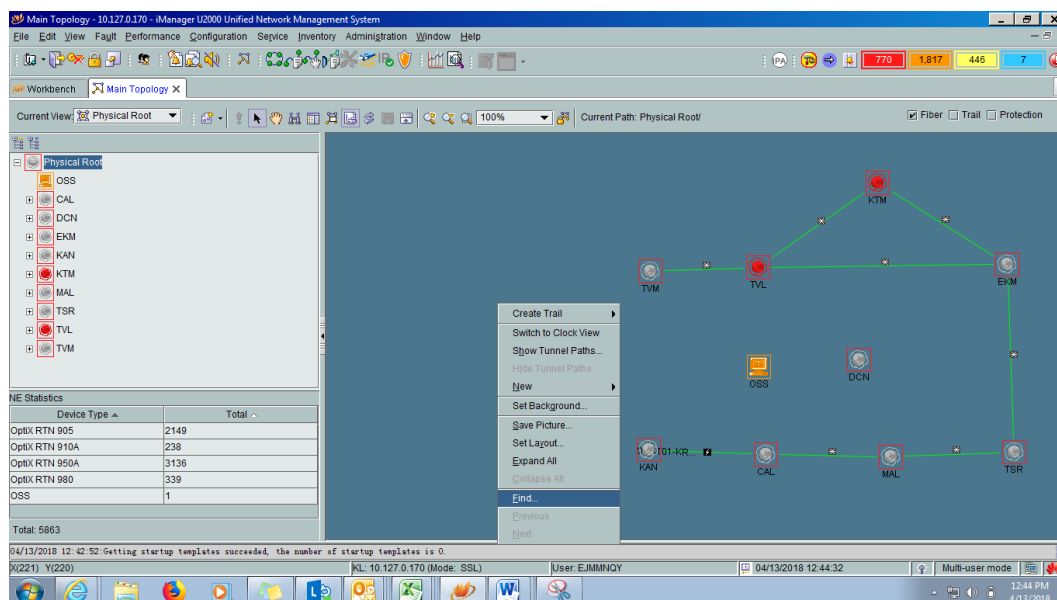
6. Right Click on the server and click on "FIND" to find the node.
