RIGHT FRONT SAFETY BELT RETRACTOR

AFFECTED VEHICLES: **CERTAIN 1996 THROUGH 2000 MODEL YEAR CROWN VICTORIA, GRAND MARQUIS AND TOWN CAR**

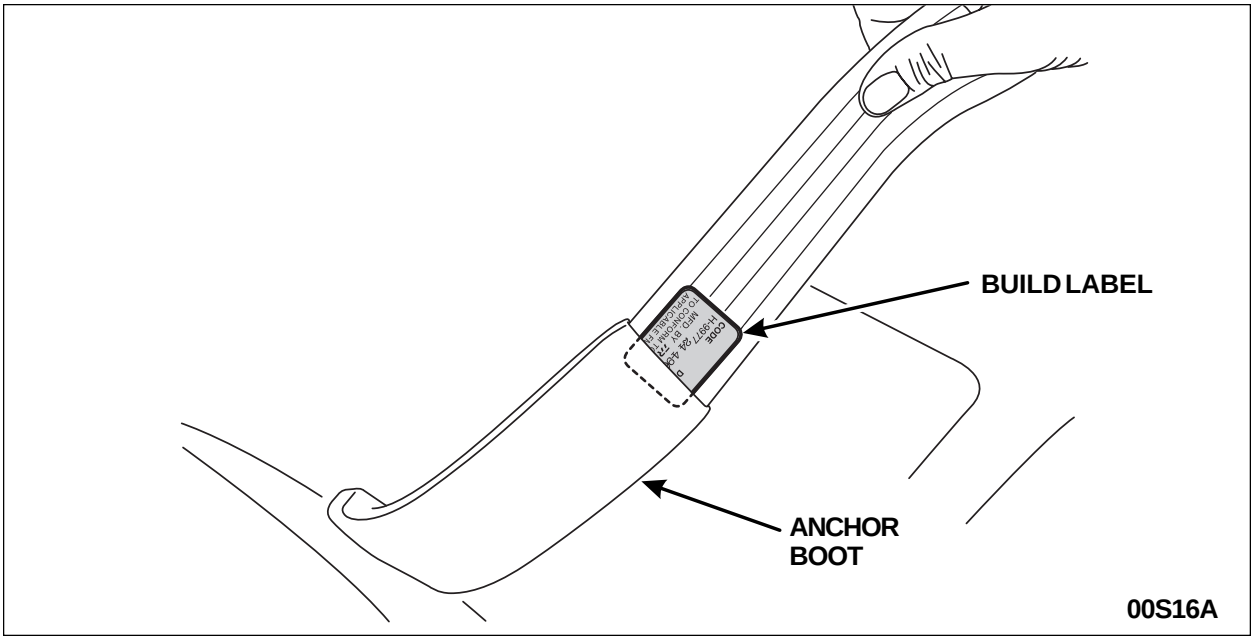
FIGURE 1

- Look for the build label on the webbing directly above the anchor boot. If the build label is located here proceed to Label Inspection on page 3. If the label is not located here proceed to the next bullet point. See Figure 1.

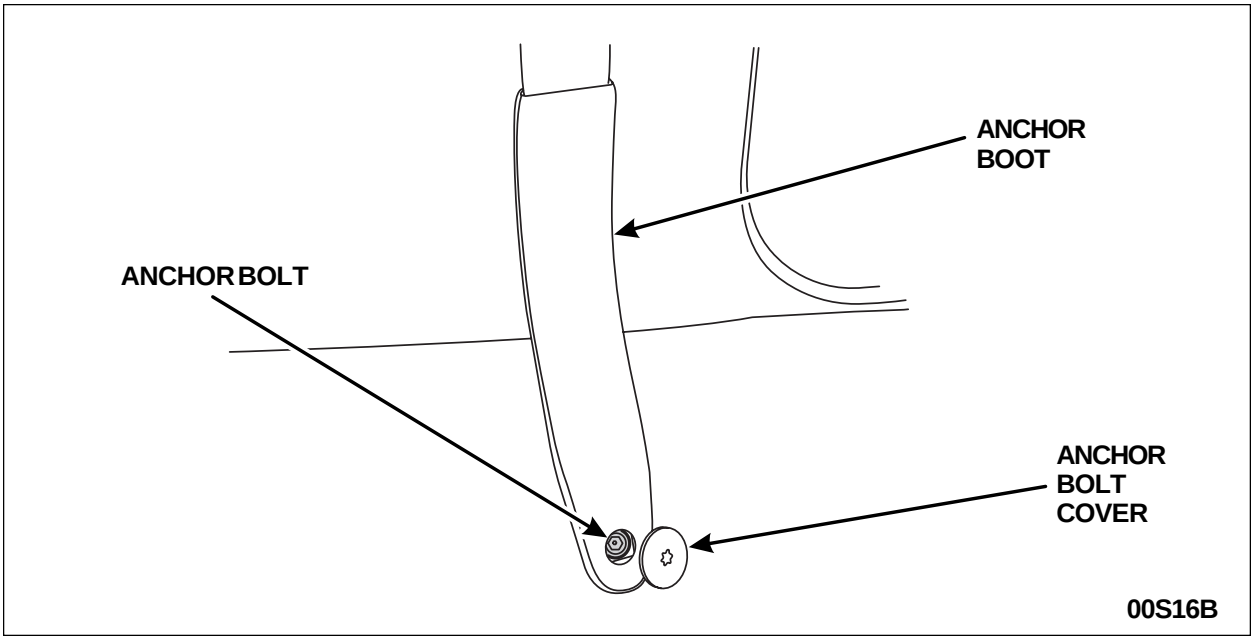
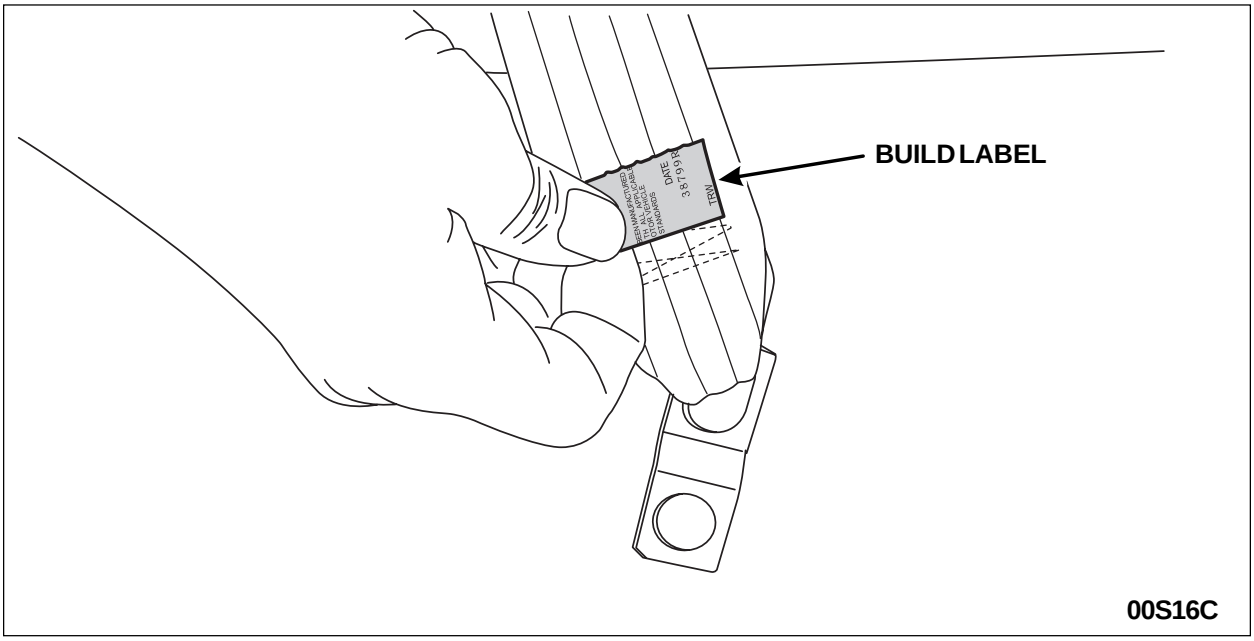
FIGURE 2

- Remove the anchor bolt cover, then the anchor bolt. Cut off the steel washer and remove the rubber washer to allow the bolt to come off, then slide the anchor boot off of the webbing. The build label is folded and sewn into the webbing. See Figures 2 and 3. Proceed to Label Inspection on page 3.

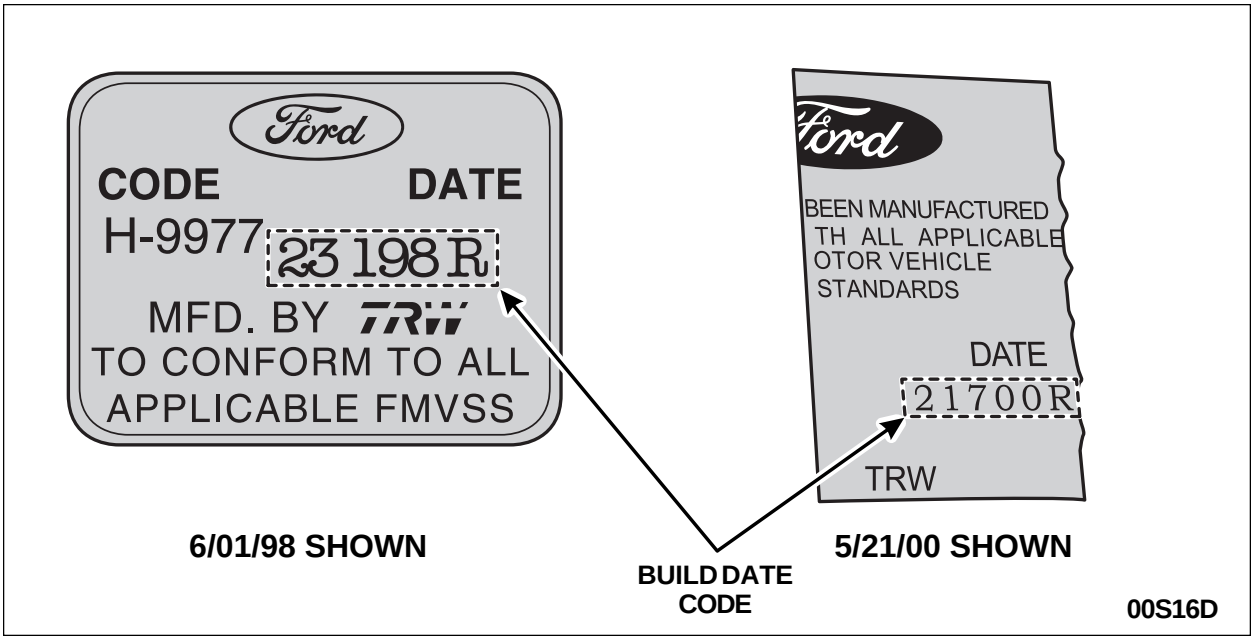
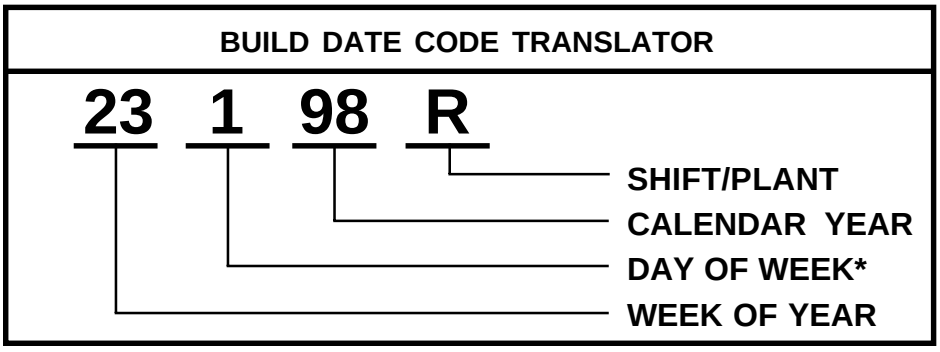
FIGURE 4

1. Locate the build date code on the build label. Use the examples in Figure 4 and the Build Date Code Translator chart to determine the build date.

2. The affected seat belt retractors were built from 6/01/98 (23 198 R) through 5/21/00 (21700R) and **must** be replaced.

A. If you have determined the seat belt must be replaced based on the build date, replace the seat belt retractor following the service procedures in Section 01-20A or 501-20A of the appropriate workshop manual.
