DRIVEABILITY—CNG BI-FUEL—HESITATION ON ACCELERATION FROM STOPPED POSITION—VEHICLES EQUIPPED WITH 2.0L CNG BI-FUEL ENGINE ONLY	Article No. 01-19-5

FORD: 2000 CONTOUR

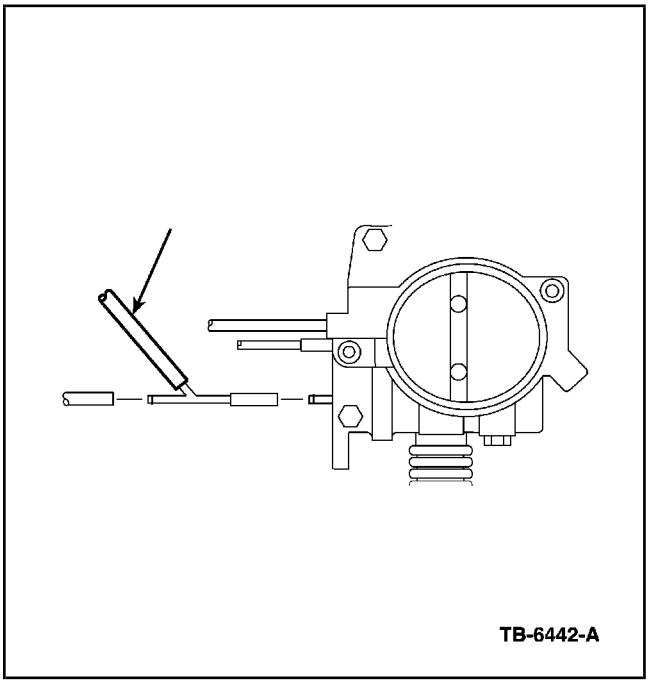
Figure 1 - Article 01-19-5

Some CNG Bi-Fuel vehicles may exhibit a hesitation when accelerating from the stopped position while operating in the natural gas mode. This may be caused by an incorrect length MAP line assembly and require an updated Compuvalve CNG calibration.

2. Inspect MAP line.
   a. Remove air box from throttle body.
   b. Remove MAP line assembly from throttle body as shown (Figure 1).
   c. Carefully remove MAP line assembly from vehicle.
   d. Measure Map line (should be approximately 28″ in total length). If longer than 28″, carefully disconnect MAP line from MAP tap and remove excess MAP line from end shown in Figure 1.
   e. Connect MAP line to MAP tap.
   f. Connect MAP line assembly to throttle body as shown in Figure 1.
   g. Carefully route MAP line to Compuvalve.
