MOP- SES 24 h Threshold crossing alarm clearance OEM Ericsson

This document outlines the systematic process involved in clearing SES 24 h threshold crossing alarm clearance on node.

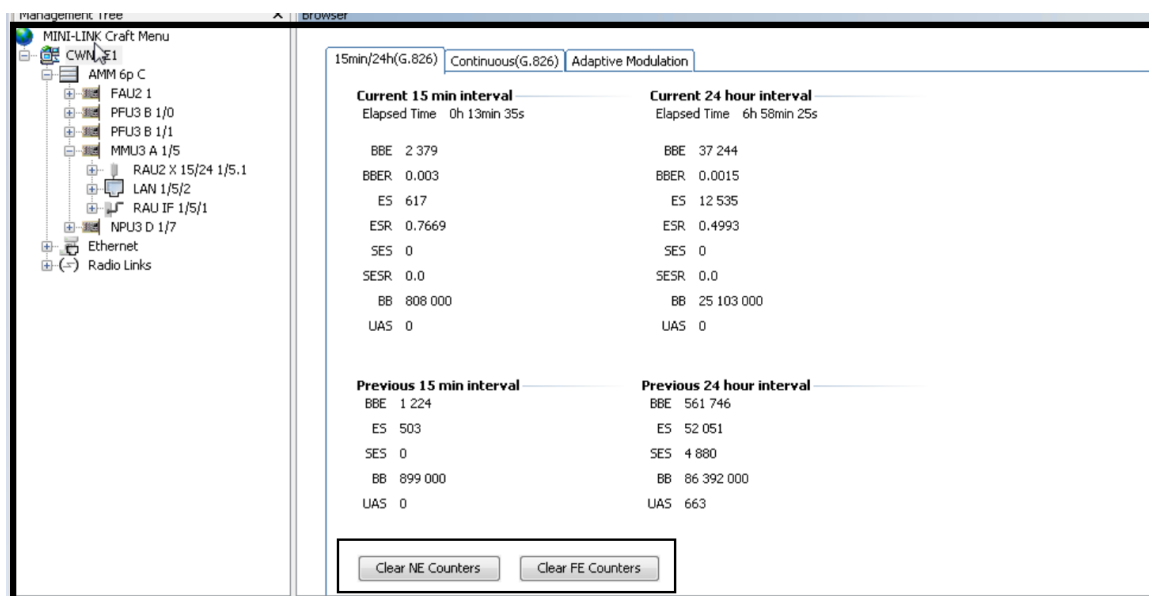
2. Perform a RAU IF performance reset as mentioned below:

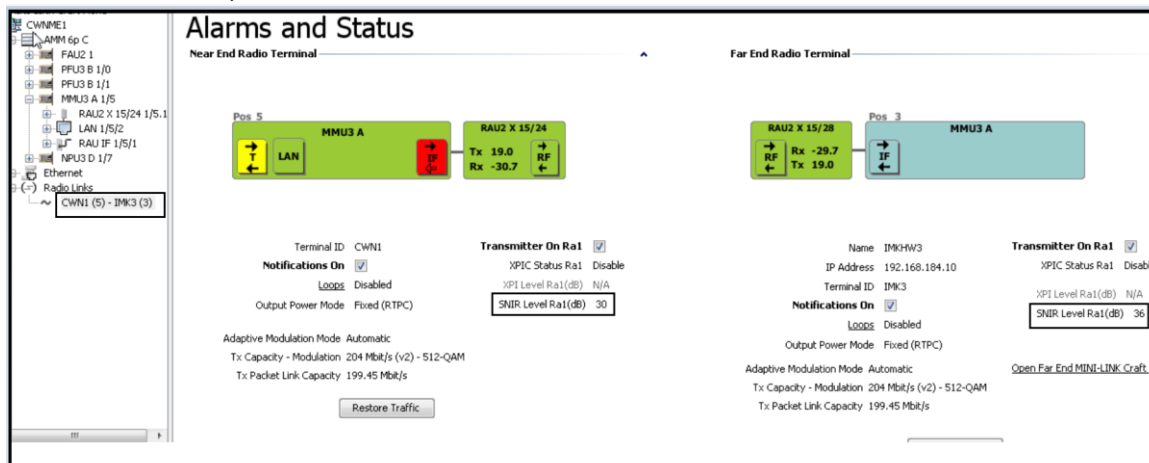
3. Check the status, if alarm is cleared, monitor the link error for next 24 hours.
4. If alarm is not cleared and SES 15 min threshold crossing alarm appear on the node within 15 minutes, then check the SNIR of the link.

5. SNIR should be approximately 40. If it is less than that go for further steps to troubleshoot
- Note: Some minor Error cases SNIR might be 40 approximately. That is exceptional.
- A Frequency scan test:

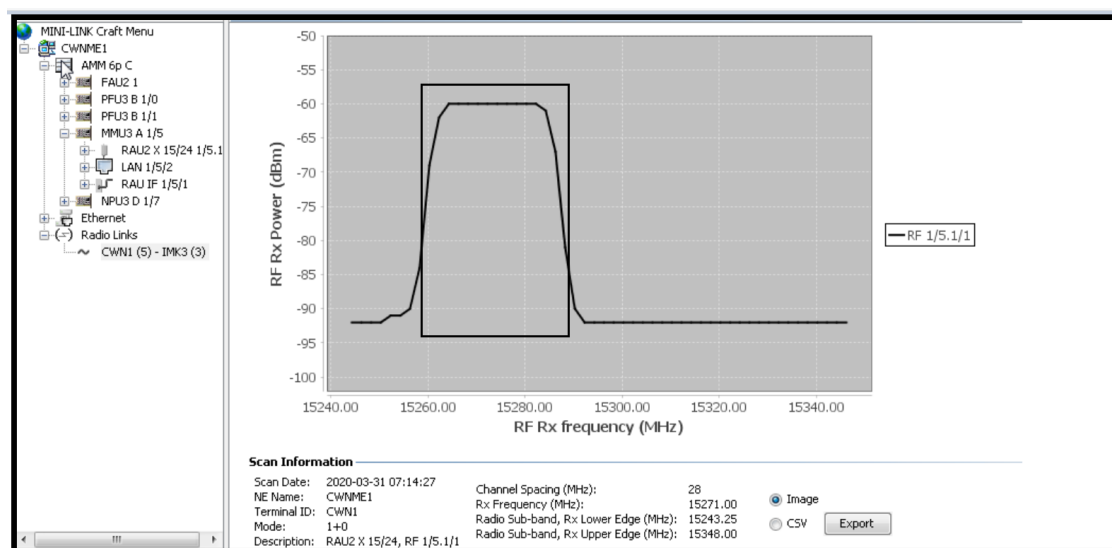
Check the result graph (Frequency Vs Rsl):

Here interference found between 15259 to 15290 MHz. Please check the configured Rx Frequency on the link. If configured Rx frequency is in the range of plus 28MHz from 15290 and minus 28MHz from 15259, then we can declare as frequency interference on the link. We can suggest them to check with the planning team to get new frequency. Configured Rx frequency is 15271 MHz as snap attached below:

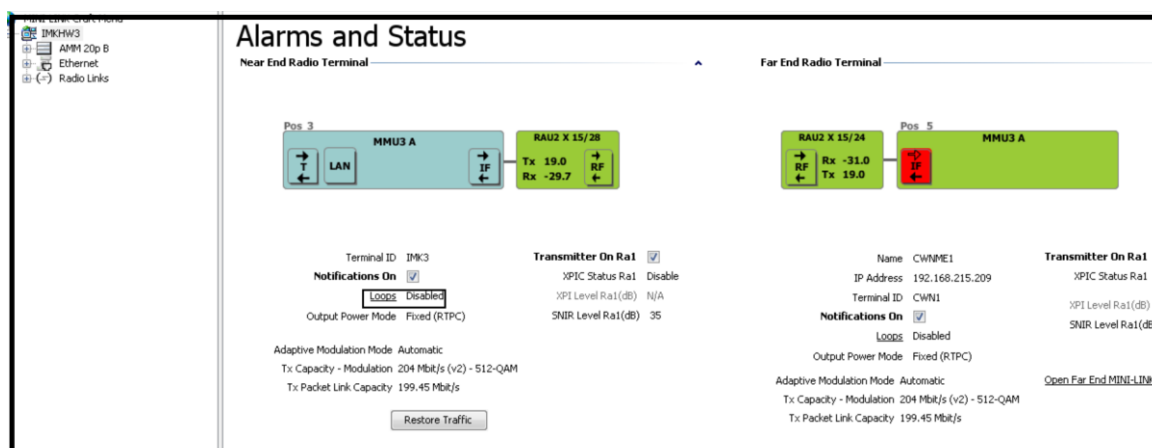
RF and IF loop test:

Select RF loop and save it. Then check the Receiving level of the link, alarms on the link and errors on the link.

Note: Rx level should be 40 to 60, alarms free and errors free on the link. If any mismatch please change the hardware accordingly (MMU, RAU & IF cable or IF connector) at same end. For confirming MMU issue we can use IF loop also in the same way.

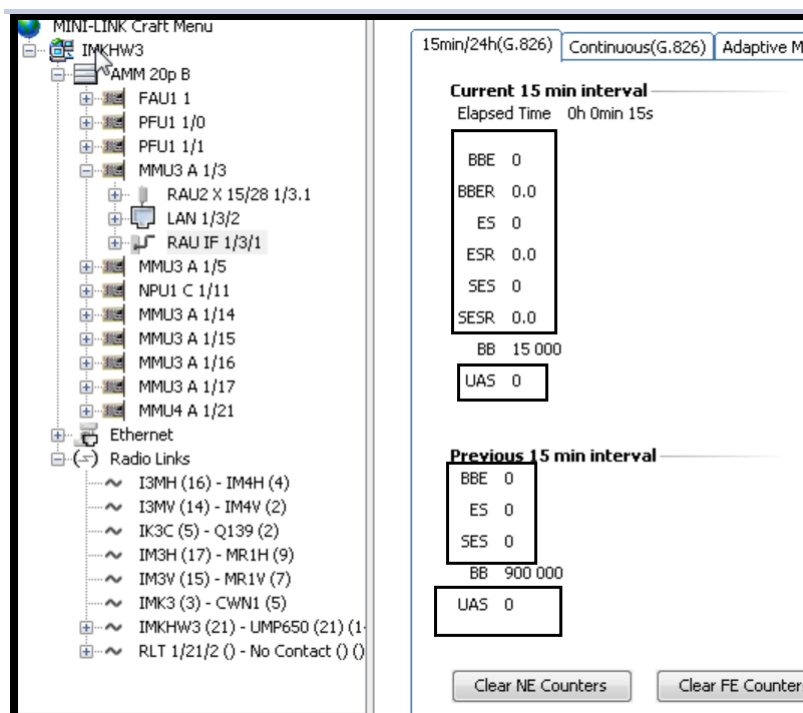
Errors in link:

If any errors found then do hardware change one by one, Issue may resolve when clear the IF connector issue at where we are getting errors.

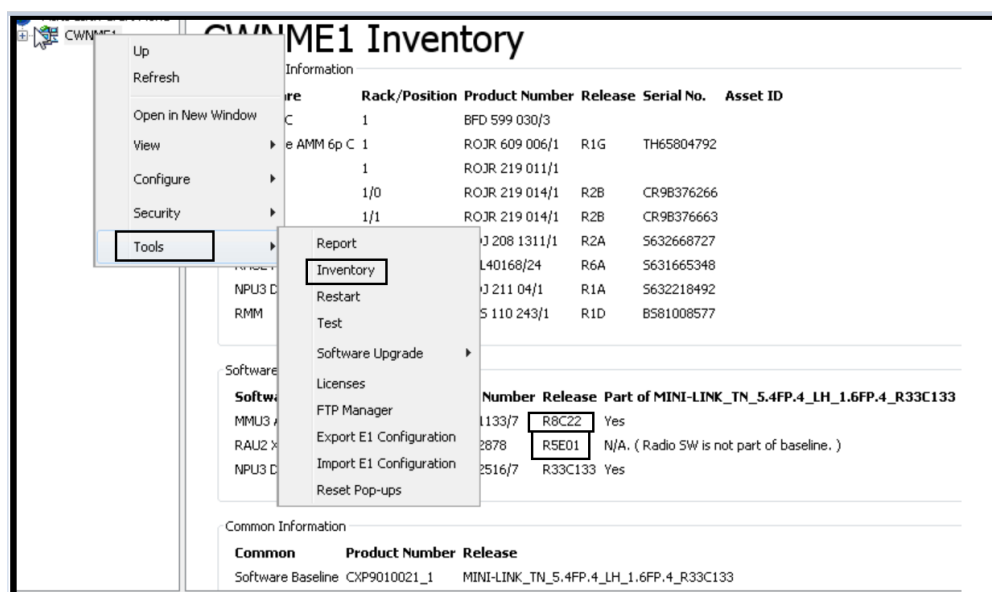
- Identify Current Hardware and Software, For the same go to Inventory Window of node. Get the information of RAU type, R-State and software version of old radio.
