- **COOLANT—COOLANT SEEPAGE AT INTAKE MANIFOLD CROSS-OVER—VEHICLES EQUIPPED WITH 4.6L 2V ENGINE ONLY**
- **ENGINE—4.6L 2V—COOLANT SEEPAGE AT INTAKE MANIFOLD CROSS-OVER**

Article No. 02-2-2

FORD: 1996-1997 THUNDERBIRD
1996-2001 CROWN VICTORIA, MUSTANG
2002 EXPLORER

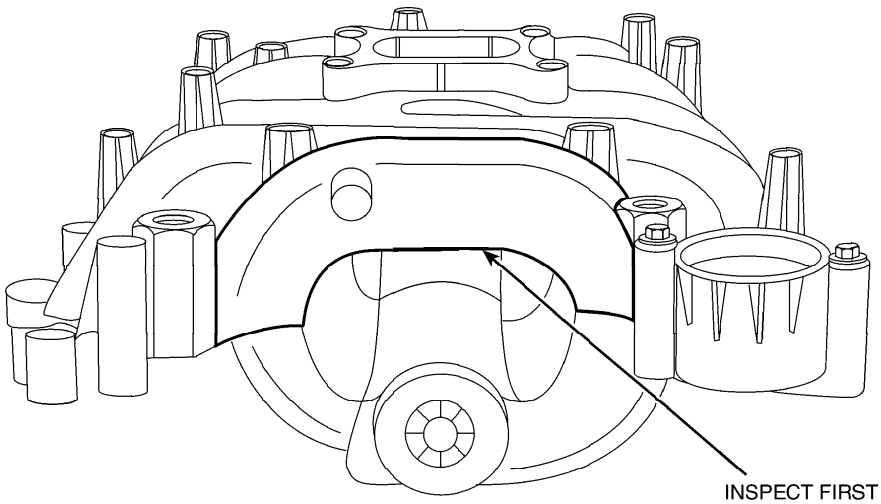
Figure 1 - Article 02-2-2

Some vehicles may exhibit an Intake Manifold crossover (first runner) coolant seepage condition. This may be caused by a crack in the Intake Manifold coolant crossover.

Inspect the suspect Intake Manifold for a coolant leak at the first runner cross-over area (Figure 1). If coolant seepage is found in this area, order the appropriate Service Kit and install parts, by referring to the appropriate Model Year Workshop Manual (Section 303-01).

Refer to Figure 1 for inspection of coolant seepage. If seepage is found, order one of the following Service Kits to repair.
