MOP of RF Module Failure of Nokia Site

UNDERSTANDING RF MODULE FAILURE ALARM No - 7654

This activity is for E2E troubleshooting and alarm clearance of RF Module Failure Alarm in sites.

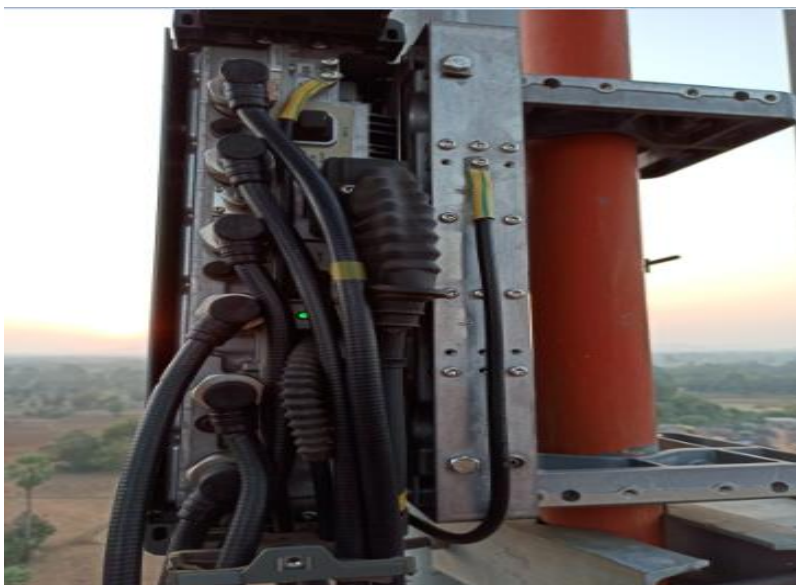
RF MODULE FAILURE.

- Refer to the instructions for the root BTS fault reported in the alarm on how to handle the failure reported in the alarm.

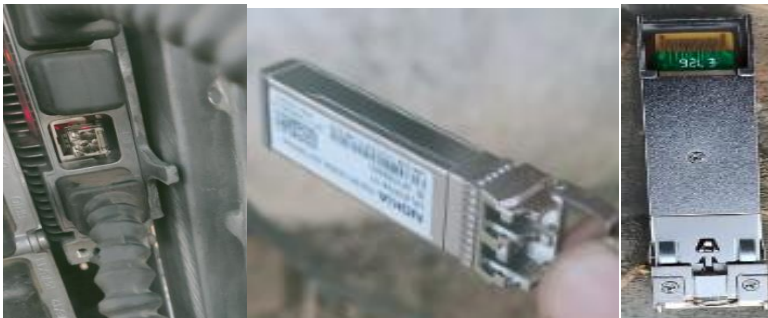
- Check the small form-factor pluggable (SFP) from both ends (the system module and the radio unit) and replace if one or both is faulty or unsupported.

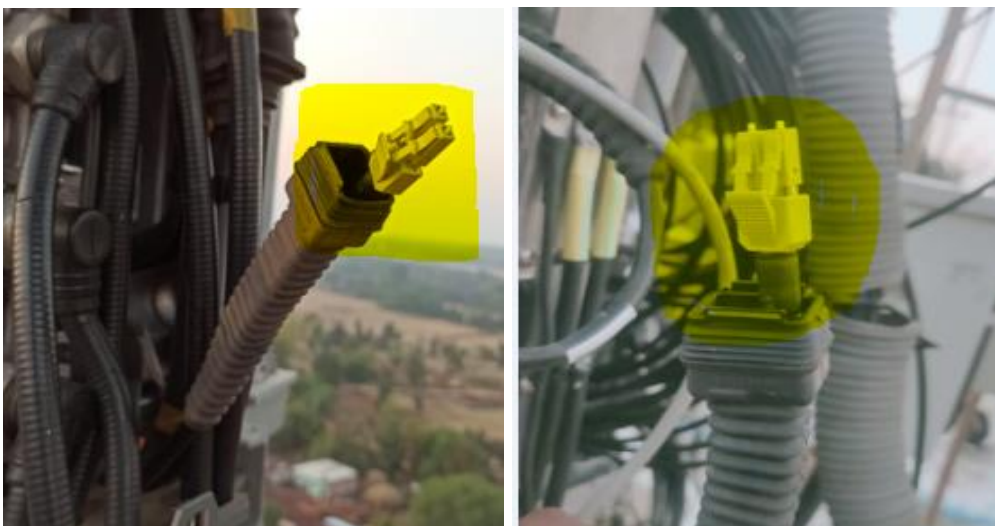
- Clean the connectors, test the fiber cable, and replace them if they are faulty.

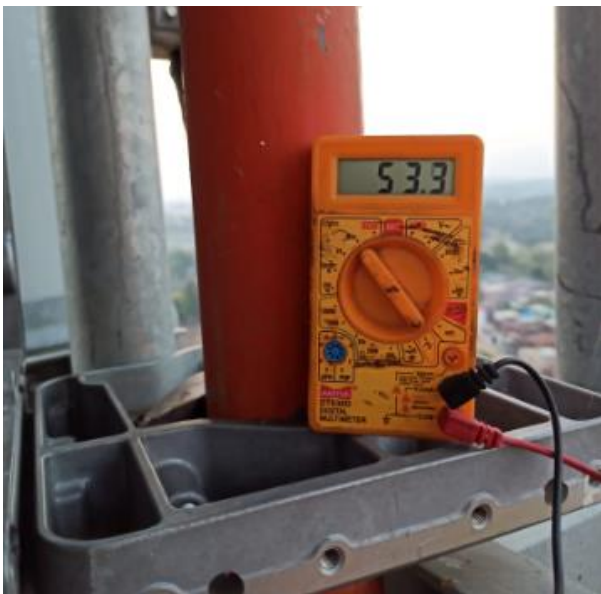
- Check the power supply to the affected radio module
