Legacy OTA extra characterization | TT / 1.8 V / 27 C
Returned data reviewed; full original acceptance remains incomplete

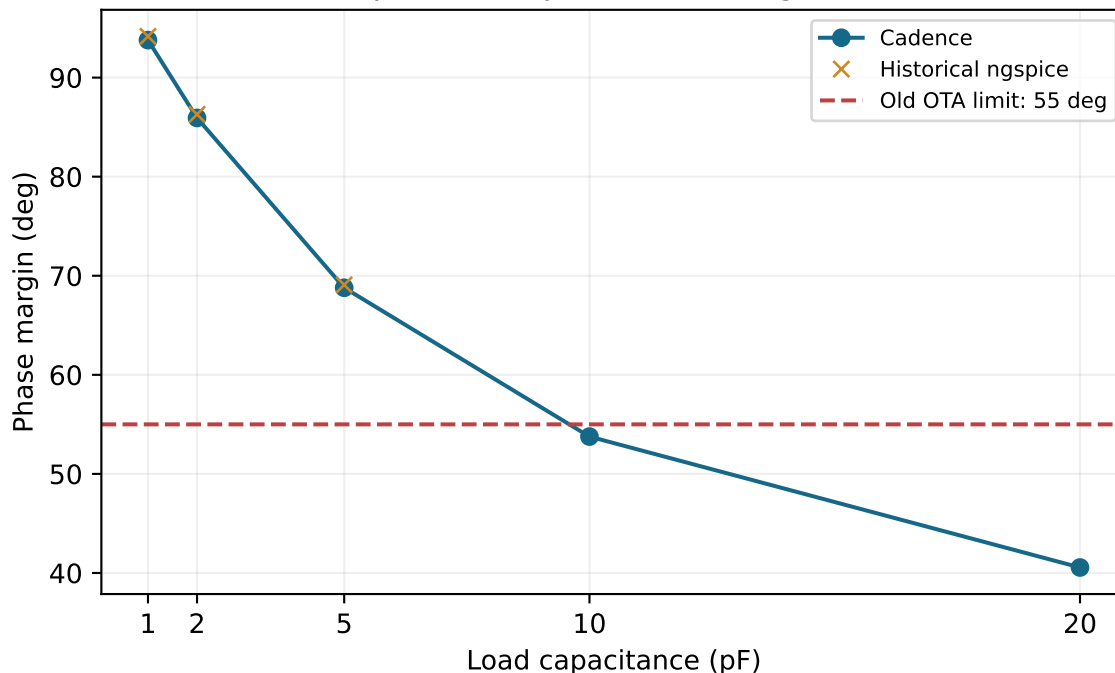
10 pF and 20 pF fail the margin limit

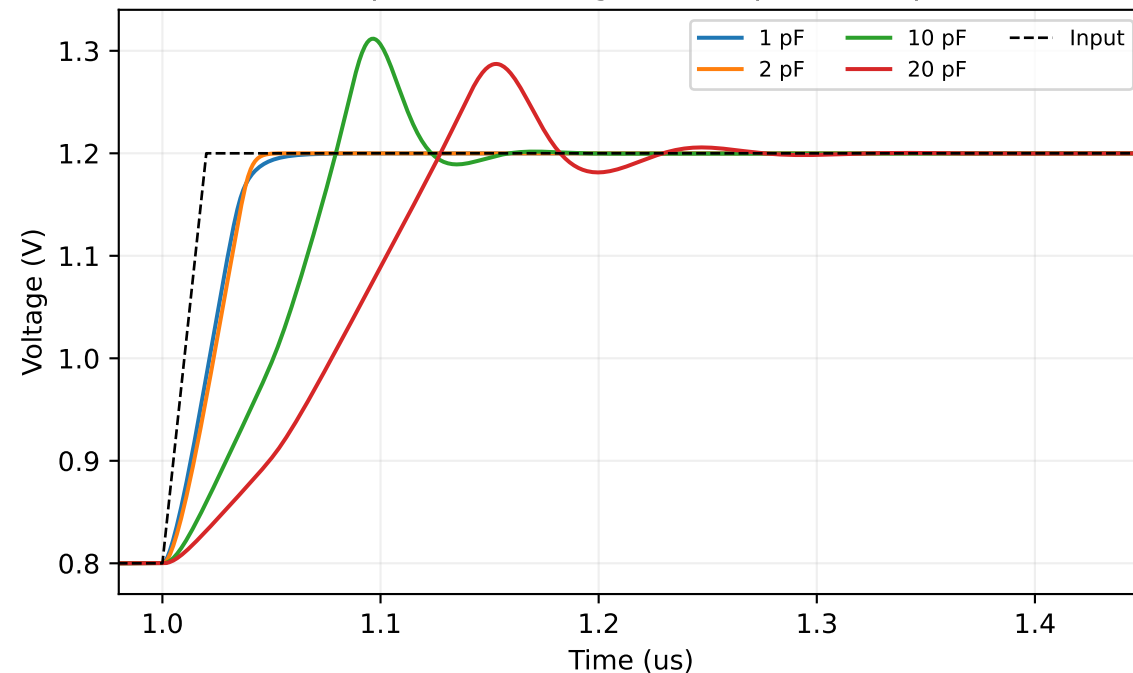
All four steps settle; margin is a separate requirement

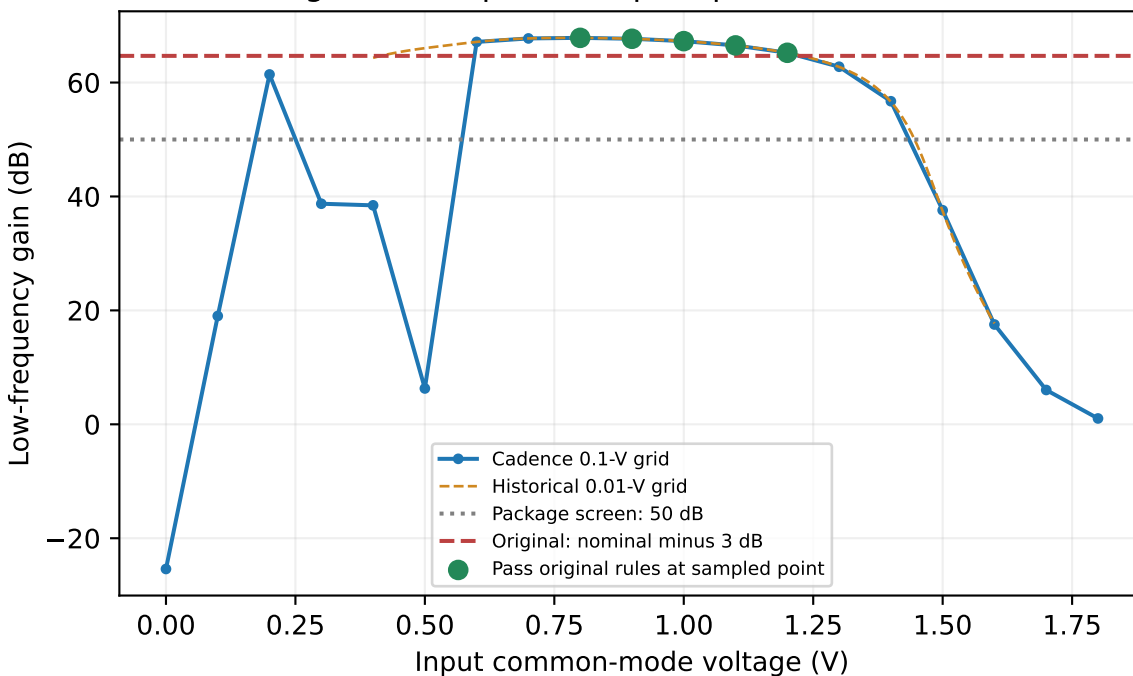
Original rules pass sampled points 0.8 to 1.2 V

Stationary noise: 401.15 nV/sqrt(Hz) at 1 kHz
