MOP of OPTICAL BER Alarm for Nokia Site

Activity Description

This activity is for E2E troubleshooting and alarm clearance of OPTICAL BER alarm.

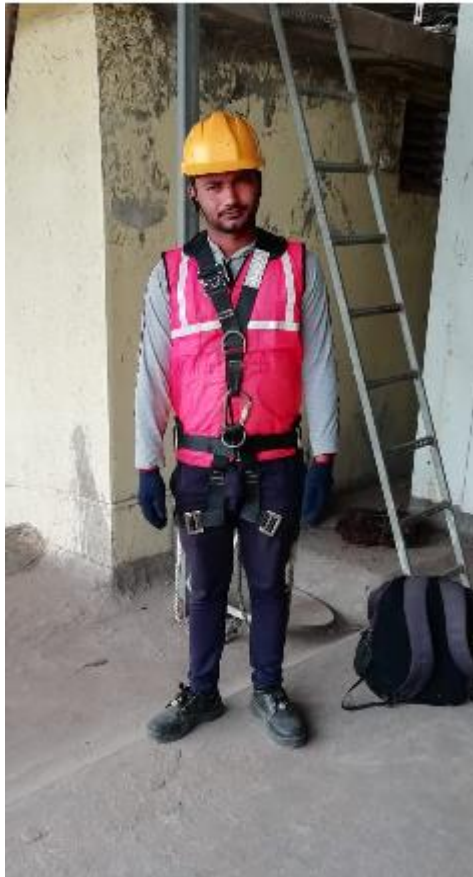
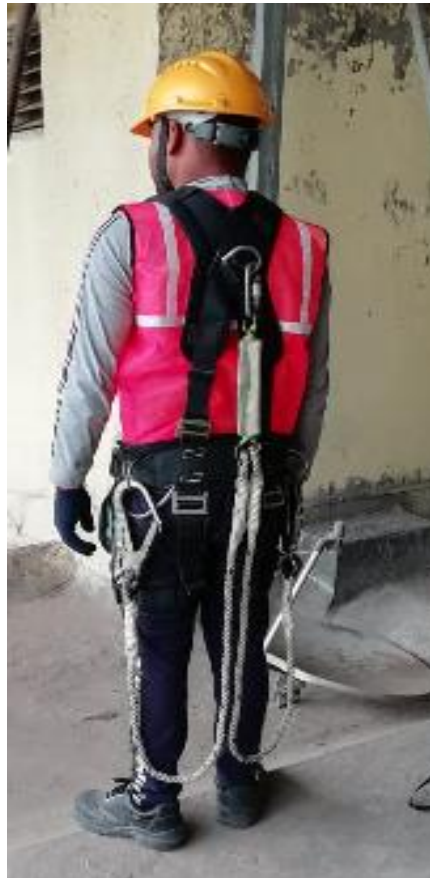
10. ZTM check the PTW and approve it.
11. Rigger will climb the tower and check below Points for actual issue identification.
12. Check if the connector seal is properly mounted and firmly in place.
13. Check if the SFP (Small Form Factor Pluggable) is properly connected to the FR module. If the SFP connection/mounting is incorrect, readjust the connection.
14. Check if the optical cable is properly connected to the SFP.
15. Clean the optical connectors at Radio module end. Reset the RF HW unit by following the block/unblock procedures, and then check if this solves the problem.
