MOP-Jitter-buffer-overflow alarm on TDM service

This document outlines the step-by-step process involved in Ceragon Jitter-buffer-overflow alarm on TDM service Alarm Fault management.

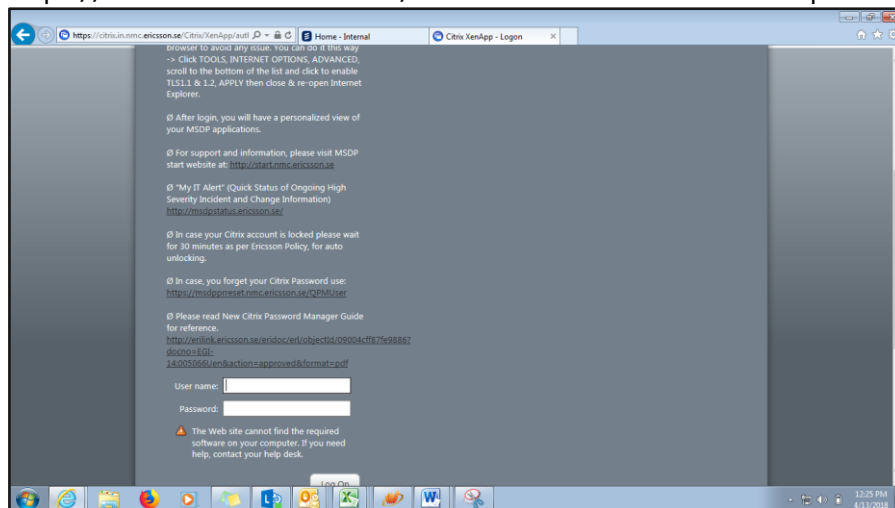
<https://citrix.in.nmc.ericsson.se/> Provide CITRIX username and password.

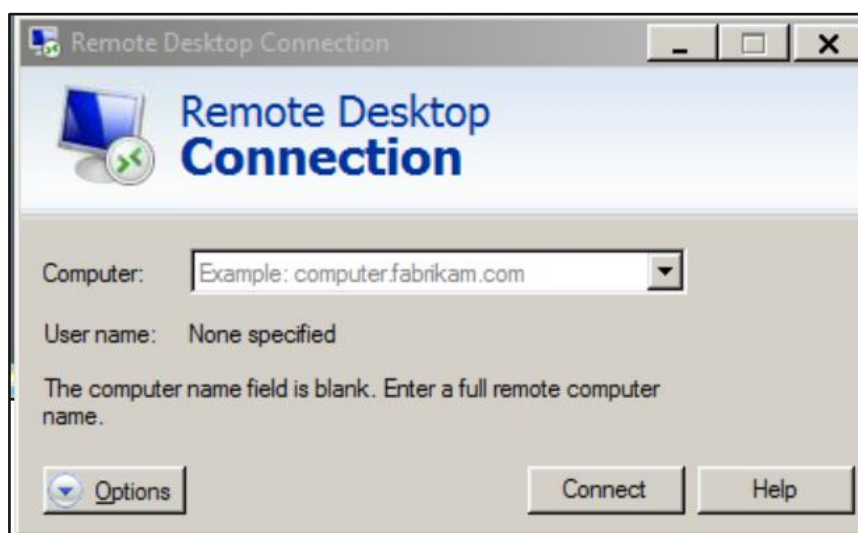
2. Click on Main > Xenapp6.5 > Bharti Noida > Bharti INNO Remote Desktop Client.

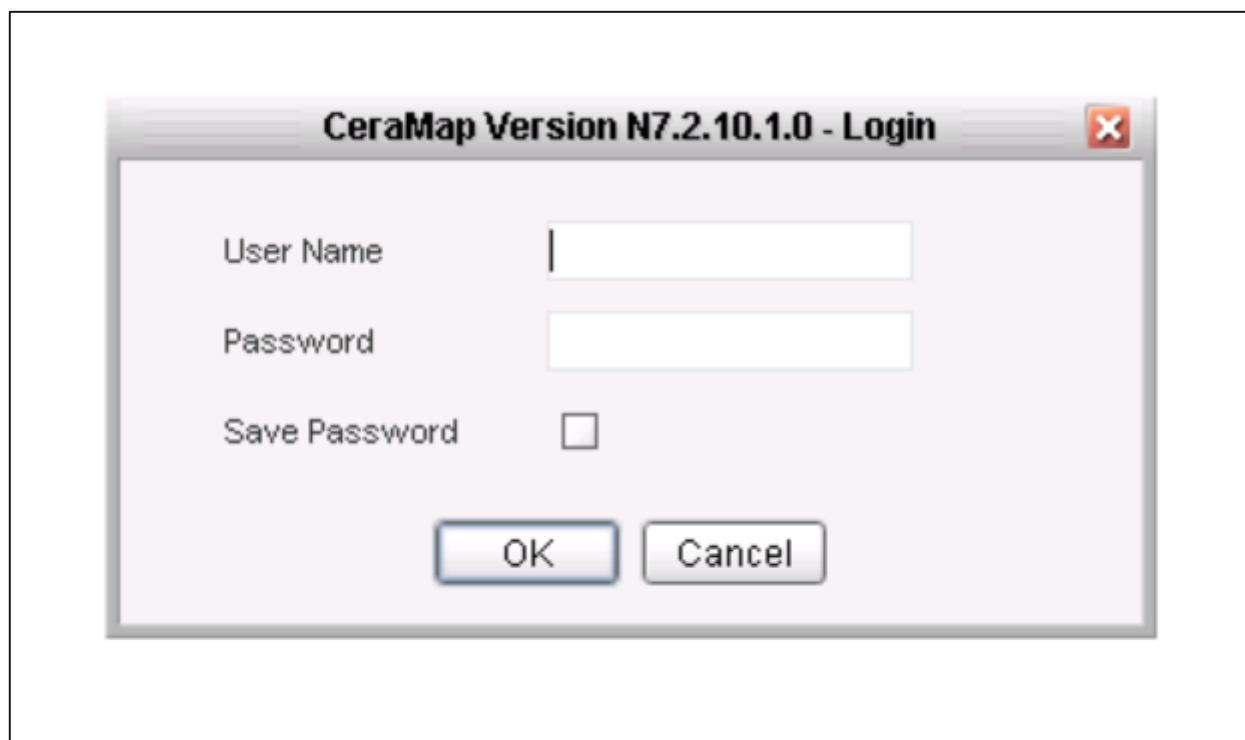
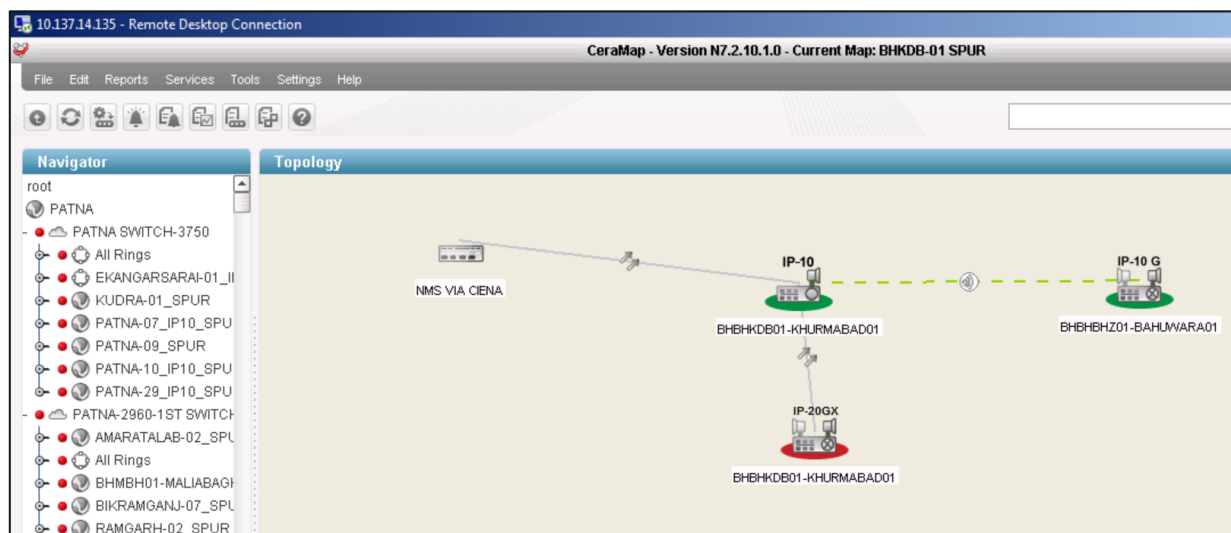
5. Search the required Node ID in Cera Map & open the node by clicking on Open Node GUI.
6. Login Ceragon IP20 NODE locally via web browser through IP.
7. Provide IDU username and password.
