MOP for BID Missing

This document outlines the systematic process involved in Backplane Identifier Missing or Corrupt alarm clearance on node.

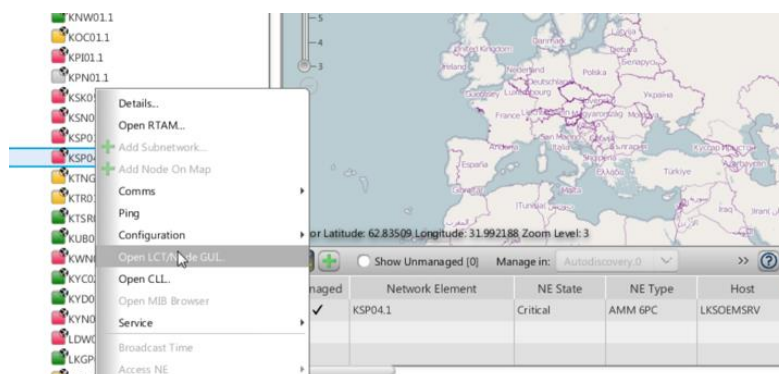
Login via SO-EM GUI
