## MOP for SFP RX power High/Low at LTU2\_155 alarm

This document outlines the systematic process involved in SFP RX Power Low/High at LTU2\_155 alarm clearance on node.

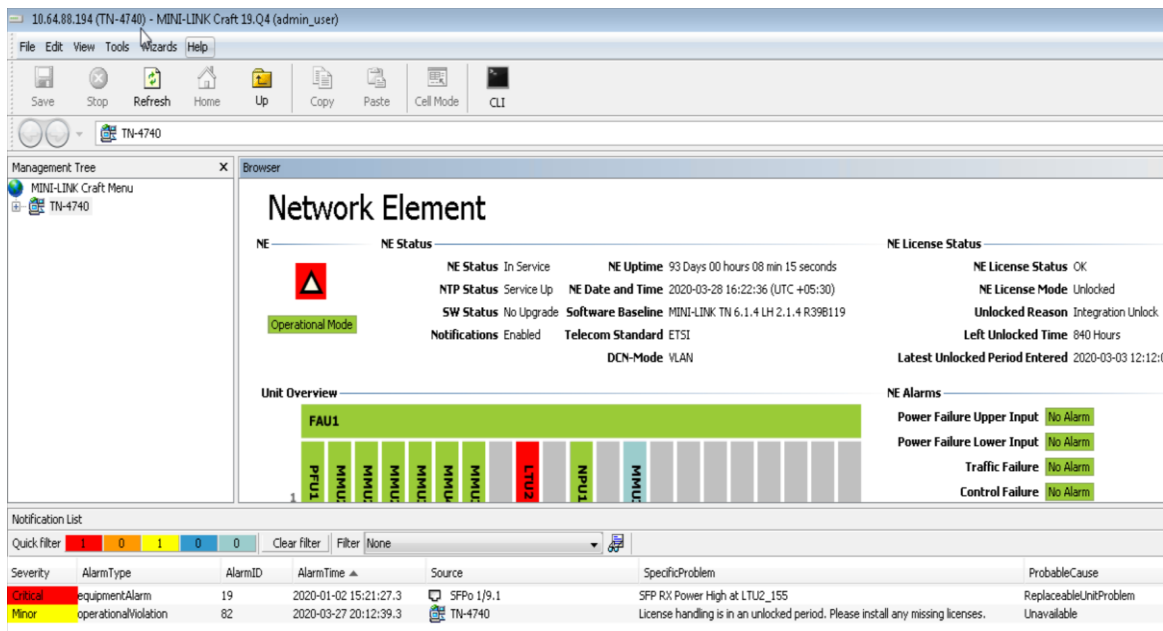
7. Check the alarms on the node.

8. Example One Node having SFP RX power high and second having SFP RX power low alarm

Severity	AlarmType	AlarmID	AlarmTime	Source	SpecificProblem	ProbableCause
Critical	equipmentAlarm	19	2020-01-02 15:21:27.3	SFPo 1/9.1	SFP RX Power High at LTU2_155	ReplaceableUnitProblem
Minor	operationalViolation	82	2020-03-27 20:12:39.3	TN-4740	License handling is in an unlocked period. Please install any missing licenses.	Unavailable
