## Technical Service BULLETIN

### GENERAL MAINTENANCE TIP

All '93 – '03 Models

ENGINE  
EG007-02

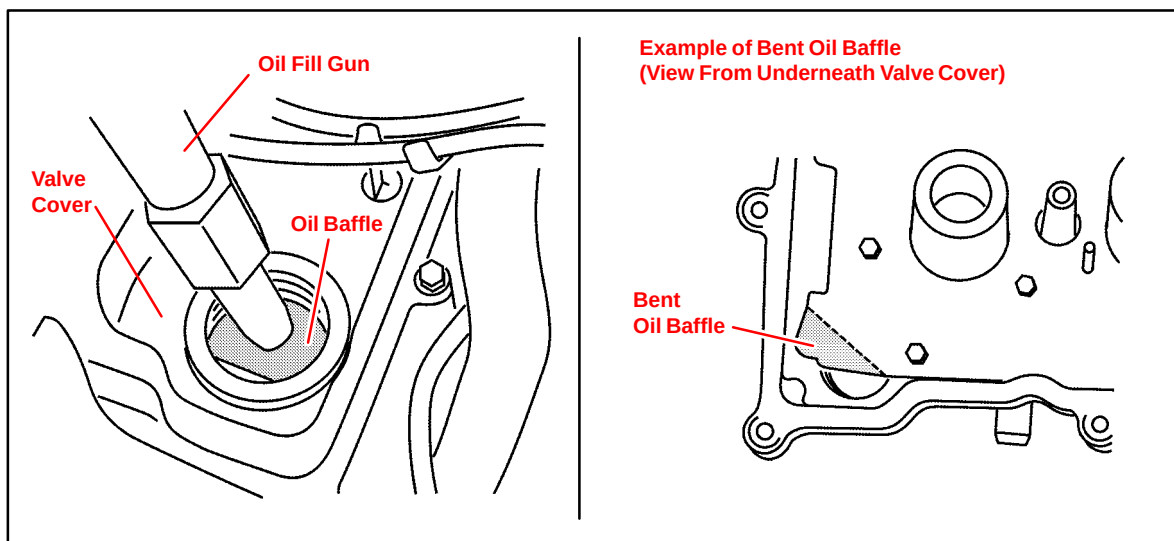
**Introduction** To help prevent unnecessary complications during the oil fill process, no undue load should be placed on the oil baffle attached to the inside of the valve cover (see illustration). This baffle is designed to deflect oil and should not be used to support the weight of heavy oil fill devices. These devices can place stress on the baffle, and bend or break it during the oil fill process.

**Oil Filling Procedure** Please take measures to ensure that the baffle is not damaged during the oil fill process. If it does become damaged, repair it before any collateral damage occurs.
