MOP for RF Unit RX Channel RTWP/RSSI Unbalanced on Huawei Site

Alarm Description:

This alarm is due to when the difference between the RTWP/RSSI of the main RX channel and the RTWP/RSSI of the diversity RX channel exceeds a specified threshold.

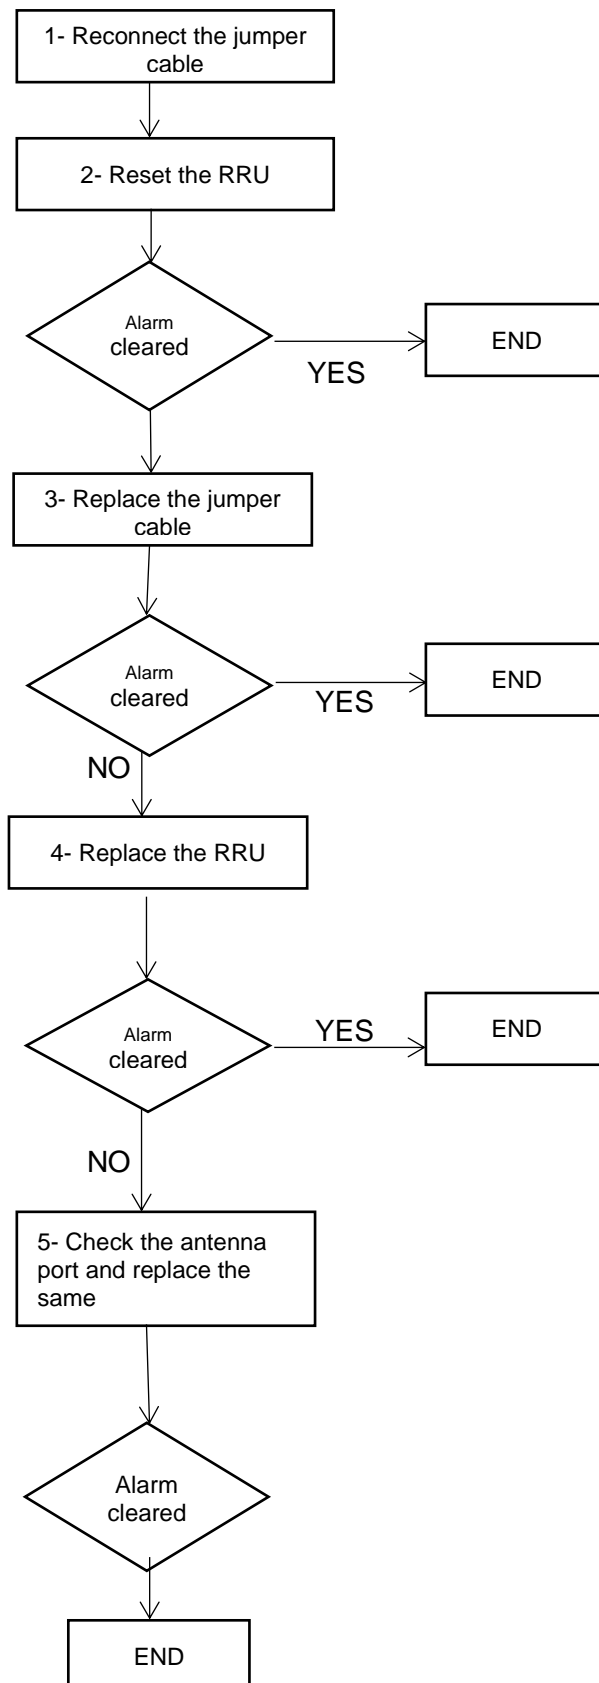
Onsite Process:

1- Reconnect the jumper cable

- Check the connection between RRU to Antenna.
- Reconnect the jumper cable properly.
- Swap the jumper cable for different sectors.
