Alignment Pin Installation during Transmission/Transaxle Assembly Installation

Service
Category Drivetrain

Section Automatic Transmission/Transaxle

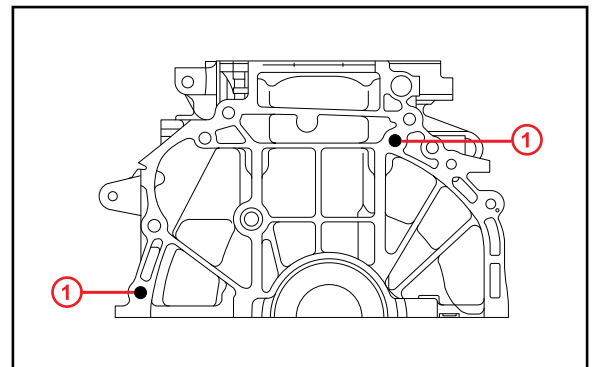
Figure 1. Example: 2007 model year Camry 2AZ-FE Rear Side

1. Inspect the rear side of the engine block assembly for 2 alignment pins.
 - If there are less than 2 alignment pins present, one may have been removed with the transmission/transaxle assembly. Check the removed assembly for the missing alignment pins. Go to step 2.
 - If there are 2 alignment pins present, the transmission/transaxle assembly may be installed following the applicable Repair Manual procedure.

A missing alignment pin may result in failure of the transmission/transaxle assembly.

2. Install the missing alignment pin(s).
 - Refer to the applicable Repair Manual procedure for location of the cylinder block rear side alignment pins.
