MOP-Excessive BER alarm clearance

This document outlines the systematic process involved in troubleshooting BER or Excessive BER alarm clearance.

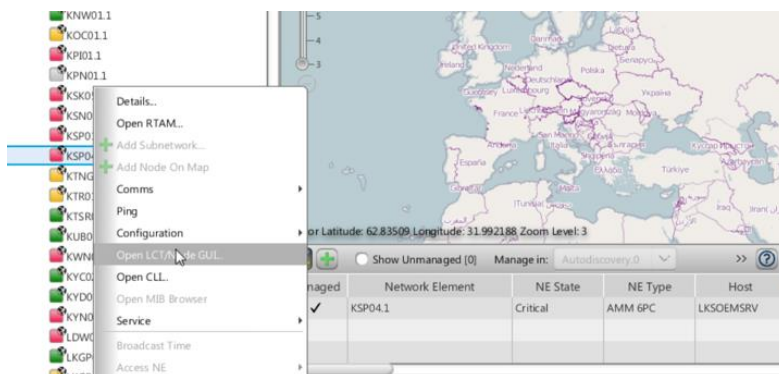
Login via SO-EM GUI

1. If node is managed, then open node using SO-EM GUI or directly from Mini-Link Craft using node IP.

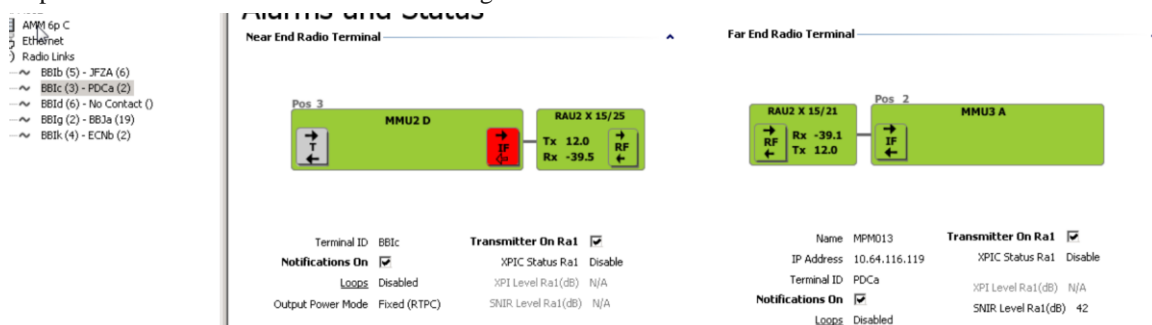
2. Verify link RF Input level on the receiving radio is at-least 5 db above the threshold for BER 10^{-6} for the current configuration. See link budget calculation for the correct level.

Expand Radio Links and click on link having alarm.

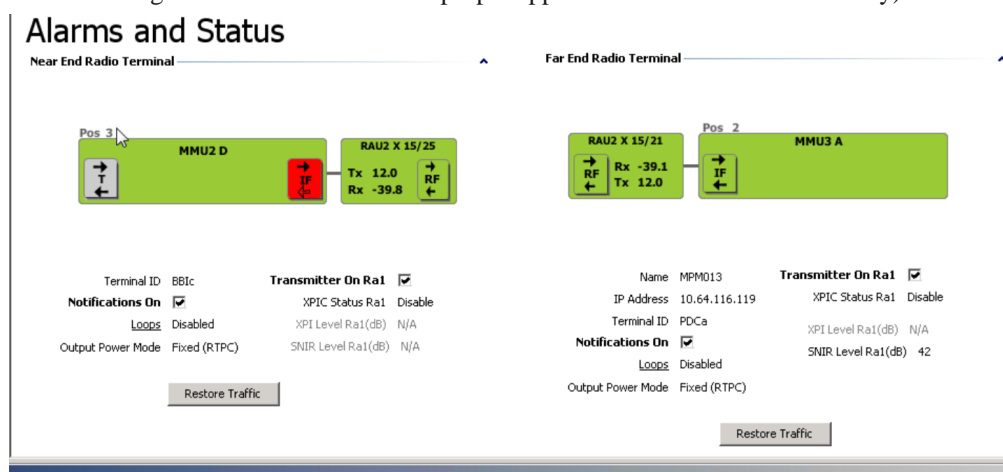
Disabling Far-End Transmitter: Uncheck the Transmitter of far-end. (Ensure the visibility of near-end node is not dependent on far-end node, if it so align FE for radio loop testing. As well during loop all dependent services will go down so ensure to have proper approved downtime for the activity).

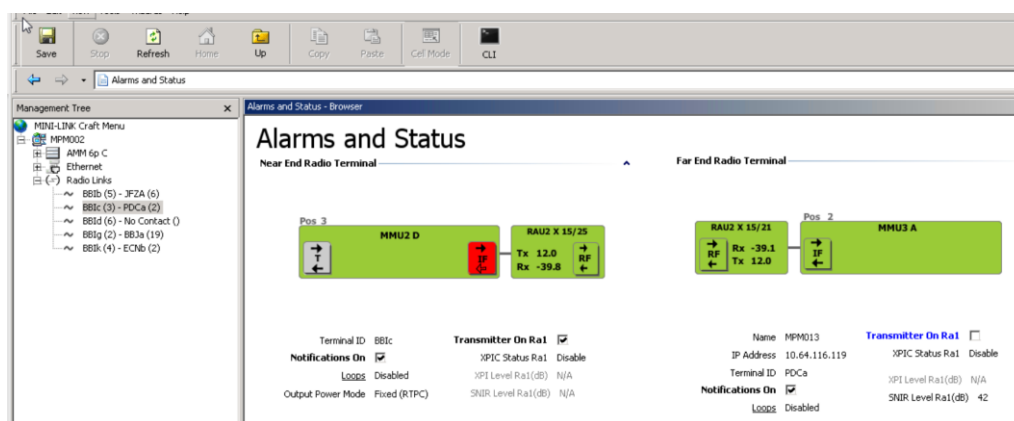
After unchecking the transmitter save the configuration

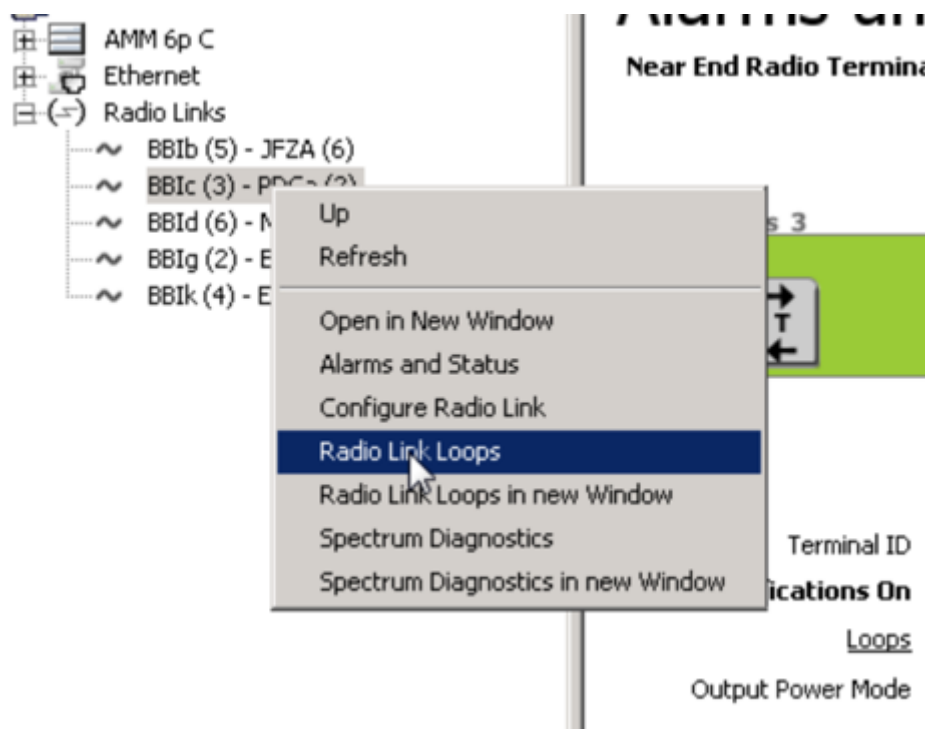
Now Select Radio Link Loops option as highlighter below for enabling loop on link

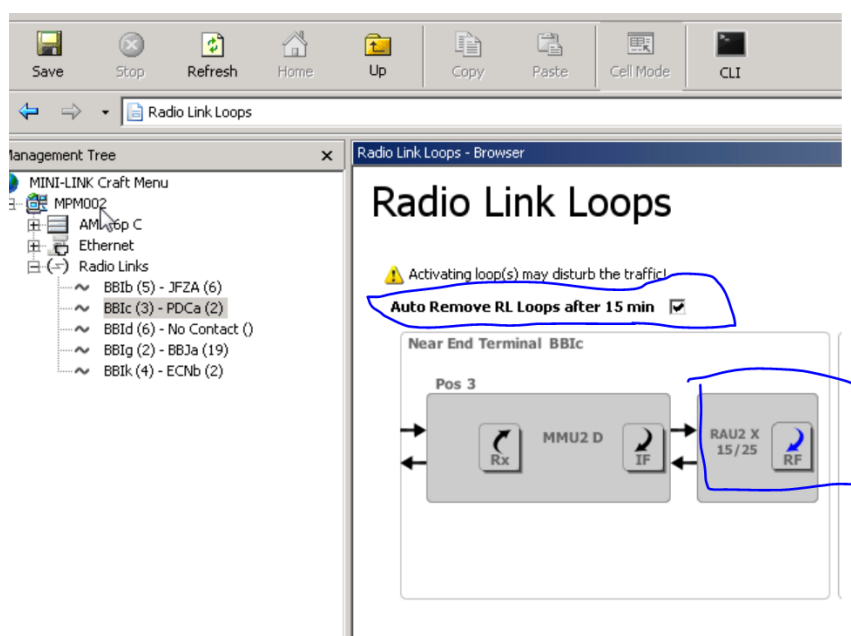
Now select RF loop as highlighted below and save to enable loop on radio link. RF will prompt as in Blue color when loop is enabled. (Ensure Auto Remove RL loops after 15 min is also checked so loop can auto removed if any visibility issue happens on node).

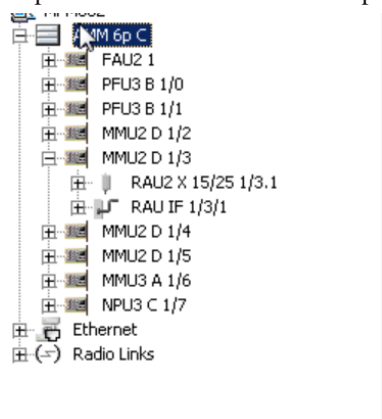
Expand the node AMM and then particular slot card.

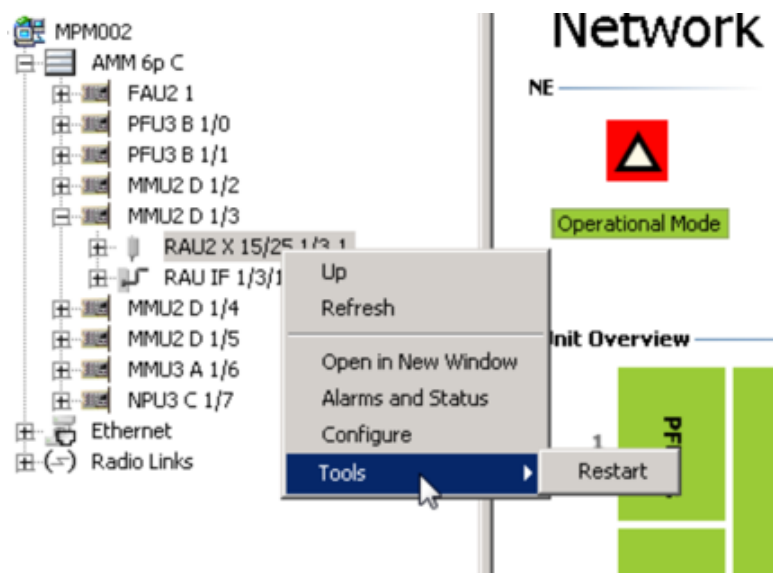
Select RAU2 X ----Tools—Restart.

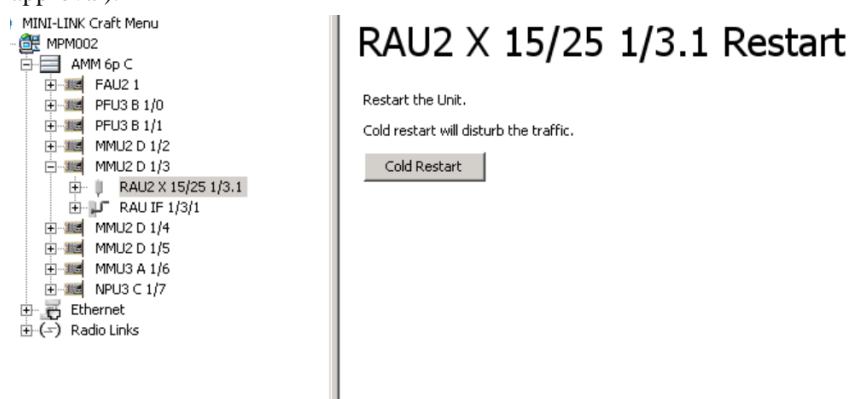
Now Click on Cold Restart (Cold restart is service impacting so need to be done with proper approval).

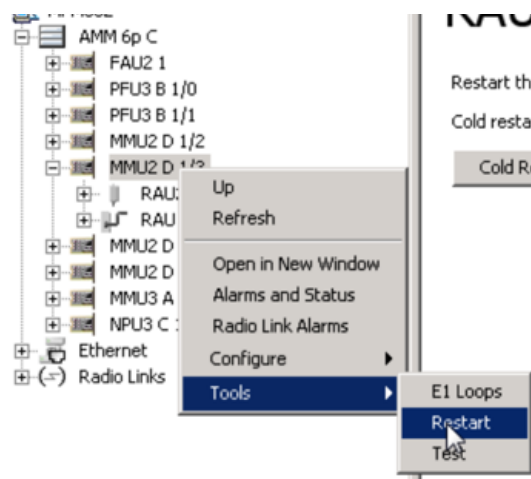
Now Select MMU card for MMU restart .

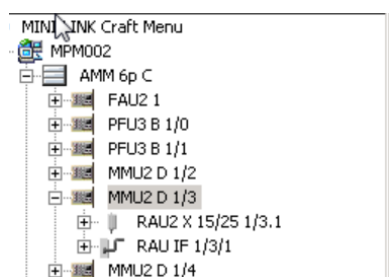
Now click on Cold-Restart to perform MMU restart.

Cold restart will disturb the traffic.

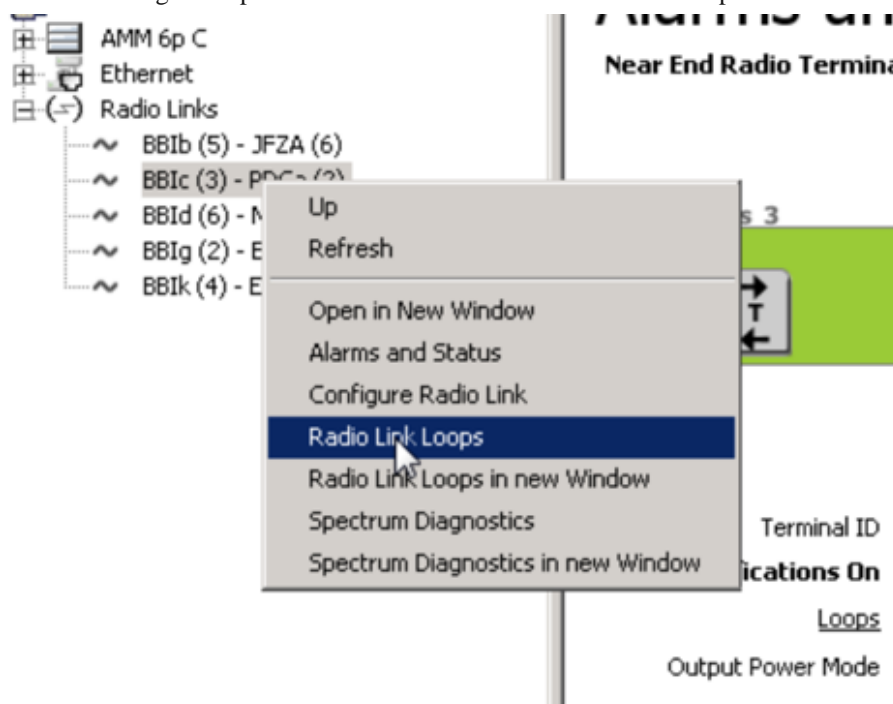
For Performing IF loop Select Particular link click Radio Link Loops.

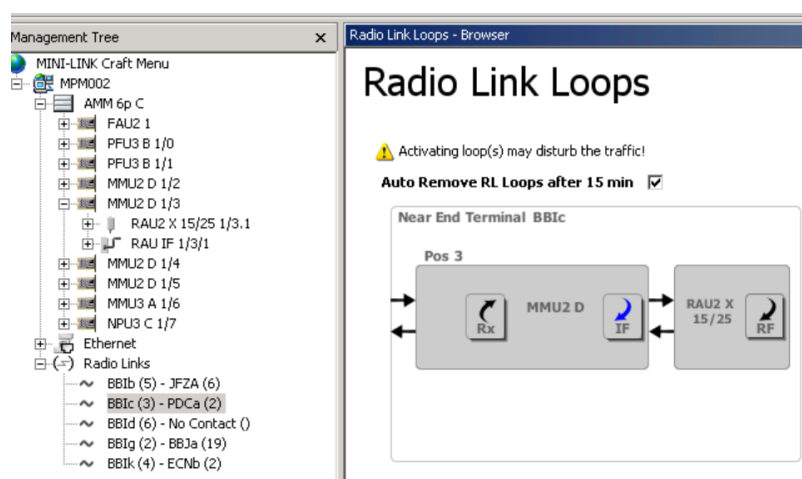
Now click on IF to enable IF loop on the link and save the configuration. Once enabled it will come in Blue color.
