# Seat Belt Tongue Plate Stopper Replacement

Toyota Supports  
ASE Certification

## Seat Belt Tongue Plate Stopper Replacement

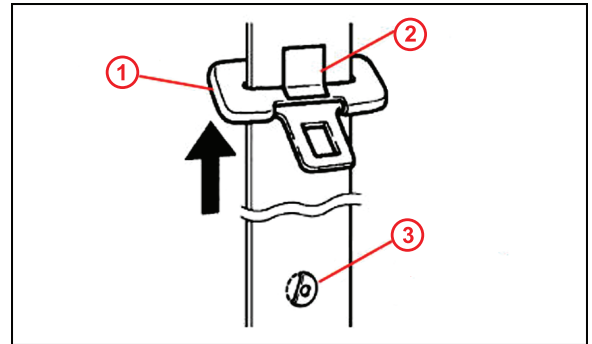
**Figure 1.**

For situations where only the seat belt stopper is broken, a new service part has been developed to eliminate the need to replace the entire seat belt assembly. Follow the installation procedure below to utilize this new part.

| <b>3</b> | Example of Broken Tongue Plate Stopper |

1. Shift the tongue plate to the upper portion of the tongue plate stopper, and temporarily hold it with a clip or tape.

2. Remove any pieces of the original tongue plate stopper in the webbing, with a pair of diagonal pliers.
