MOP - SFP TX Power Low at LTU2_155 OEM Ericsson

This document outlines the systematic process involved in SFP TX Power Low at LTU2_155 alarm clearance on node.

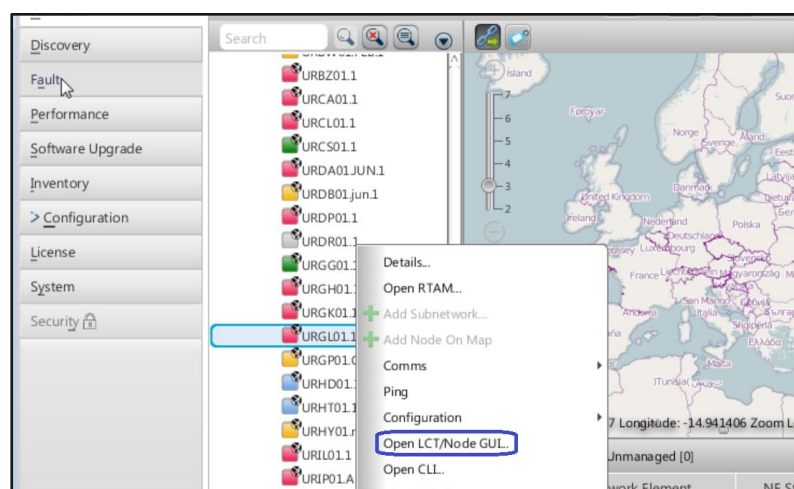
- Search the required Node ID in GUI & If node is managed, then open node using SO-EM GUI or directly from Mini-Link Craft using node IP.

MINI-LINK Craft 19.Q2
