SUPPLEMENT

Bose® Model 1801/1800 Power Amplifier

Bulletin #13

Bulletin #13A

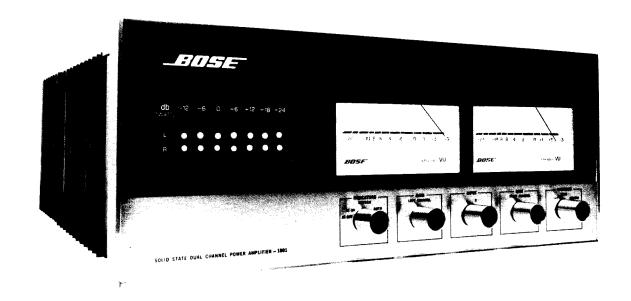
PM-2 Boards: Approximately 30800 and above

When replacing output transistors, you must use the correct replacement device. Older units with P/N 102433 on the output transistors must be replaced with 102433 (2N5840) transistors. Units with output transistors with P/N 117579 must be replaced with 117579 (MJ15011) transistors.
