Service Documentation

Service Information No. 08/2010

Appliance switches to demo mode / does not switch on after power failure

Models: GGU 15...

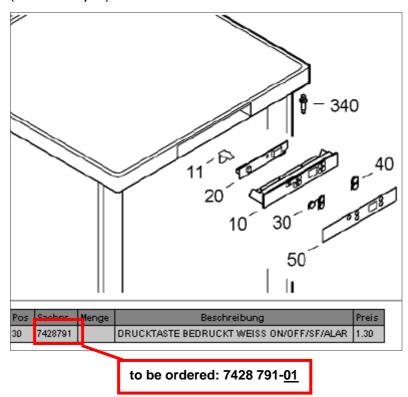
Fault profile: - Appliance switches to demo mode.

- Appliance fails to switch on after power failure.

Cause: - The pushbuttons are accidentally pressed.

EMC influences.

- Order new pushbuttons with spare part index 01 according to Liparts (see example).

- Fit optimized electronic module (6114 597-00).
- Fit two clips (7429 541-01) in the control housing.
- Fit two interference filters (7426 324-00) to the mains cable.
