## MOP of VSWR Alarm for Nokia Site

This activity is for E2E troubleshooting and alarm clearance of VSWR of the antenna feeder abnormal.

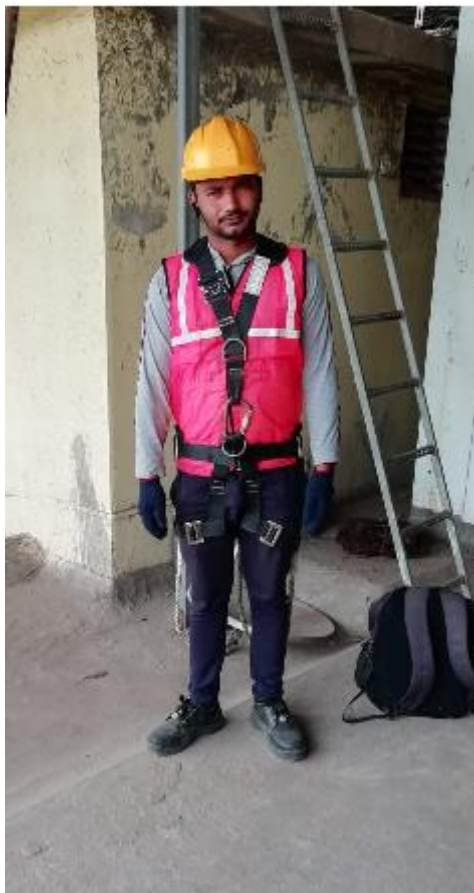
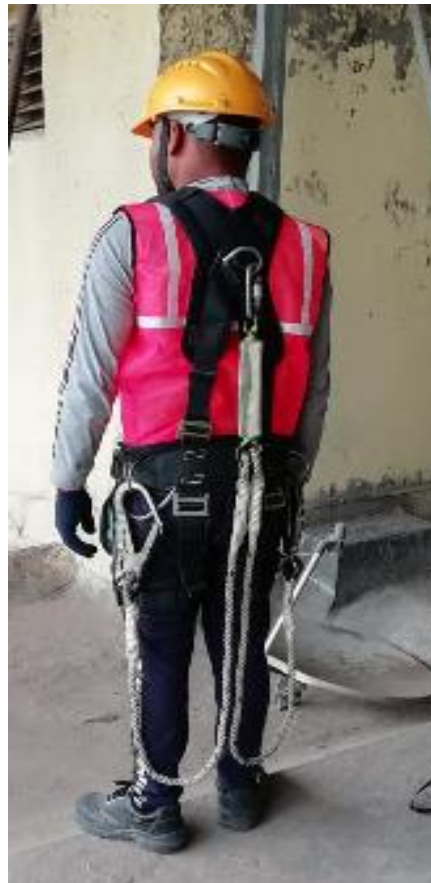
3. FME also verifies VSWR Value of all connected RF Module Ports. If getting any other port VSWR value High. Then will resolve at same time
4. FME will share same information to rigger (RF Module Sr. No. & High VSWR Port detail)
5. FME will ensure the PPE kit, work at height certificate, medical certificate, present healthy physical condition, site condition including hygiene
6. Raise PTW request

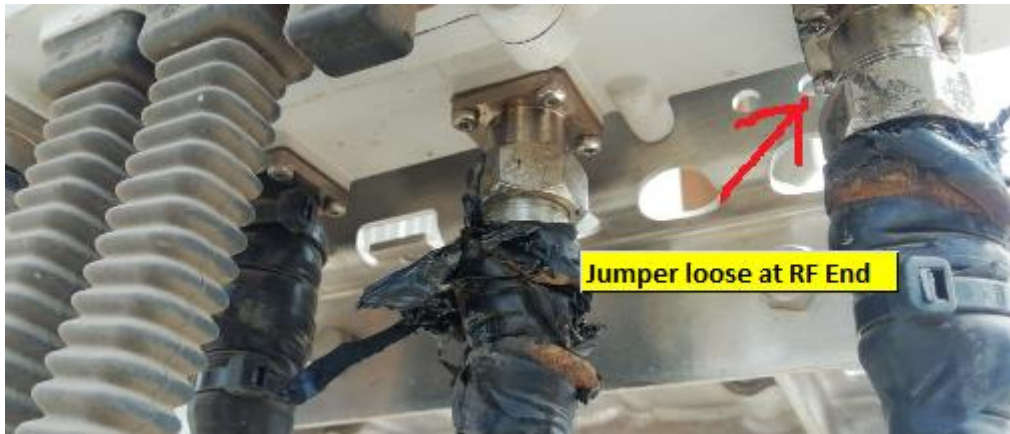
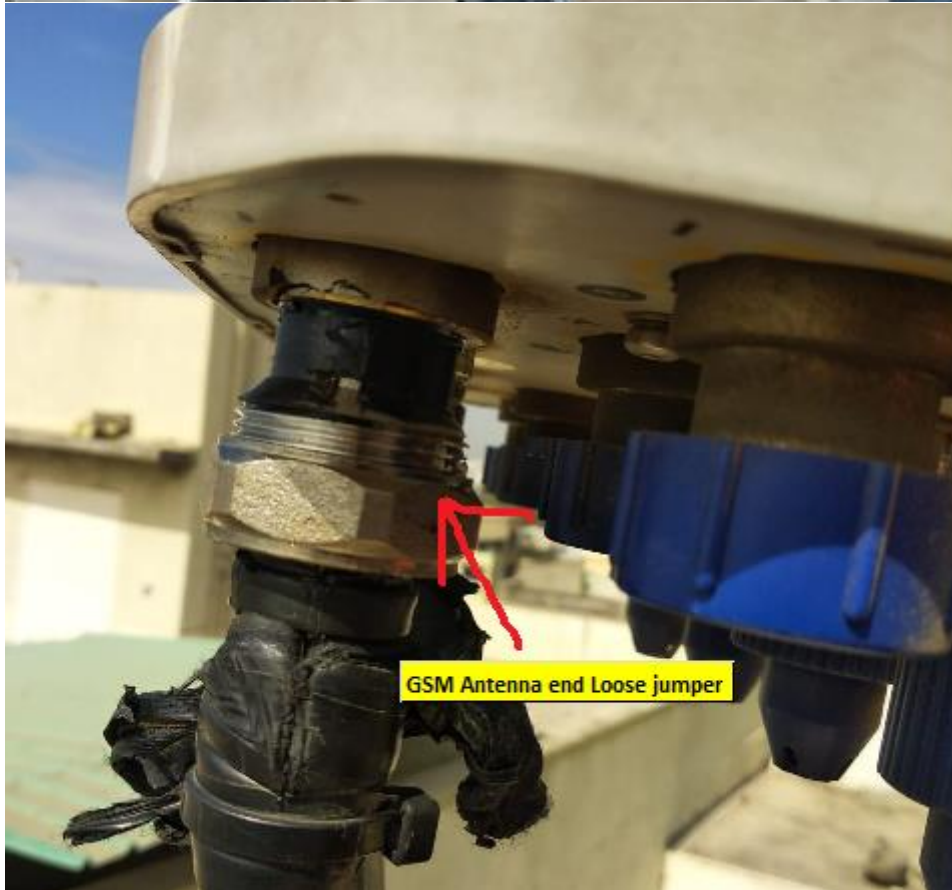
- A. RF Jumper connection at RF Module & GSM End. If issue found in jumper tightening, then close issue & take VSWR Value Feedback from FME. If not resolved, then will follow below step

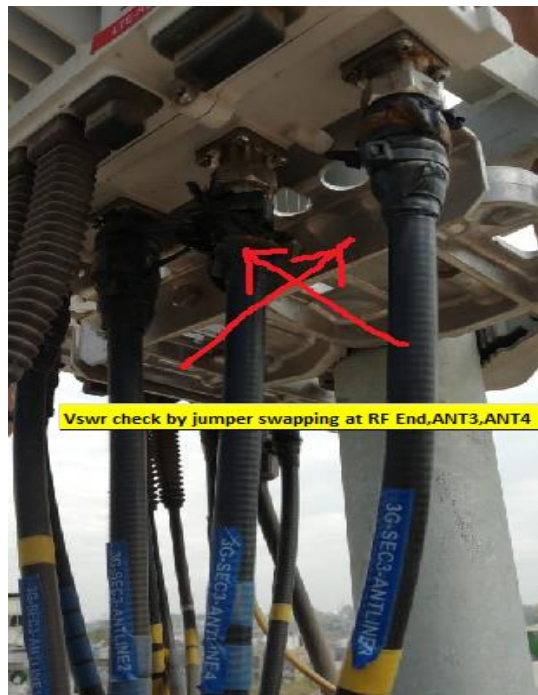
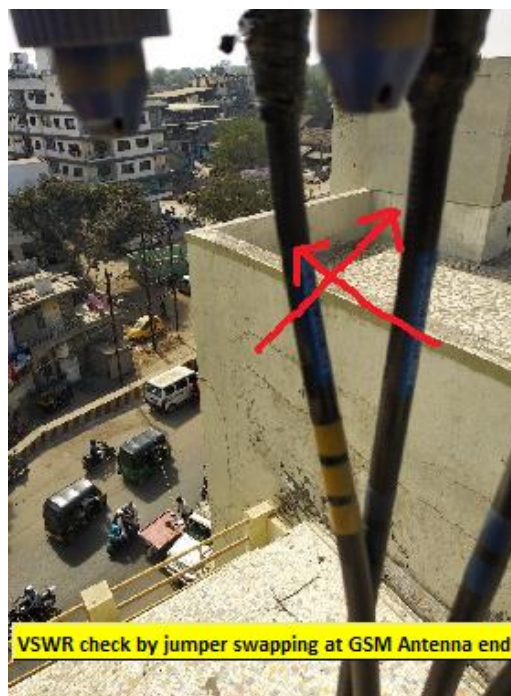
- B. Rigger will Swap jumper with OK VSWR value port Jumper. If VSWR Value swapped with jumper swapping. That means Jumper faulty. Rigger will replace Jumper. If alarm not swapped. Then will follow below step

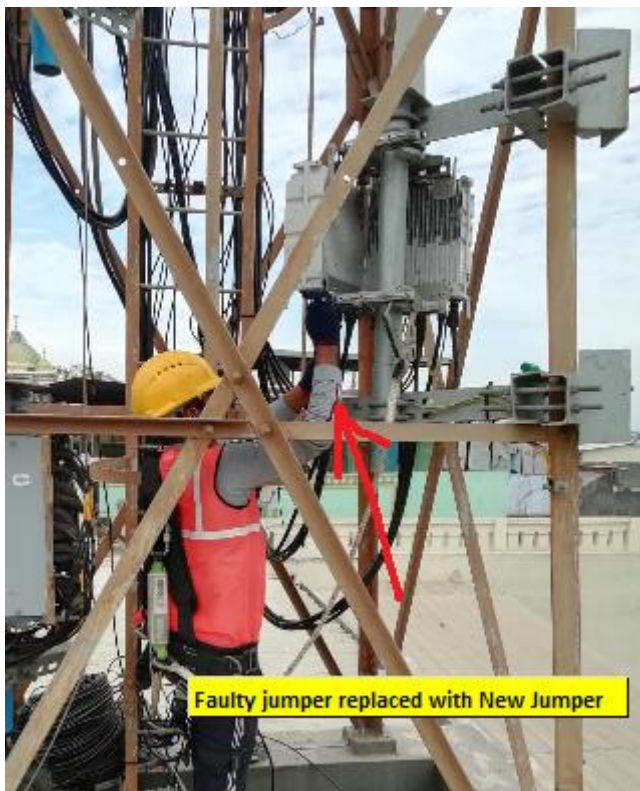
- C. Rigger will swap Jumper at RF Module End with OK VSWR Port. If alarm reflecting in same Port then RF module port faulty & If alarm swapped with Jumper Swapping then GSM Antenna Port faulty
- If GSM antenna Port Faulty, then same information is passed to ZTM & Put WO in Waiting External & Leave site. (ZTM Will coordinate with Customer for GSM Antenna Replacement with Project team)
  - If RF Module faulty then replace RF Module.
