MOP For MW_BER_SD Alarm Troubleshooting

This document outlines the step-by-step process involved in MOP for MW_BER_SD Alarm Troubleshooting.

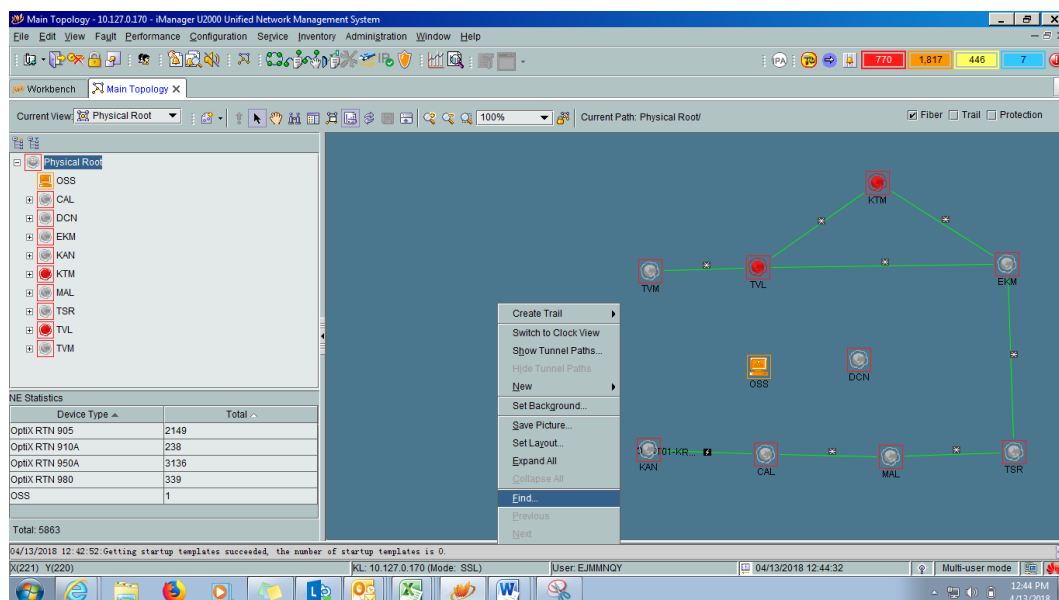
6. Right Click on the server and click on "FIND" to find the node.
