MOP of AM_DOWNSHIFT Alarm for Huawei

Activity Description

This activity is for E2E troubleshooting and alarm clearance of AM_DOWNSHIFT.

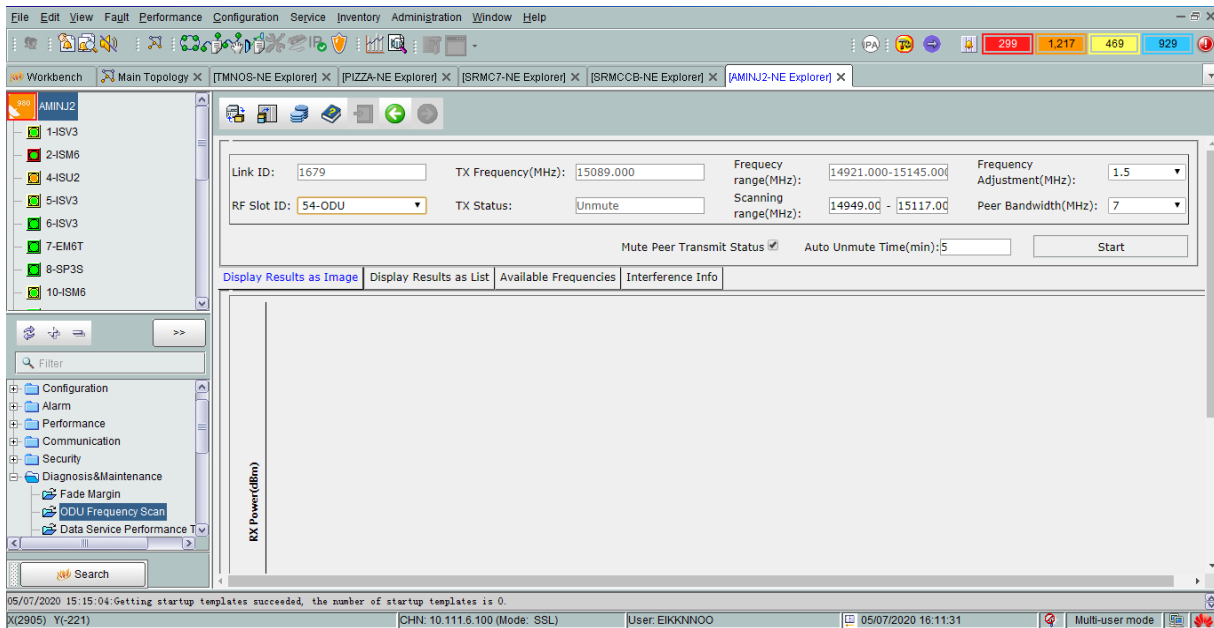
b. How to perform ODU Frequency scan

Select the Diagnosis & Maintenance and expand the link, click ODU FREQUENCY Scan to Select the ODU which is connected to corresponding link and mute peer end transmitter to select AUTO UNMUTE TIME should be 5 MINS.

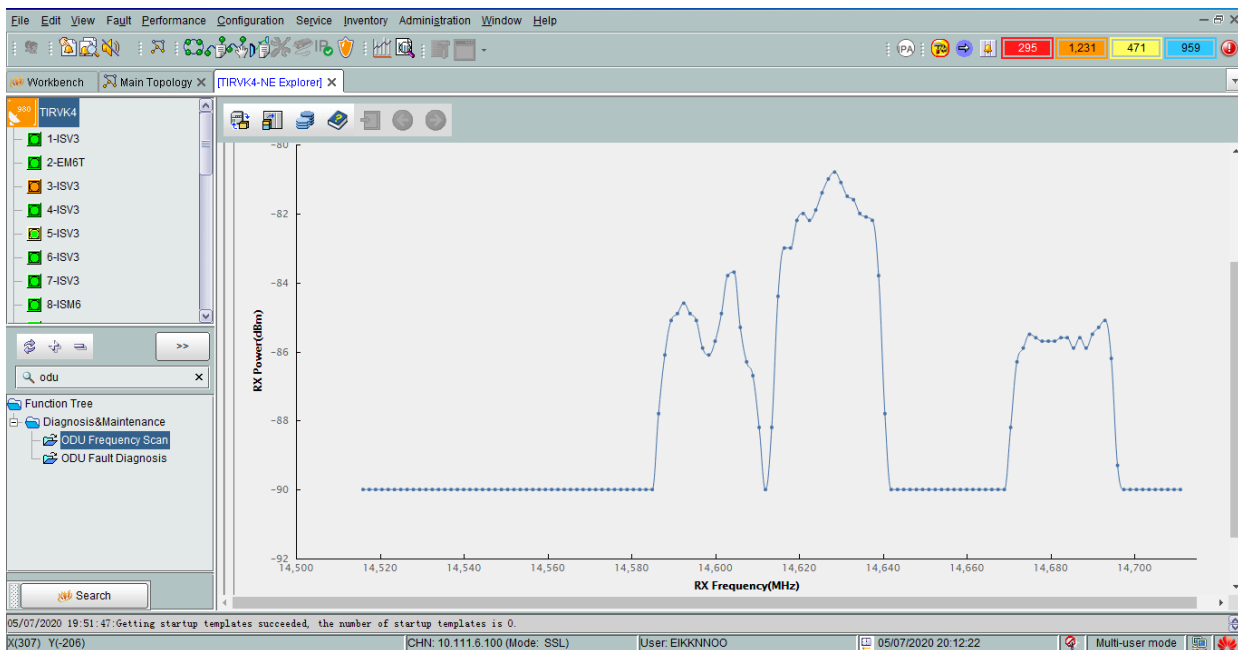
c. ODU Frequency scan report

Both end frequency scan report required to find the frequency interference level and also to get right frequency

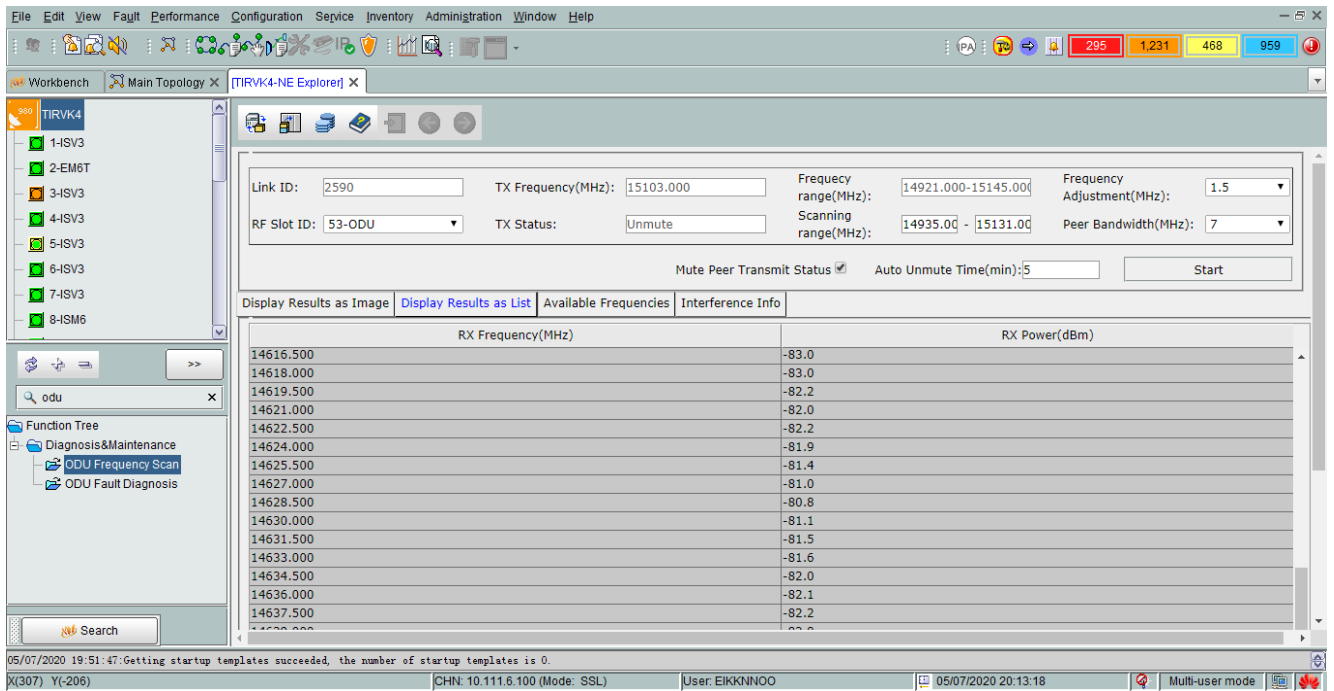
d. Find out right frequency

ODU Frequency scan report required both end it shows all frequency interference level to find out right frequency with planning to support

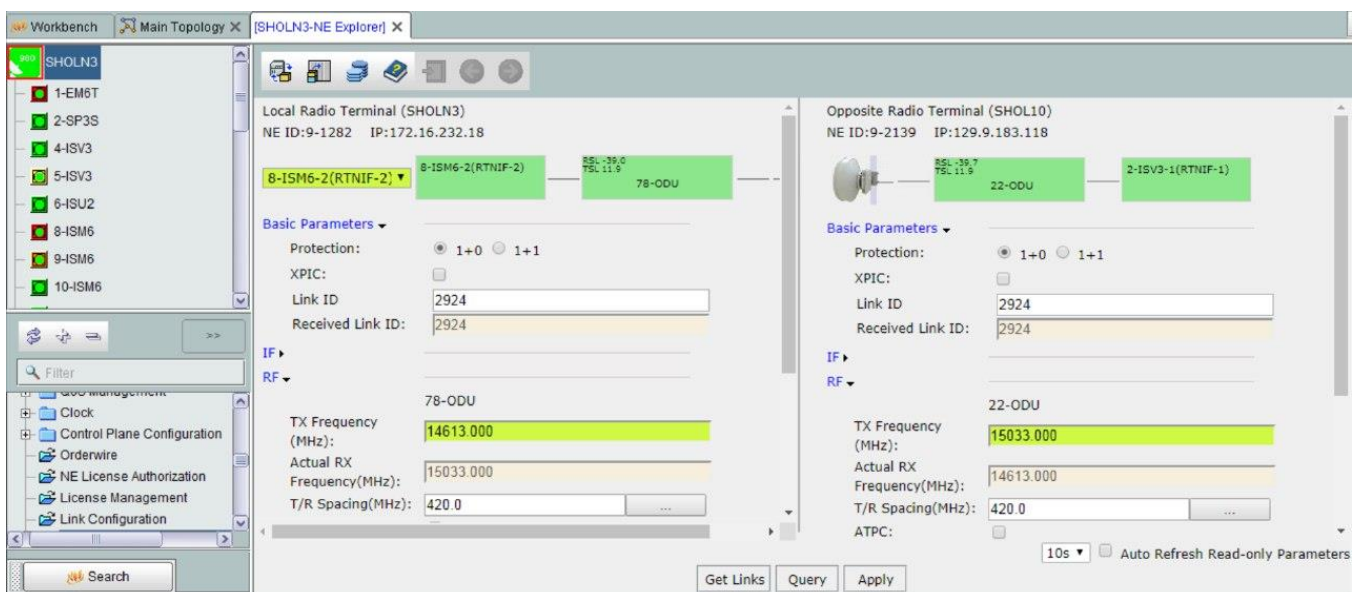
e. Frequency change

Take planning team support with ODU scan report to find out right Frequency and change frequency as show below snap.

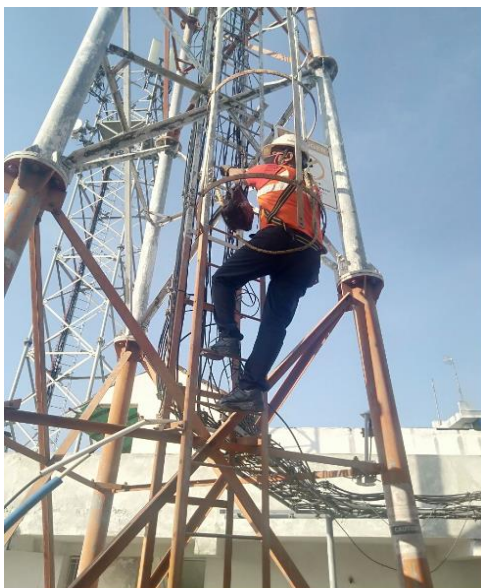
Site –A end Antenna alignment

RSL achieved and Link working full Capacity modulation – AM downshift got cleared.
