## (wafer1,0,0,-1,-1,2,2) Plots and Summary

- Cell Size = 10um
- Number of Times Accessed = 27
- Last Stimulated = 2022/February/28 at 05:01PM

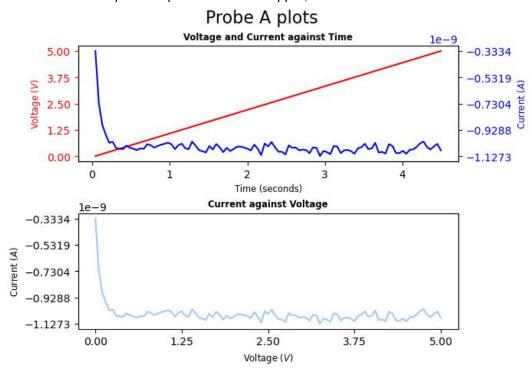
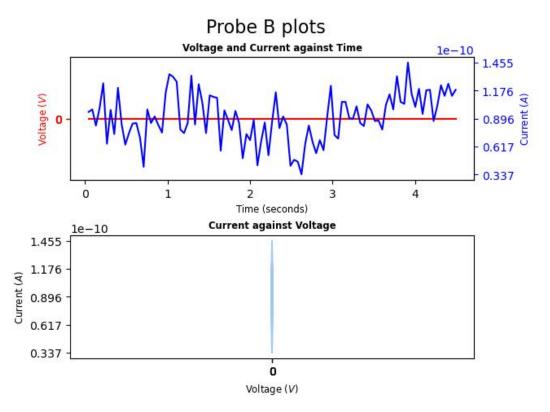
Comments = Failure to form. Bad probe to pad contact. A: Copper, B: Platinum.

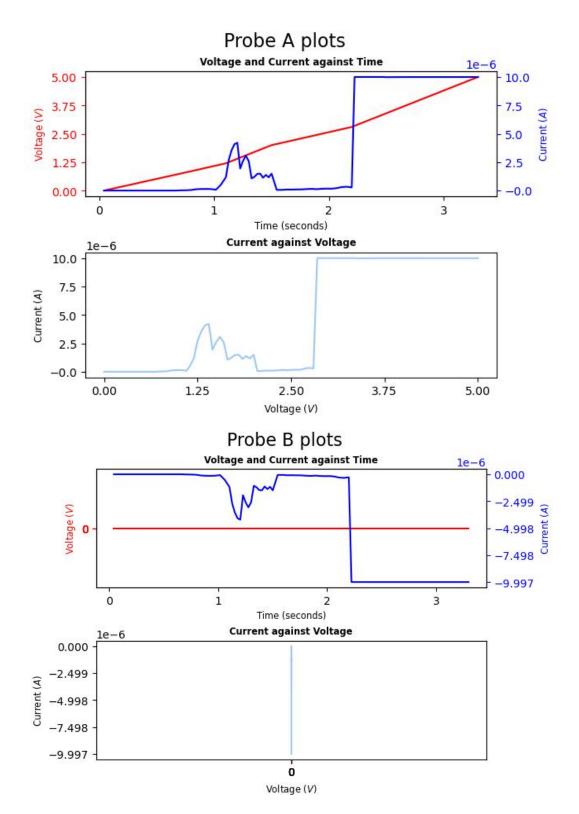
Comments = Success, but strange curve in the beginning. A: Copper, B: Platinum.

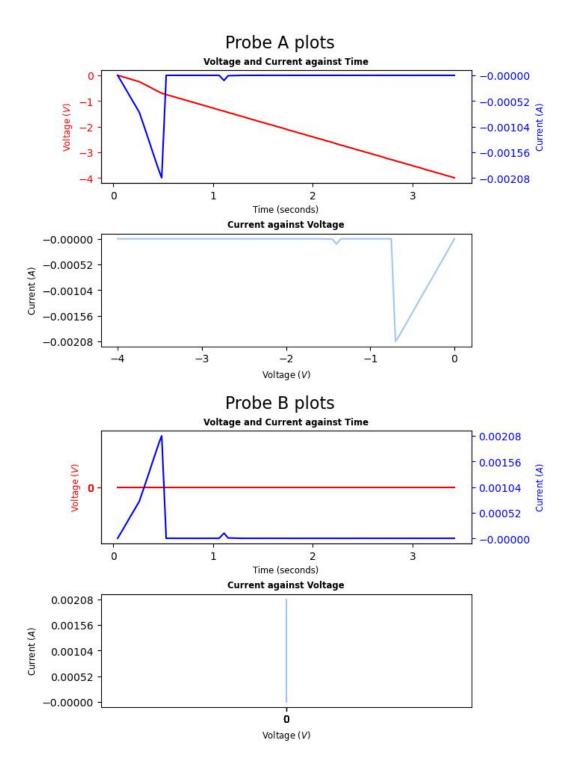
Comments = Success. AV column missing, copied from run 2202281620. This run was a near perfect reset. A: Copper, B: Platinum.

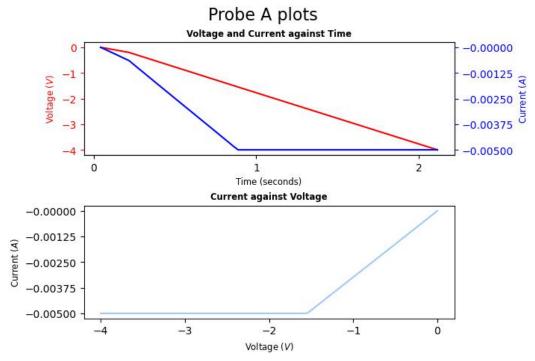
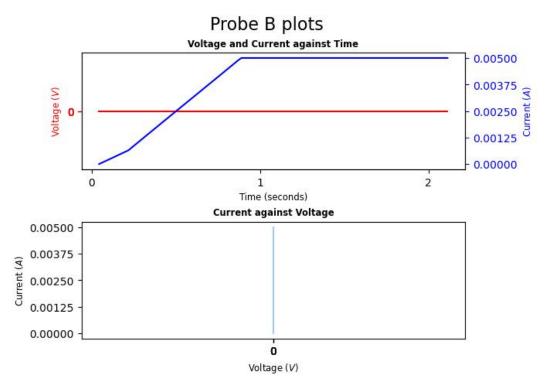
Comments = Failure to reset. A: Copper, B: Platinum.

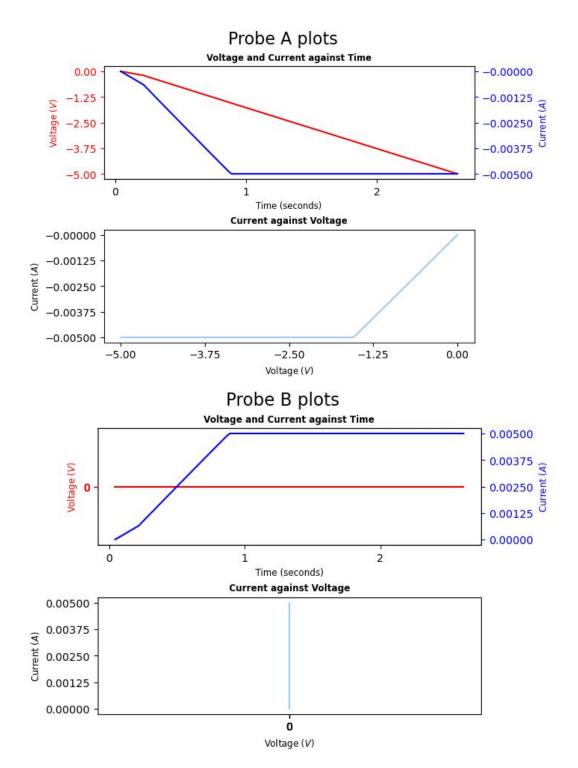
Comments = Reset failure. A: Copper, B: Platinum

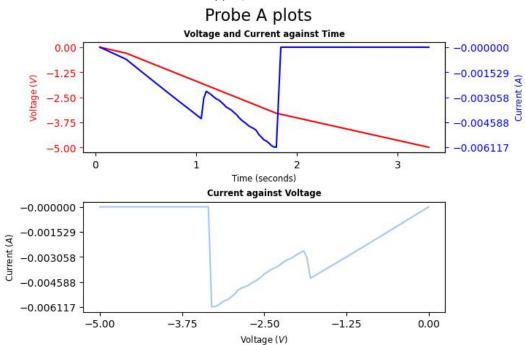
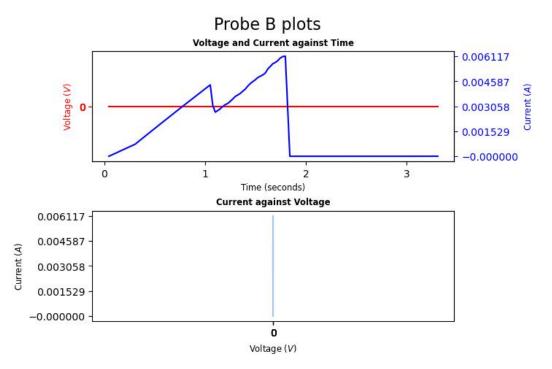
Comments = Reset success. But not smooth. A: Copper, B: Platinum.

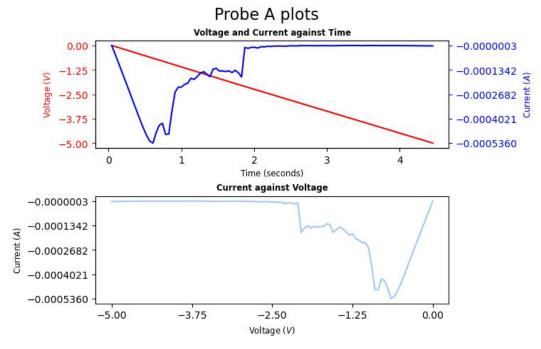
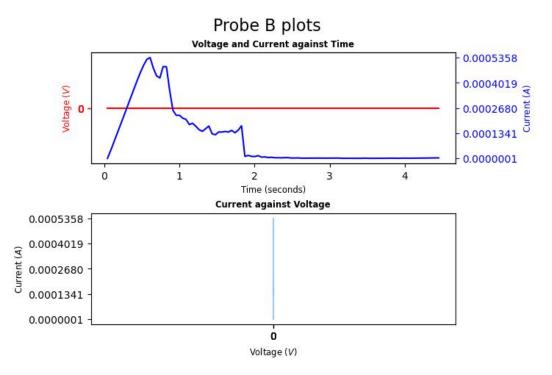
Comments = Successful reset, but very janky. A: Copper, B: Platinum.

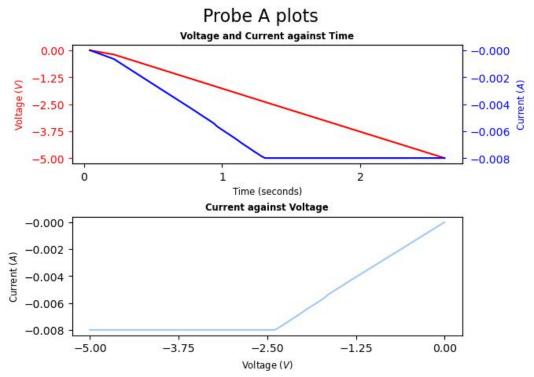
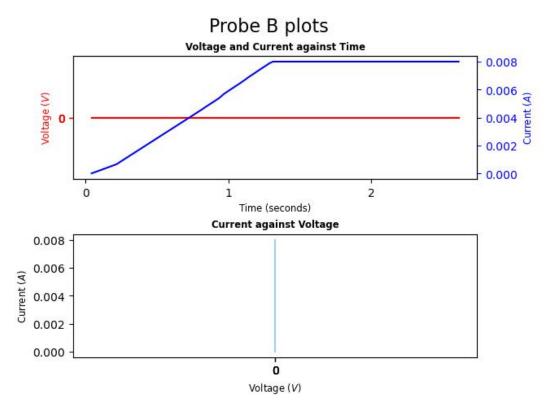
Comments = Reset failed. A: Copper, B: Platinum

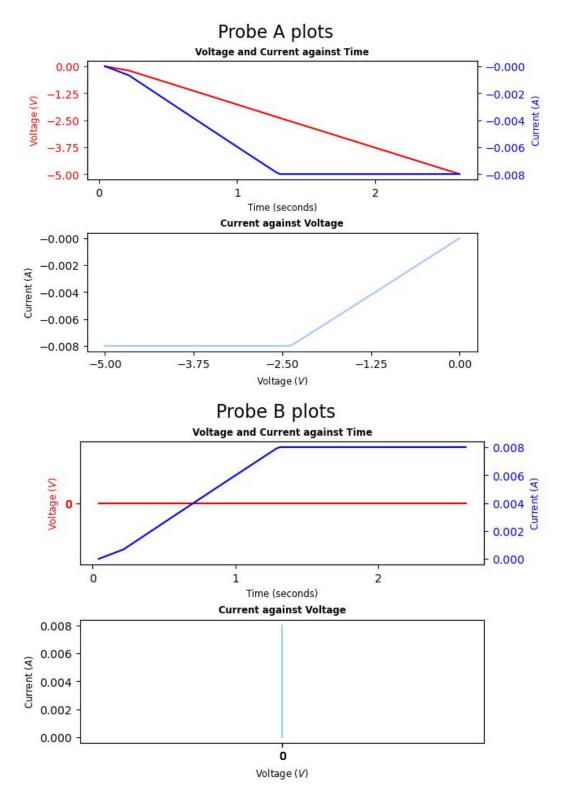
Comments = Reset failed. A: Copper, B: Platinum.

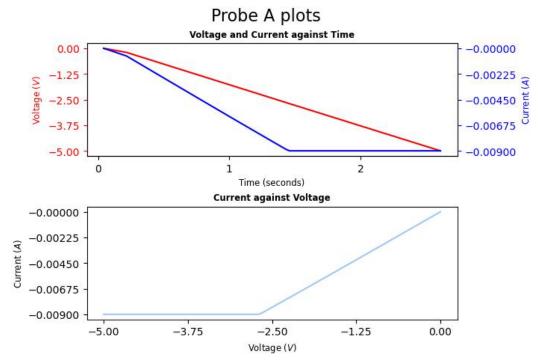
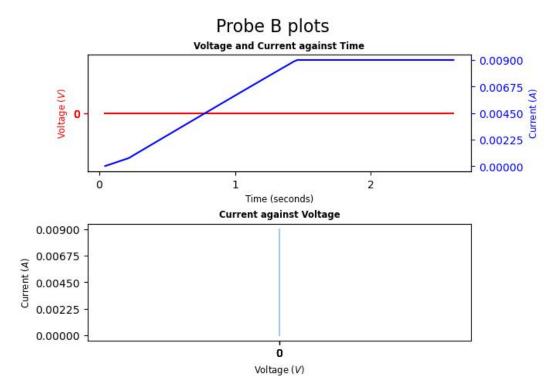
Comments = Reset failed. Something wrong, cell is possibly burnt out (i.e. too strong of a filament. A: Copper, B: Platinum.

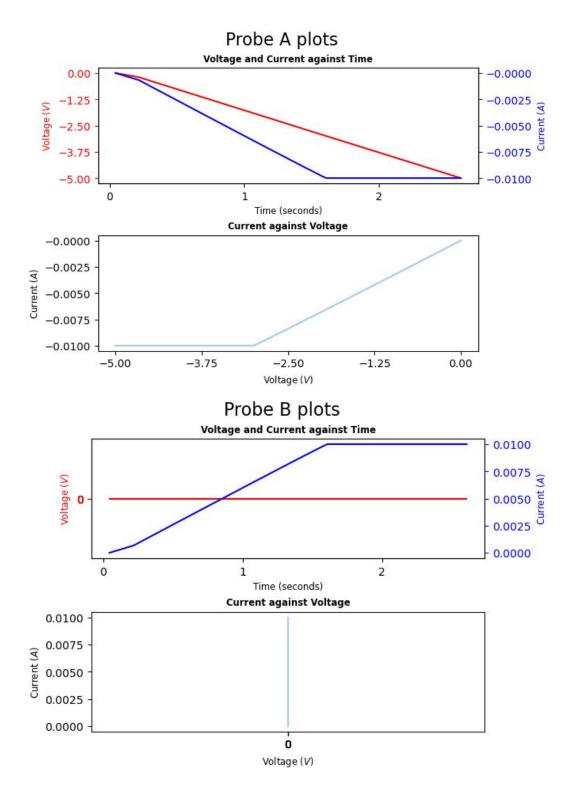
Comments = Reset failed. A: Copper, B: Platinum

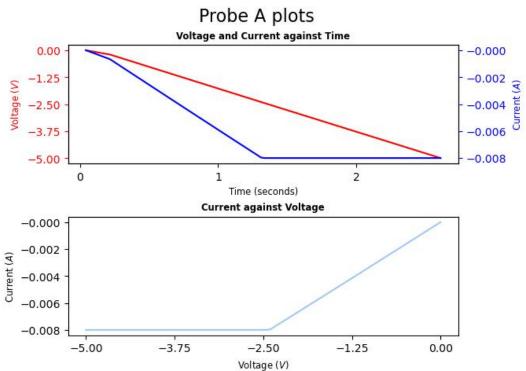
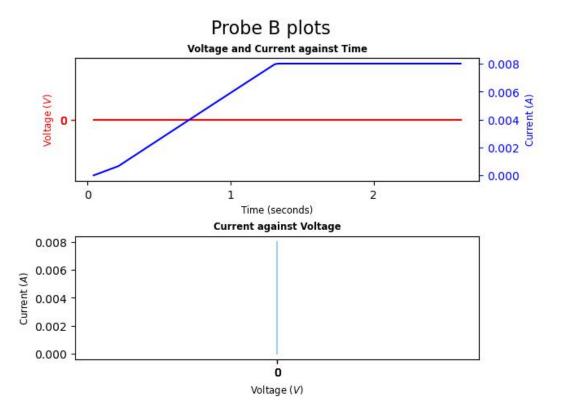
Comments = Failed reset again. A: Copper, B: Platinum.

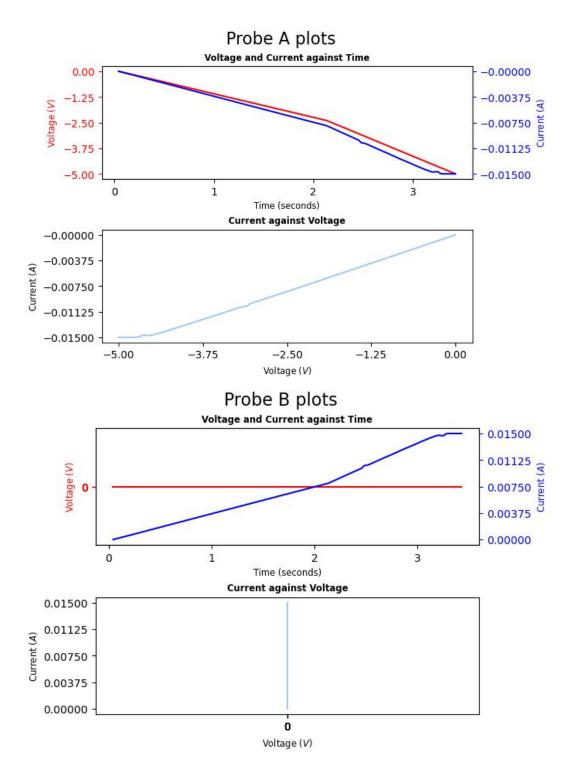
Comments = Reset fail. Cell damage confirmed. A: Copper, B: Platinum.
