MOP for Ceragon Excessive BER on TDM-LIC STM1/OC3 port Fault management

This document outlines the step-by-step process involved in Ceragon Excessive BER on TDM-LIC STM1/OC3 port Fault management

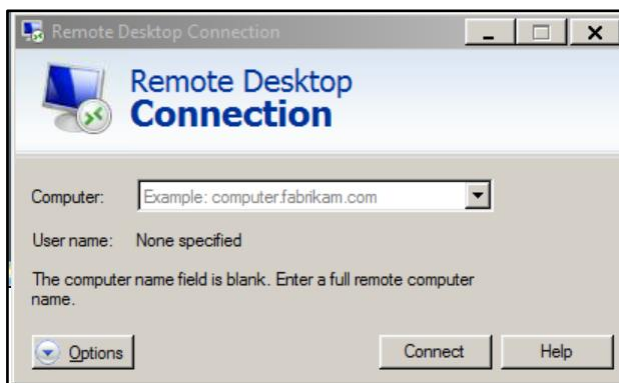
- ***Click on Main > Xenapp6.5 > Bharti Noida > Bharti INNO Remote Desktop Client.***

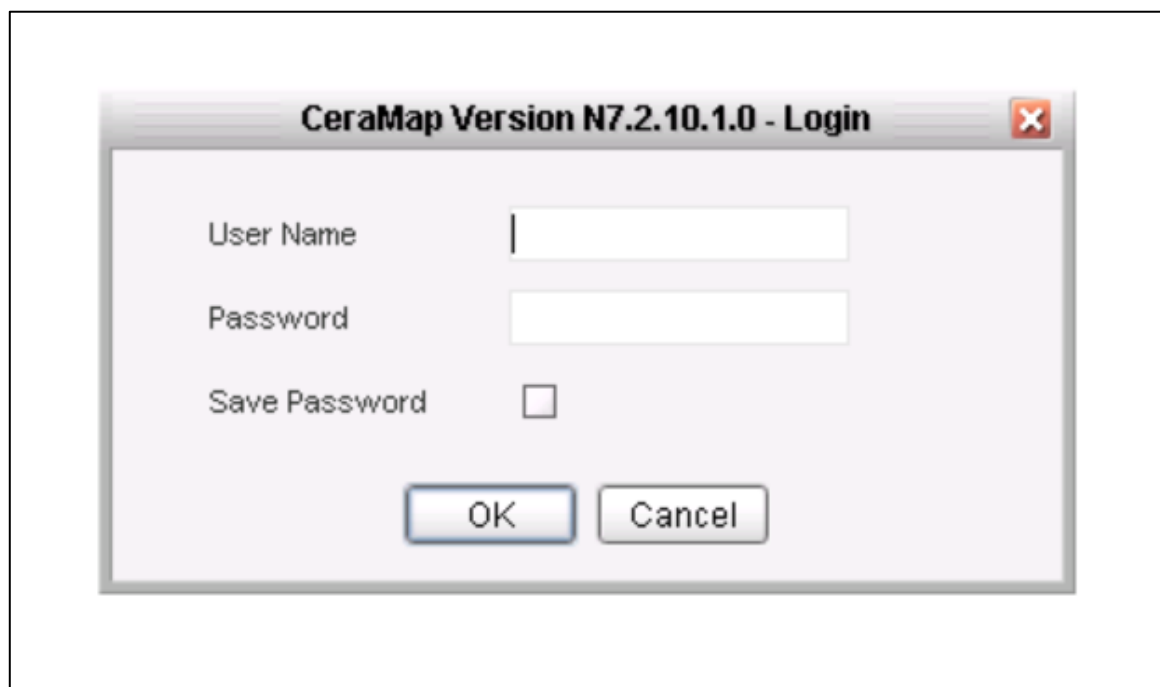
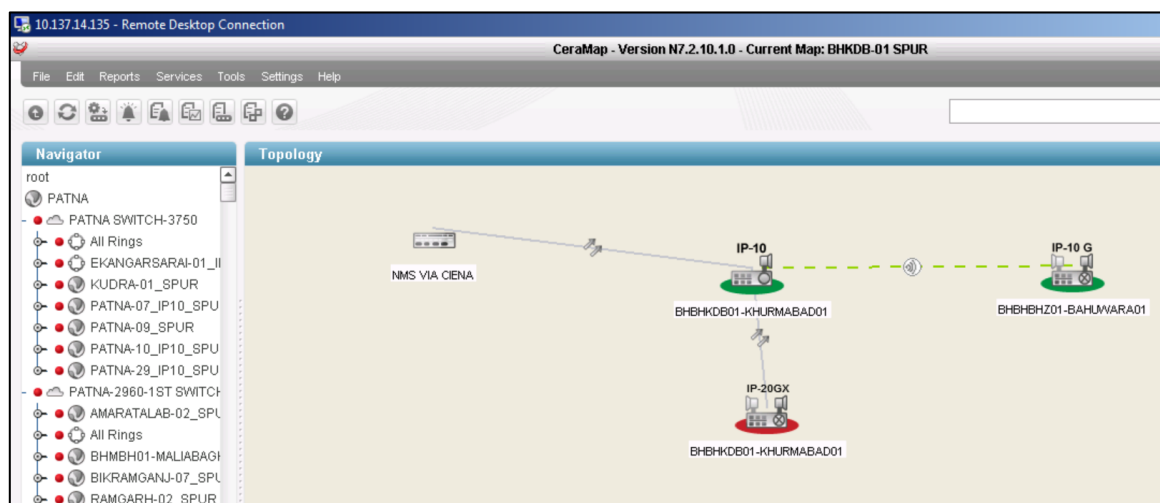
- **Search the required Node ID in Cera Map & open the node by clicking on Open Node GUI.**
- **Login Ceragon NODE locally via web browser through IP.**
- **Provide IDU username and password.**
