FMI Completion Certification Report

FMI No.: 25355

FMI Title: HP80 & RT (Varian Tube) Quick Disconnect

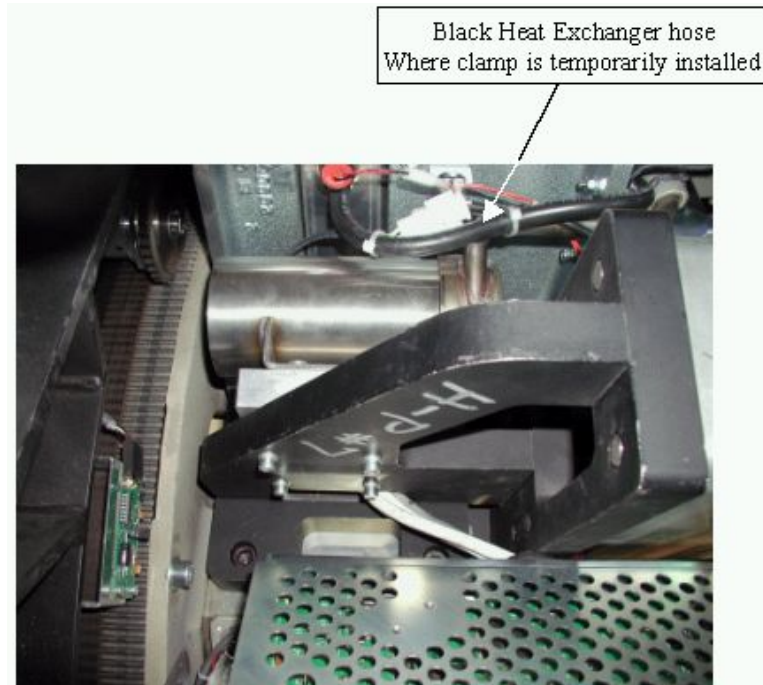
The purpose of this FMI is to update the selected HP80 & RT LightSpeed 5.X systems that were shipped with incorrect Quick Disconnect. Corrosion build up inside steel plated quick disconnect may cause plunger to stick open, causing leakage of coolant during pump or heat exchanger replacement. This FMI will fix this issue.

1. **Overview:** The male Quick Disconnect being replaced in this procedure can become corroded, and stuck in the “open” position. A new design Quick Disconnect eliminates this failure mode.
2. Follow gantry positioning in this procedure closely – doing so prevents a faulty quick disconnect from leaking too much fluid.
3. The propylene glycol mixture in the heat exchanger is conductive – so be sure to catch it all. Only a few mL of fluid will leak.
4. Remove side, top, and front gantry covers.
5. Turn off the Axial Drive Enable, HVDC Enable, and 120VAC switches on the service switch board.
6. The quick disconnect that will be replaced during this procedure is circled in the following picture. Note that the pump’s disconnect will not be touched – only the heat exchanger’s male quick disconnect in this location will be replaced.

1. Place the finger clamp on the black heat exchanger hose near the pump (this hose leads to the accumulation bellows). Turn the clamp to finger tight – you'll notice that the clamp might bend a little bit – this indicates the hose is successfully clamped off. The clamp prevents coolant flow from the heat exchanger accumulator during this procedure.

2. Position Gantry so that the Quick Disconnect is around 2 o'clock (you will be working in this area so position the gantry such that you can easily access the pump mounting screws)
3. Since access to the 4 pump mounting screws is easy in this gantry position, remove the 4 pump mounting screws, but do not disconnect pump.

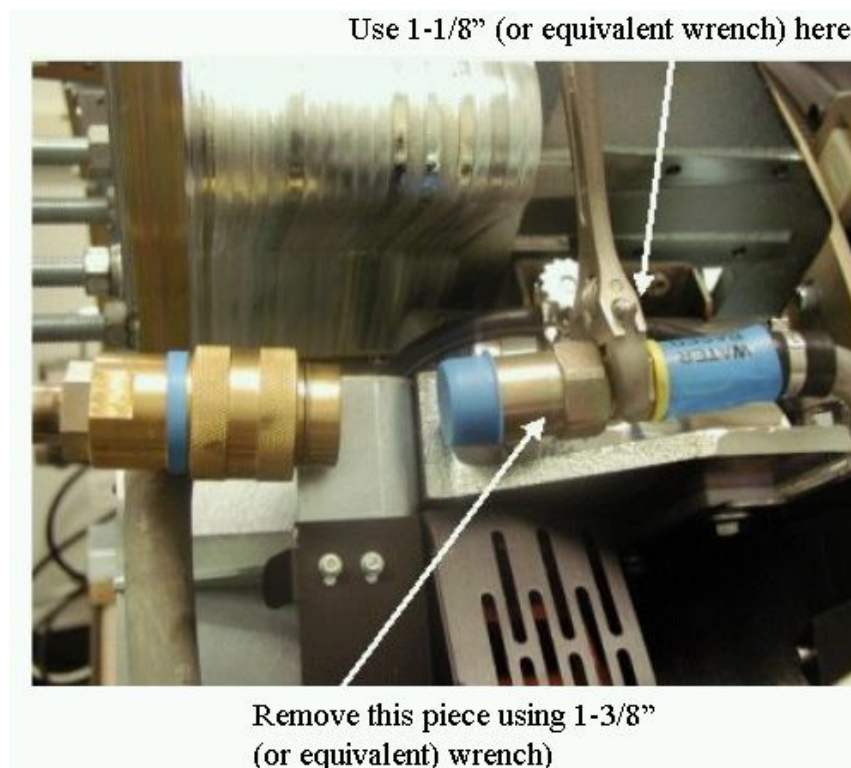
Positioning the gantry in the following step is crucial – since gravity, combined with the clamp from step 1 will not allow excess fluid to spill if the Quick Disconnect is defective.

4. Rotate the gantry so that the quick disconnect is at the 12 o'clock position. Place an absorbent pad underneath the disconnect joint to catch residual fluid.
5. Disconnect the pump from the heat exchanger, absorbing any residual fluid that may come out (a few drops is normal). Leave the pump suspended on the gantry for the replacement.
6. Put the protective plastic cap from the new male quick disconnect onto the old one.
7. Move the gantry back into a workable position to loosen the quick disconnect (quick disconnect at 3 o'clock).
8. Using 1-3/8" and 1-1/8" wrenches (or equivalent – adjustable wrenches will work), loosen the male quick disconnect from the heat exchanger. Do NOT remove it yet. Note that the yellow ferrel in the short hose attached to the heat exchanger allows the quick disconnect to rotate without damaging the connection.
