**ADMINISTRATIVE INFORMATION****FMI No: 25402****FMI Title: VCT VIG EMC Update**

Unit Tracked: LightSpeed 7.x and Discovery VCT systems**FMI Instructions Part No.: 5231915-1EN****Do NOT leave unsecured on site**

Purpose

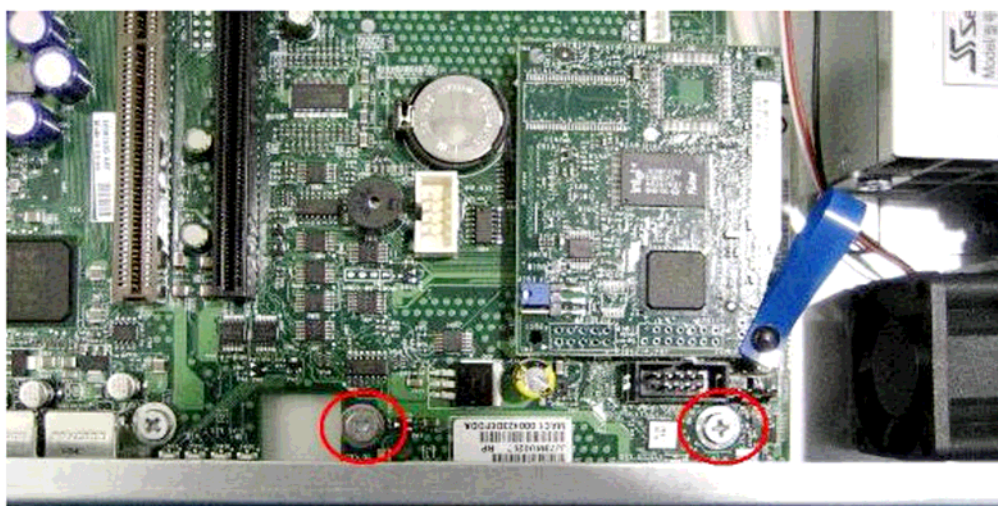
9. Verify that the EMI gasket under the PCI mounting bracket remains securely adhered to the system with no visible damage.

8. Remove and discard the 3 screws and PCI mounting bracket from the rear of the chassis.

10. Install the PCI cover (FAB-COVERPCI0570) to the rear of the chassis using 3 screws (MSC-M3/.5/5MM/B).

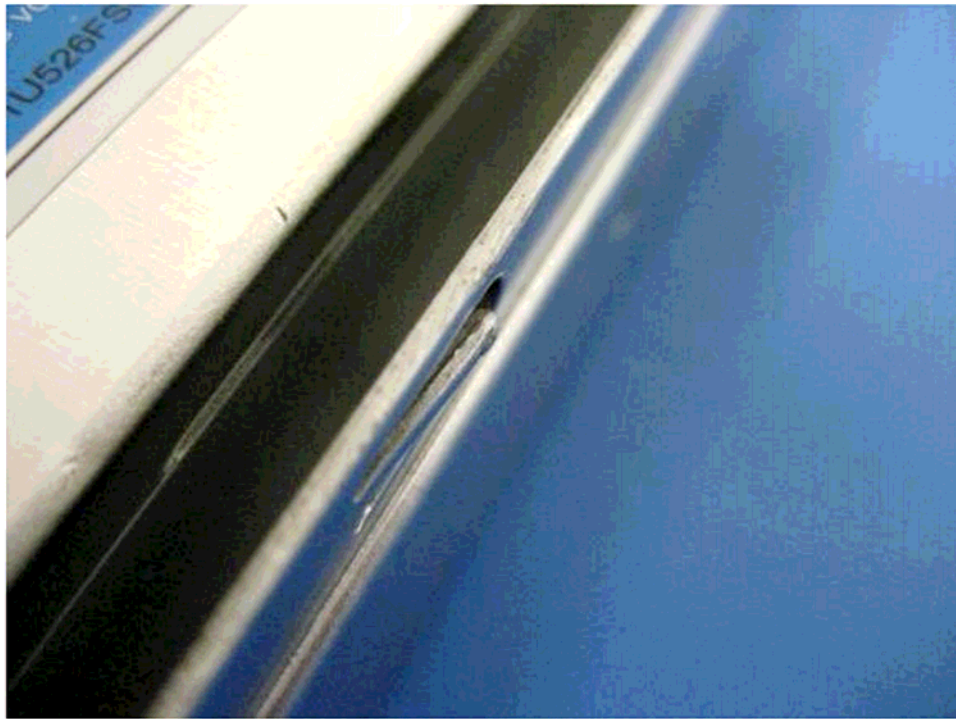
33. Verify that the metal tabs are bent out on both sides of the system as shown. These ensure that the lid makes a good connection with the system.

NOTE: If any of the tabs are not bent out, use a small flat-head screw driver to bend them out.
