**Direction 2249156FMI
Revision 0**

GE Medical Systems FMI 25257 4-Way Video Splitter Replacement

4-Way Video Splitter Replacement

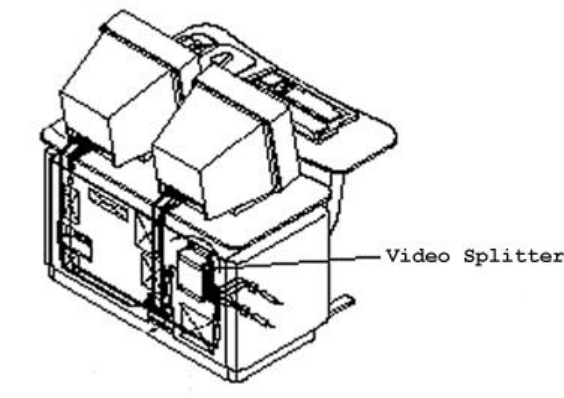
To replace the current four-way video splitter (part # 2151622-2) for SmartView.

1. Bring down applications and turn console power off.
2. Remove console front panel.
3. Unplug the video splitter power source
4. Locate video splitter on the back of the console and unplug all video coax connectors attached to the video splitter. Note which video cables were input and which ones were output.

5. Remove the upper bracket securing the video splitter.
6. Lift out old video splitter and replace with new video splitter.
7. Reattach the upper bracket removed in step 5.
8. Reconnect all video cables paying close attention which ones were input and which ones were output.
9. Plug one end of the power cord into the back of the splitter and the other end into the console.
10. Replace front cover of the console and power back up.
