Confidentiality Class	External Confidentiality Label	Document Type	Page
Ericsson Internal		Method of Procedure	1 (10)
Prepared By (Subject Responsible)	Approved By (Document Responsible)		Checked
ECGGJLJ Subhash Chandra	BMASJZMF [Nitin Baranwal]		
Document Number	Revision	Date	Reference
BMAS-20:001135 Uen	A	2020-01-20

MOP for Huawei MW_LOF Alarm Troubleshooting

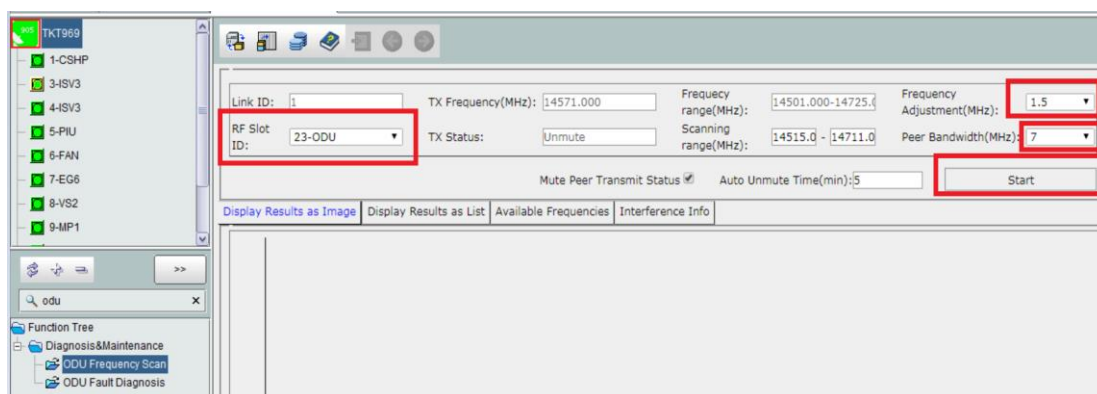
1. Open the NE explorer>> Diagnosis&Maintenance>> ODU Frequency Scan
2. Select the ODU for which the scan needs to be performed, then select the Frequency adjustment scheme from Frequency adjustment TAB and then select the Bandwidth from bandwidth TAB on which the link is configured.
3. After selecting the above parameters click "START" tab and wait till the scan is completed and click query

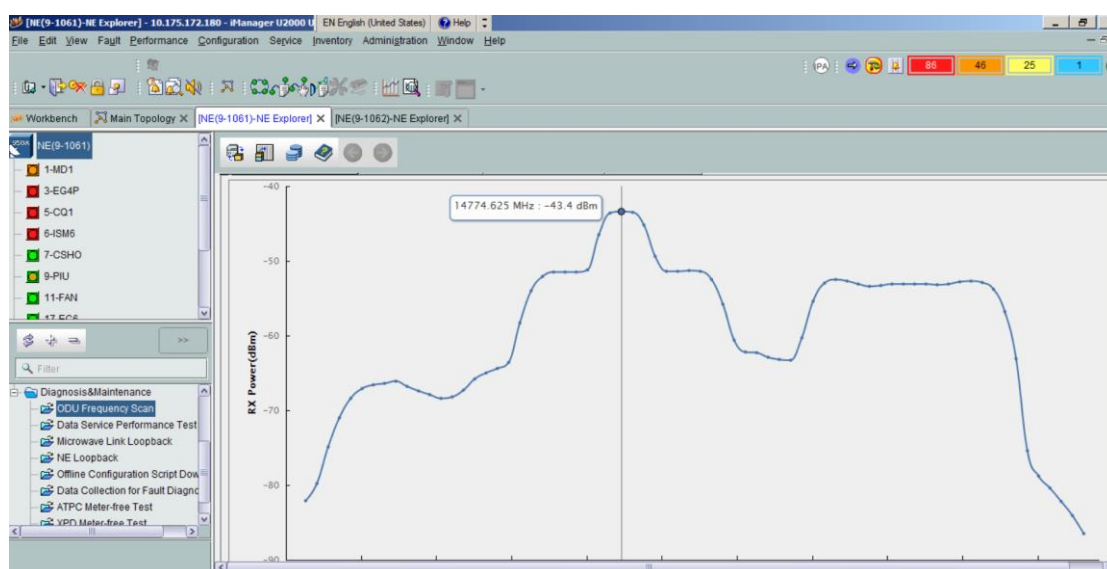
4. Interference check: After the result is displayed on performing the steps stated above need to firstly check the if MW link have interference, if have, try to change the frequency to avoid the interference after discussion with circle team; if does not have, please go to the next step

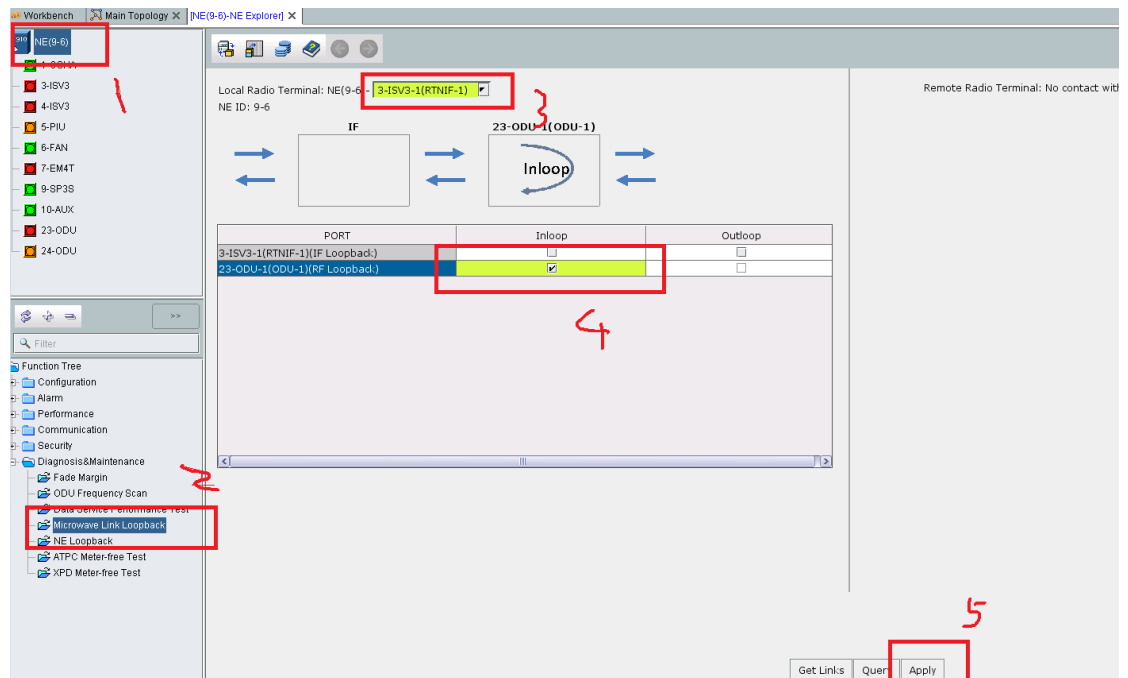
Before inloop, should mute all other ODUs in same link, except the one will inloop

Select the NE, do inloop as described in below picture;

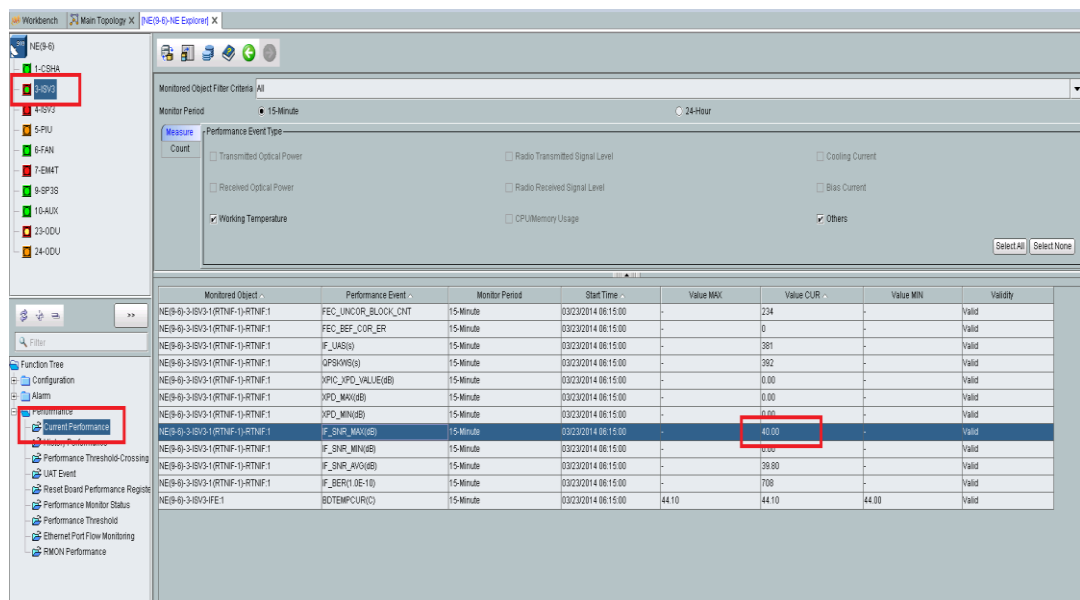
Then check the MSE(Or SNR) current; if the MSE is lower than 32dB (if your U2000 shows MSE, the value should be negative), go to the step 3; if the MSE is bigger than 32dB, means these side does not have problem, need check the other side;

Then do the IF board port inloop, if the MSE is big than 37dB (if your U2000 shows MSE, the value should be negative), means the ODU has problem, need replace the ODU; if the MSE is less than 37dB, means the IF board has problem, need replace the IF board
