MI&CT ESERVICE NOTE SN07021310a

Subject: Global Table Leg Bearings Issue

Effectivity: VCT 64 and 32, RT16 and PET Discovery VCT

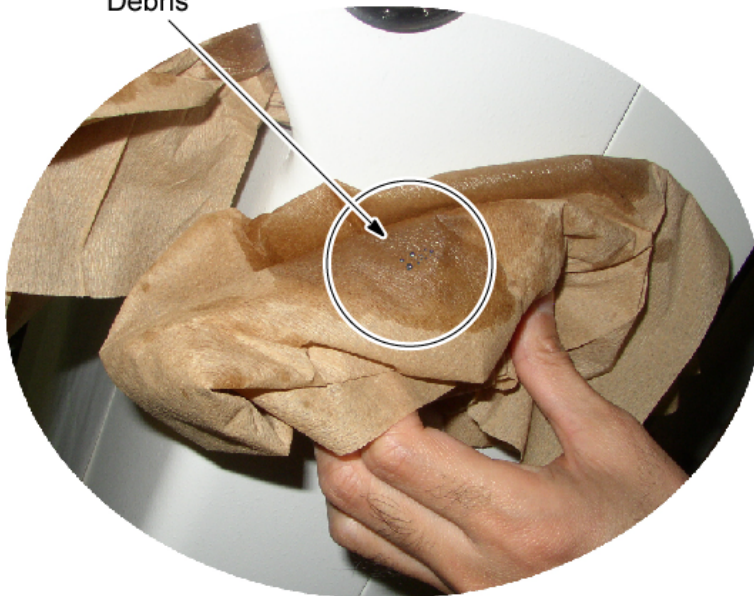
Figure - 8 Debris

If apparent debris from the bearing appears, please write a PQR to report this problem.

Debris

- 10). Spray a leg bearing with CRC5-56 of equivalent spray lubricant (WD-40, etc.) to flush debris from each bearings, and wipe off the oil flowed from the bearing.

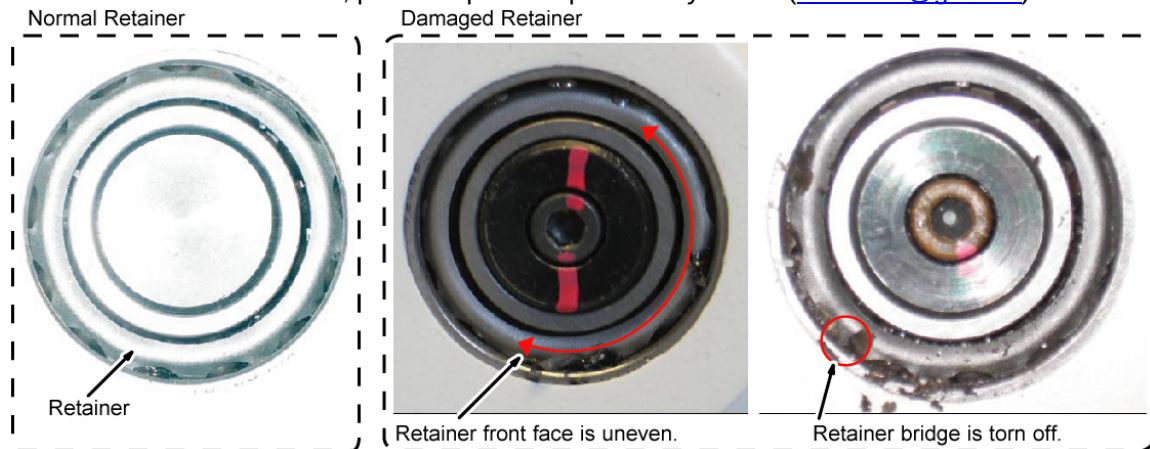
Figure - 9 Retainer

- 11). Visually check the retainer of the bearing for damage and deformation.

If the retainer is NOT OK, please report this problem by e-mail (fmi26812@ge.com).
