MI&CT eSERVICE NOTE
SN0803070720a

Date: March 7, 2008

Subject: Collimator Cam Motor FRUs

Effectivity: VCT systems

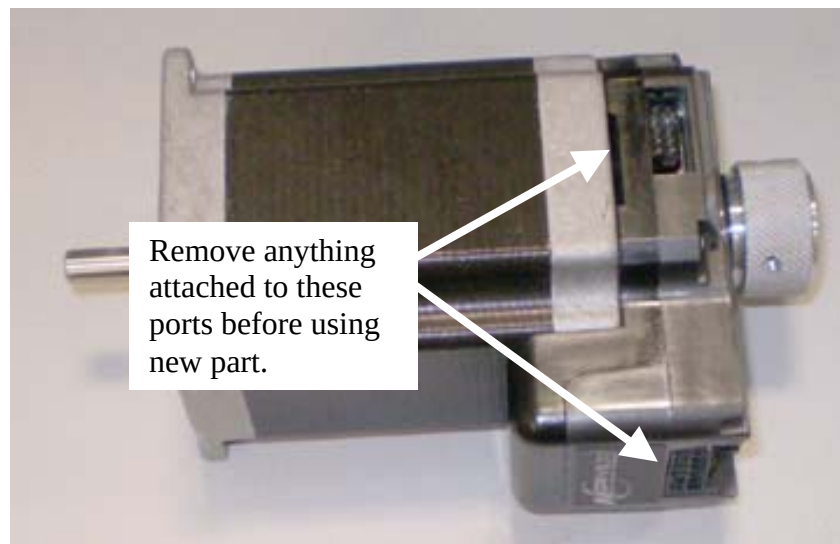
One older version of the collimator cam motor FRU has a small circuit board attached to the power plug of the cam motor when shipped as a replacement part. This small circuit board is for shipping purposes only to provide a back potential to keep the motor from spinning during shipping and handling. It is not part of the system design.

Remove the small circuit board and discard it, it is only for shipping purposes for one version of the cam motor. The small circuit board is not used on the collimator. This notation will be added to the replacement procedure.
