MOP for RADIO_RSL_LOW alarm clearance

This document outlines the step-by-step process involved in MOP for RADIO_RSL_LOW alarm clearance.

The RADIO_RSL_LOW is an alarm indicating that the radio receive power is very low. This alarm is reported if the detected receive power is equal to or lower than the lower threshold of the ODU (The upper threshold is -80 dBm for the 112 MHz channel bandwidth and -90 dBm for the other channel bandwidths).

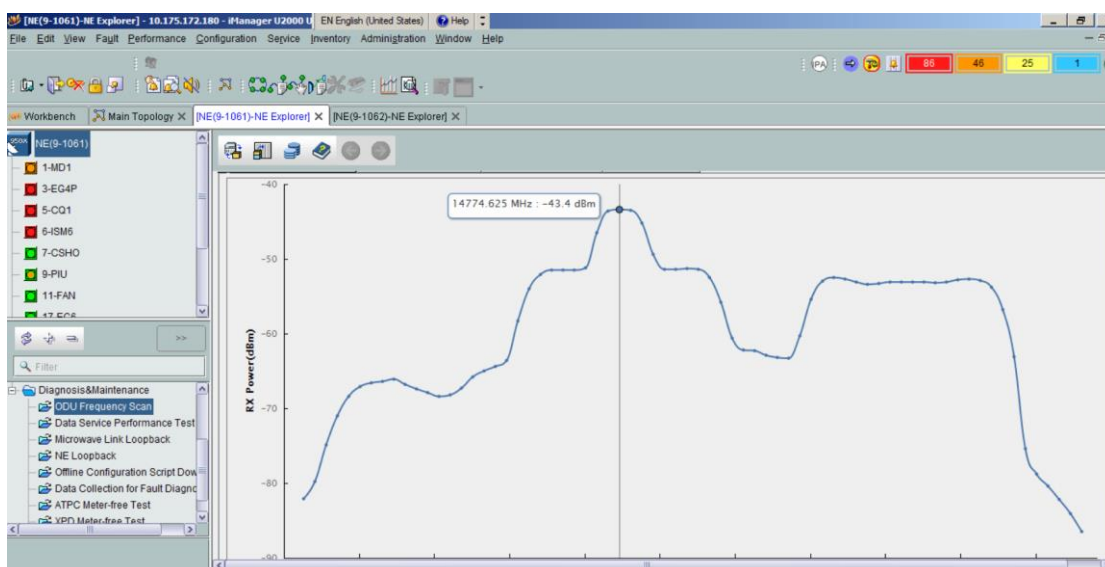
Interference check: firstly check the if MW link have interference, if have, try to change the frequency to avoid the interference; if does not have, please go to the next step

Note: loopback will interrupt service

before inloop, should mute all other ODUs in same link, except the one will inloop

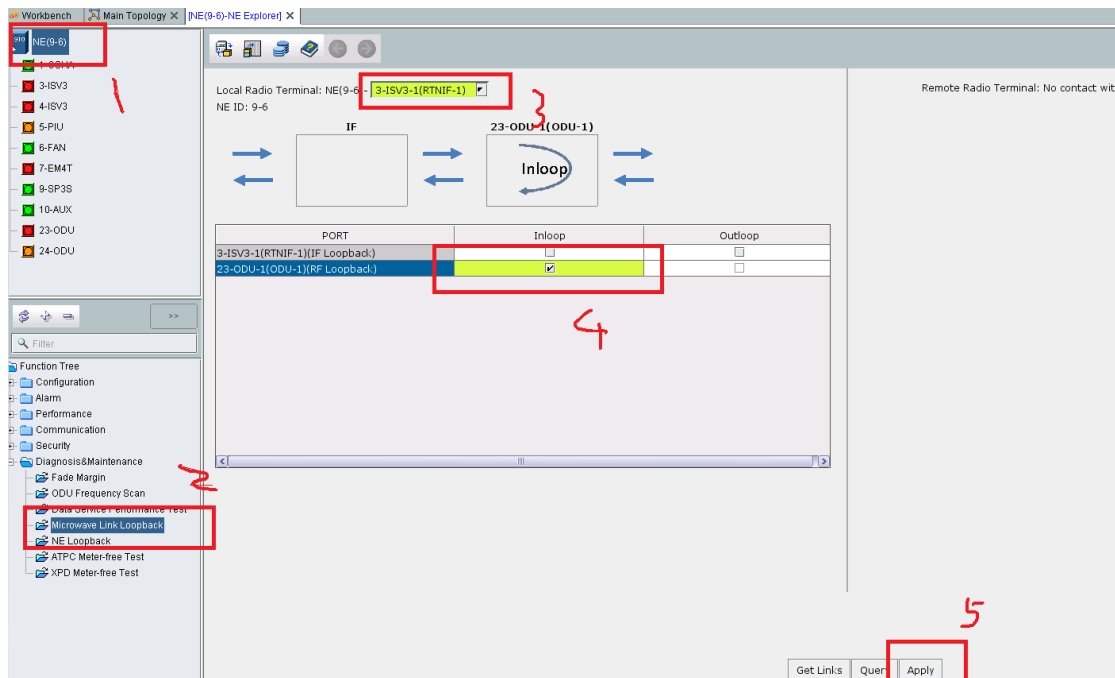
Select the NE, do inloop;

Then check the MSE(Or SNR) current; if the MSE is lower than 32dB (if your U2000 shows MSE, the value should be negative), go to the step 3; if the MSE is bigger than 32dB, means these side does not have problem, need check the other side;

Then do the IF board port inloop, if the MSE is big than 37dB (if your U2000 shows MSE, the value should be negative), means the ODU has problem, need replace the ODU; if the MSE is less than 37dB, means the IF board has problem, need replace the IF board
