HSDCD Taxi Modem Violation Upgrade Kit P/N: 2345224 - KITS ARE AVAILABLE NOW!

MQUE-5AYL5G

Direction 2344544-100

LightSpeed Ultra/Plus HSDCD TMV Upgrade

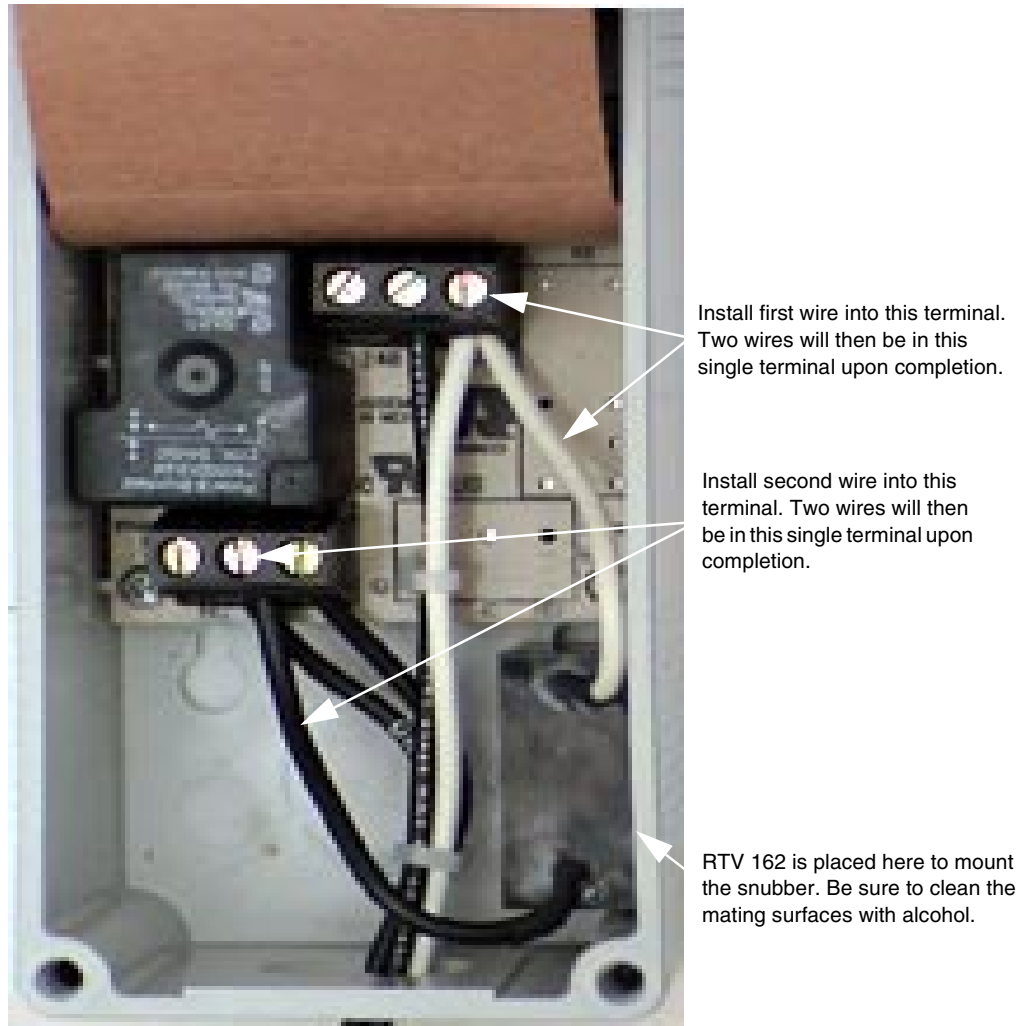
Figure 1 Gantry Thermostat Modification

- 1.) The gantry thermostat switches the gantry fans on and off. The inductive kick of the fan motors creates 500 V spikes on the 120 VAC wave form. The spikes generate noise that is picked up by the HSDCD receiver.
- 2.) When high voltage is asserted across the slip rings, a brief (about 5 cycles) spike of noise is generated between the stationary and rotate side grounds at a frequency of approximately 1.5 to 2.5 MHz - the resonant frequency of the cable. This creates noise on the HSDCD ring.

- 1.) Refer to the *System Service Manual* as needed in the performance of these tasks.
- 2.) Remove the left and right gantry side covers.
- 3.) Turn OFF all three switches (Gantry 120 VAC, Axial Drive Enable and HVDC Enable) on the STC backplane.
- 4.) Remove the gantry thermostat from the left side of the gantry. It is mounted with a bracket and held by two screws on either side.
- 5.) Remove the thermostat cover held on by four screws at each corner of the face cover plate.
- 6.) Install the supplied snubber device as shown in [Figure 1](#).

Note: Do not remove any of the existing wires.

- 7.) Clean the snubber housing and the mating surface inside the thermostat housing with alcohol prior to applying RTV 162. Ensure both surfaces are clean and dry.
- 8.) Apply a dab of RTV 162 on the side of the snubber being mounted to the thermostat housing.
- 9.) Stick the snubber to the side of the thermostat housing.

- 10.) Connect the wires as shown in [Figure 1](#).
- 11.) Replace the thermostat cover and remount the thermostat to the gantry.
- 12.) Turn ON gantry 120 VAC at the STC backplane.
- 13.) Reduce the thermostat setting until the fans activate. If fans do not activate, shut off gantry 120 VAC at the STC backplane and verify good connections were made at the terminals inside the thermostat. Begin again at step [11](#).
- 14.) Restore original 26, 1 setting to thermostat.
- 15.) Turn OFF gantry 120 VAC at the STC backplane.
- 16.) Continue to [Section 3.0](#).

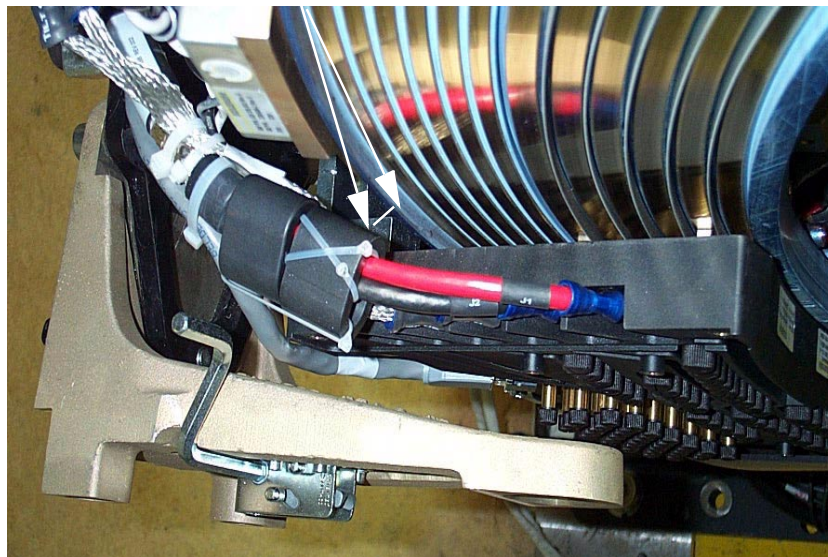
Figure 3 Ferrite Core Clearances

Note: **These ferrite cores are insulators so they will not short out the slip ring. To prevent these cores from rubbing against the slip ring and causing wear, follow the next step carefully.**

- 17.) [See Figure 3](#). Verify that there is a minimum of 1 cm clearance between the ferrite cores and the slip ring. If needed, pull on the wires a bit to provide this clearance. The wires are stiff enough to hold a new shape. Make sure all wires and cables are clear from the slip ring. Use additional cable ties as needed.

Ensure at least 1 cm clearance between slip ring surface and ferrite cores as shown.
