MOP of GNSS Receiver Satellite Searching Fault (198096837) for ZTE Site

This activity is for E2E troubleshooting and alarm clearance of GNSS receiver satellite searching fault (198096837)

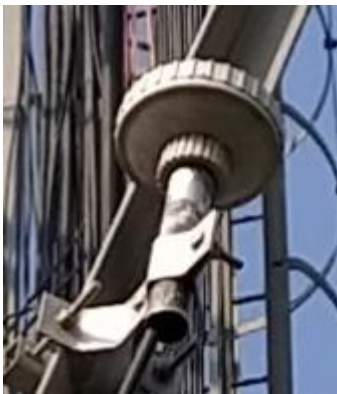
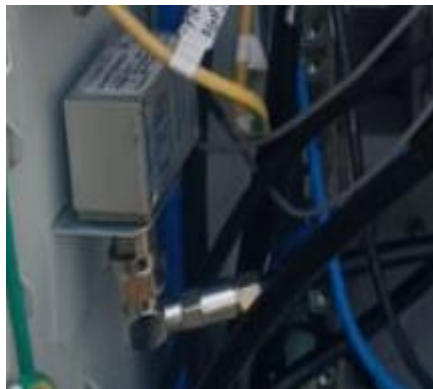
d) Replace hardware as per fault location.
