TECHNICAL BULLETIN

Mini, 100, 200/400, New 200, New 400

Bull. No: 0028

REMOTE HANDSET, BUTTON DAMAGE

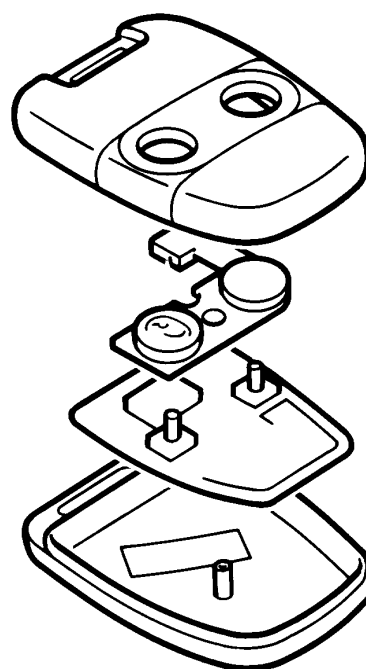
A6957TC1

Buttons split (damage by finger nail).

Buttons stuck down (displaced and trapped under casing).

Remote handset service kit, part number YWX101010 introduced to enable button and casing replacement whilst retaining the original transmitter component. This improved housing is supplied with modified rubber buttons to prevent reoccurrence of the above problems.

- Prise original handset apart, with a small screwdriver, inserted into the cut-out at the rear (key ring end) of the remote handset.
- Using finger pressure only, prise apart the two clips holding the printed circuit board and remove it from the remote handset.

- **Press the new button moulding into the new upper casing.**
- **Clip the original printed circuit board into the new upper housing assembly taking care to align it correctly.**
